Inspection Report For:
Fairford Town Council

Inspection Location:
39989 - The Croft Park

Inspection Date:
24/02/2026

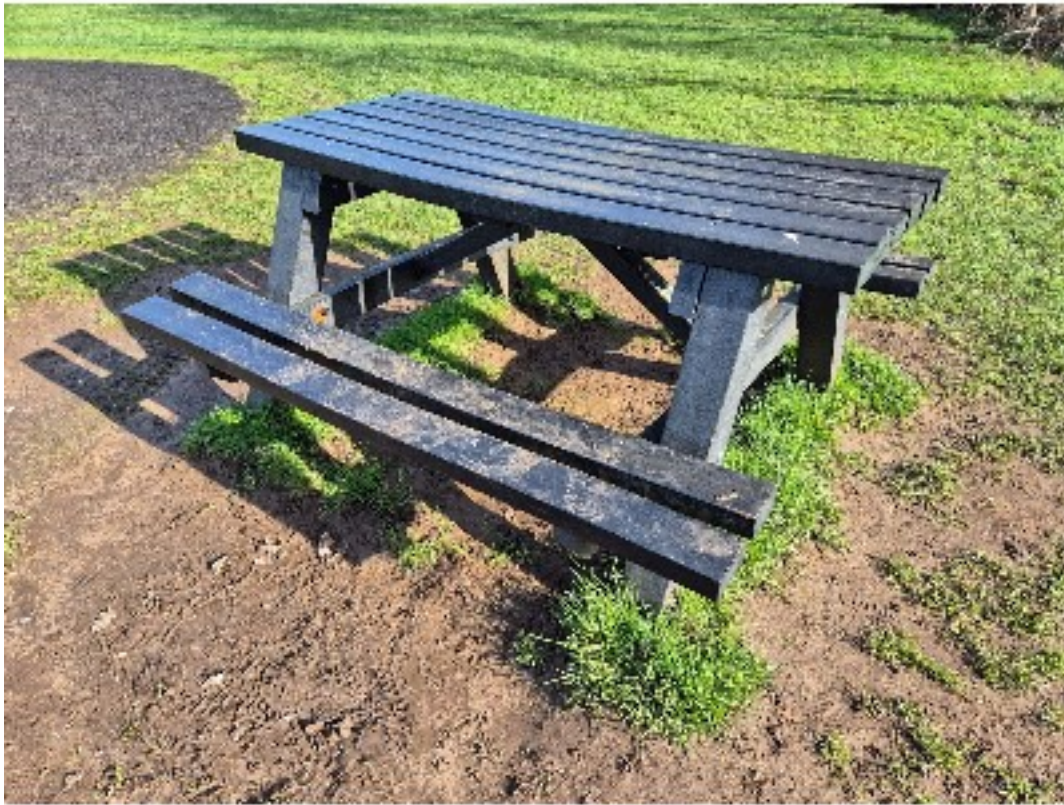
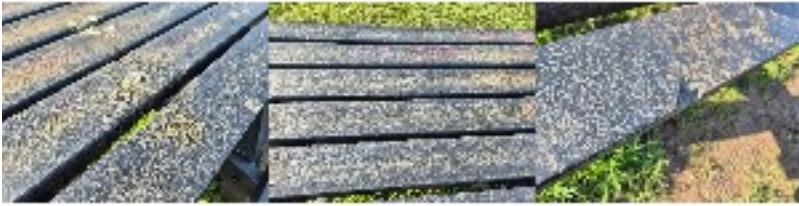
Picnic Tables

Finding Two: There is some fire damage to a couple of the units.

Finding Three: There is graffiti present on the item.

Finding Four: There is minor damage to a couple of the slats.

Finding Five: There is a fixing missing on one of the slats

Action(s): Clean and treat appropriately

Action(s): This is a low risk finding and no remedial action is required at this time - monitor use

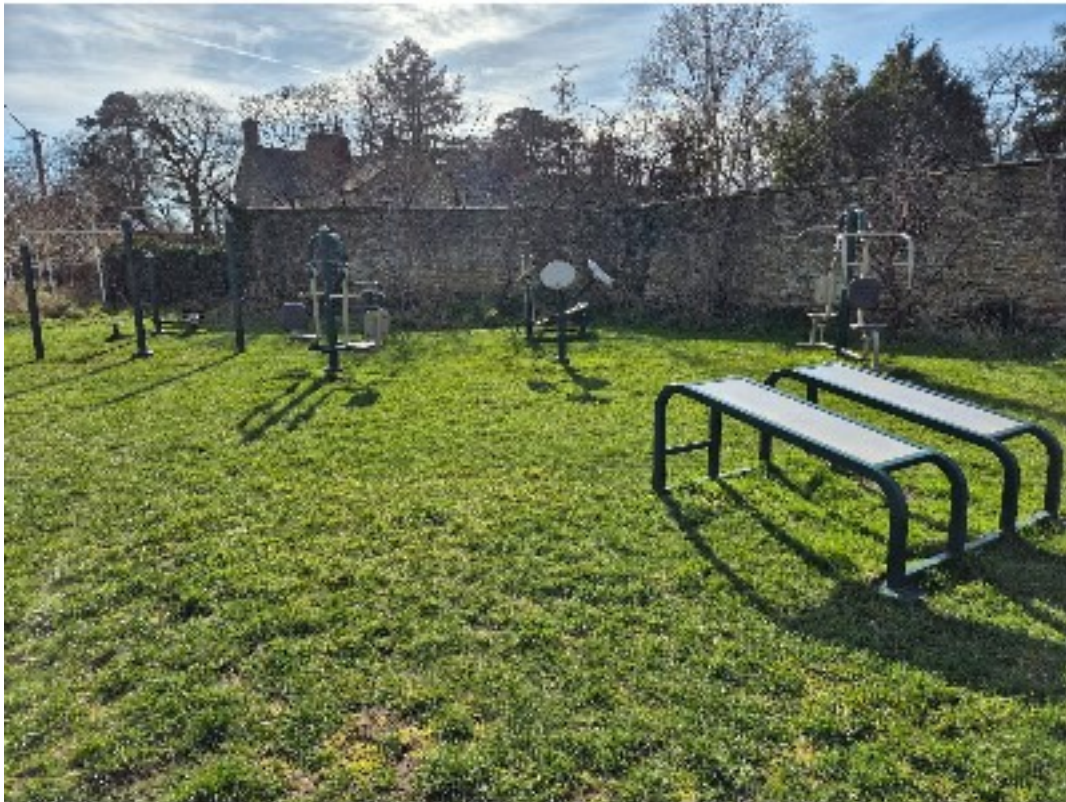
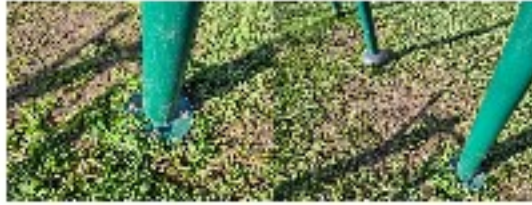
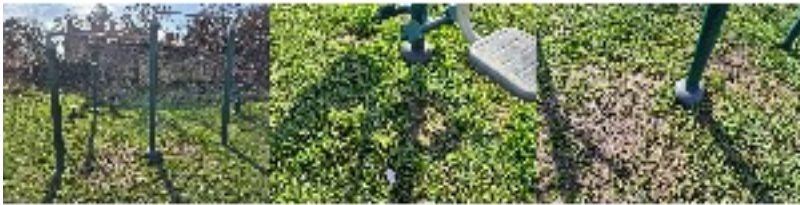
Fitness Equipment

Finding Two: Equipment had missing or damaged safety caps
Action(s): This is a low risk finding and no remedial action is required at this time - monitor use

Finding Three: Some of the base covers are missing

The Grass Tiles have sunk into the ground and are unlikely to provide the correct level of impact attenuation.

Consider relaying replacing, or an alternate surface

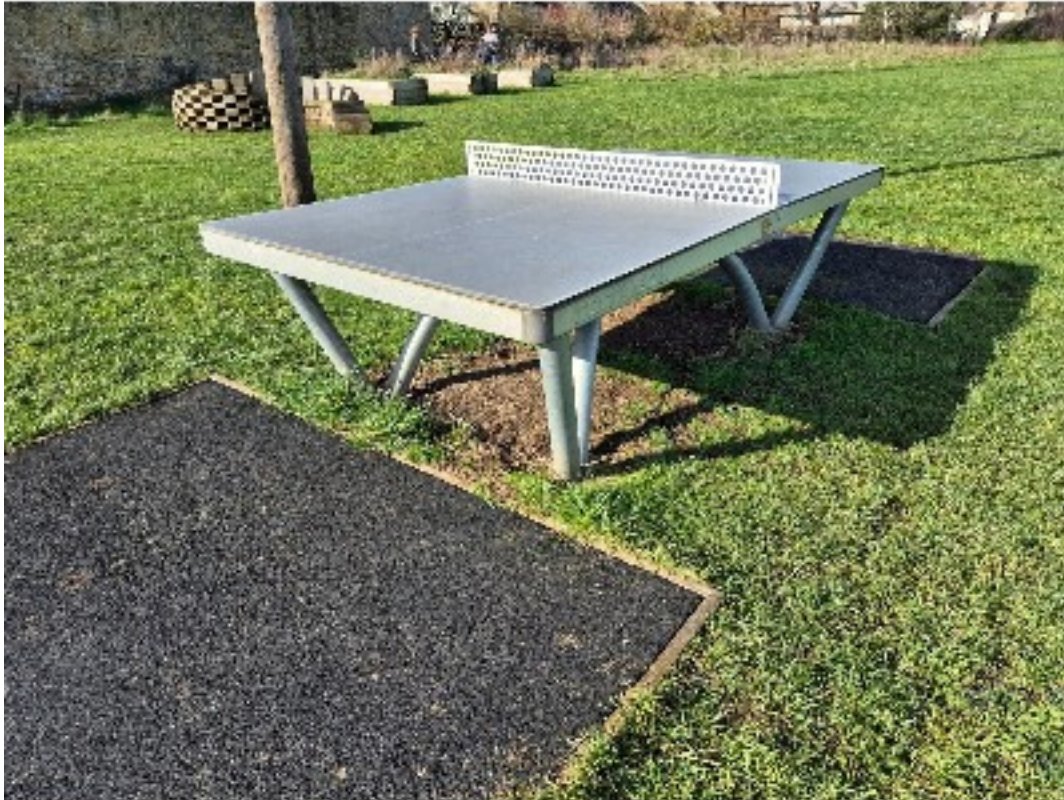
Table Tennis Table

Finding Two: There are trip hazards at the edge of the surface

Action(s): Consider building up ground level to eliminate trip hazards

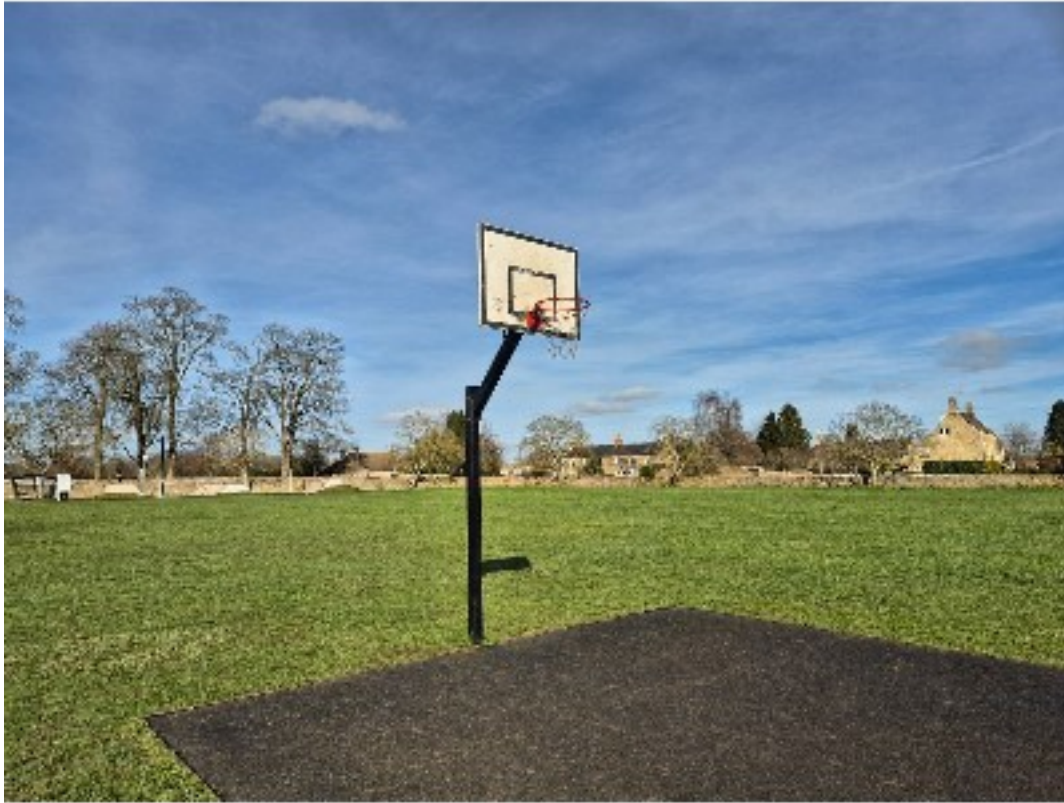
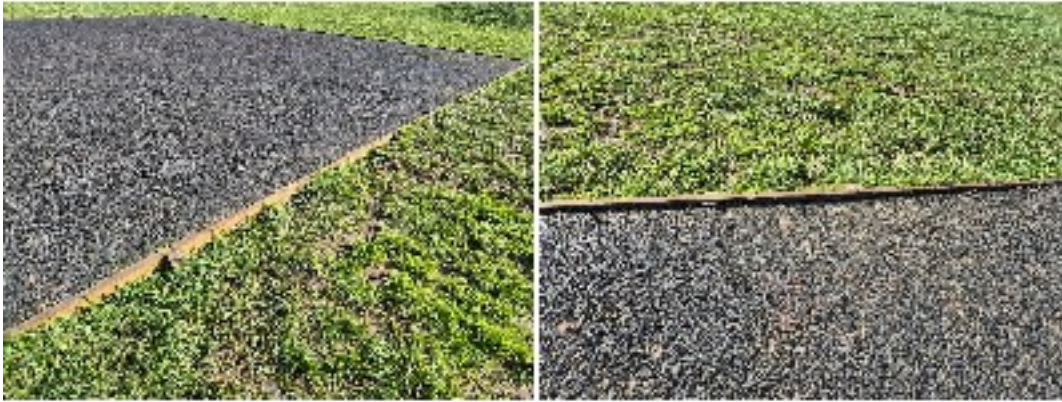
Basketball Post

Finding Two: Parts of the metal work are starting to rust/corrode

Finding Three: There are trip hazards at the edges of the surface

Action(s): Consider treating and repainting

Consider building up ground level to eliminate trip hazards

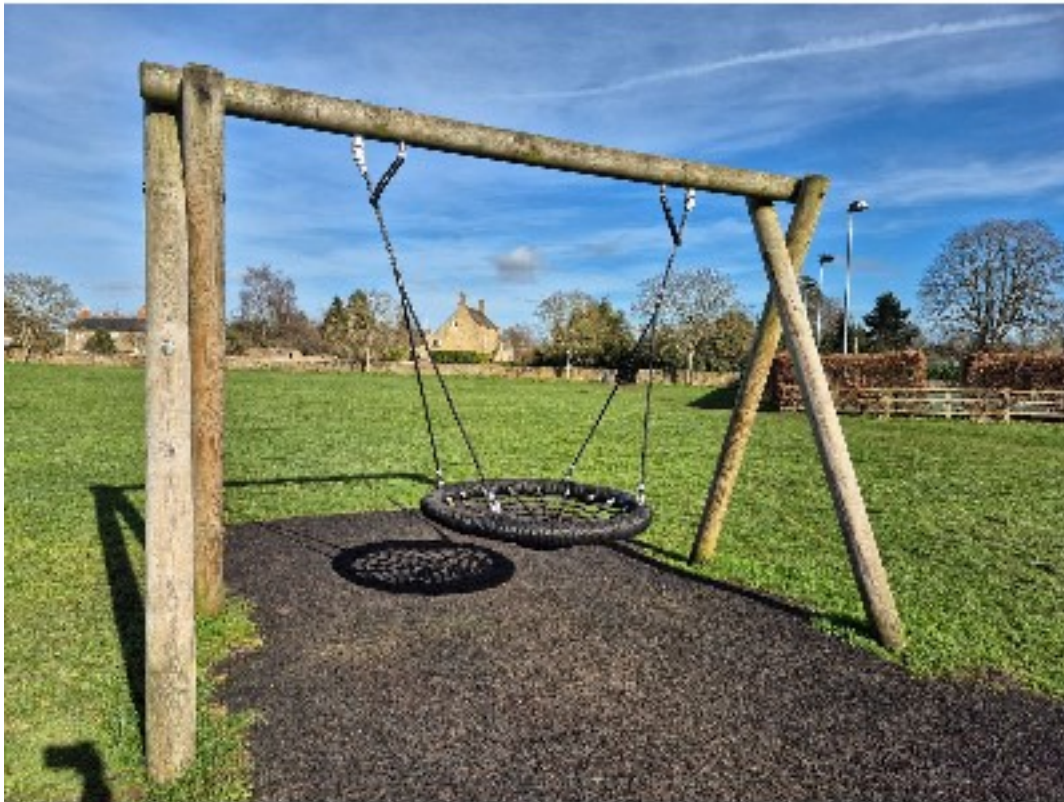
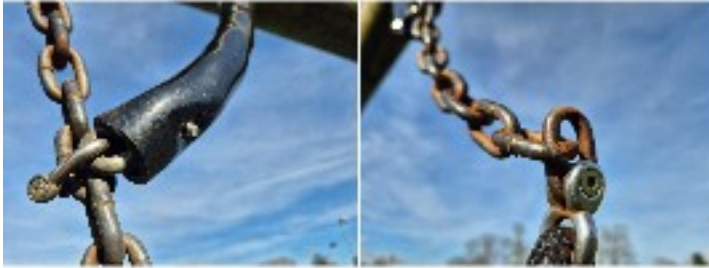
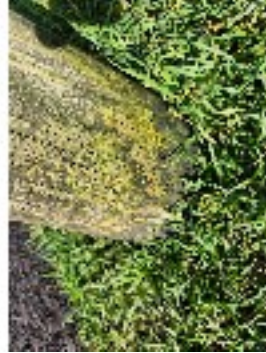
Basket Seat Swing

Finding Two: There was a fixing missing on the safety chain.
Action(s): This is a low risk finding and no remedial action is required at this time - monitor use

Finding Three: There is minor chain wear.

Finding Four: Some of the timbers have been cut into by machinery.

Action(s): Monitor for any further deterioration and replace as required

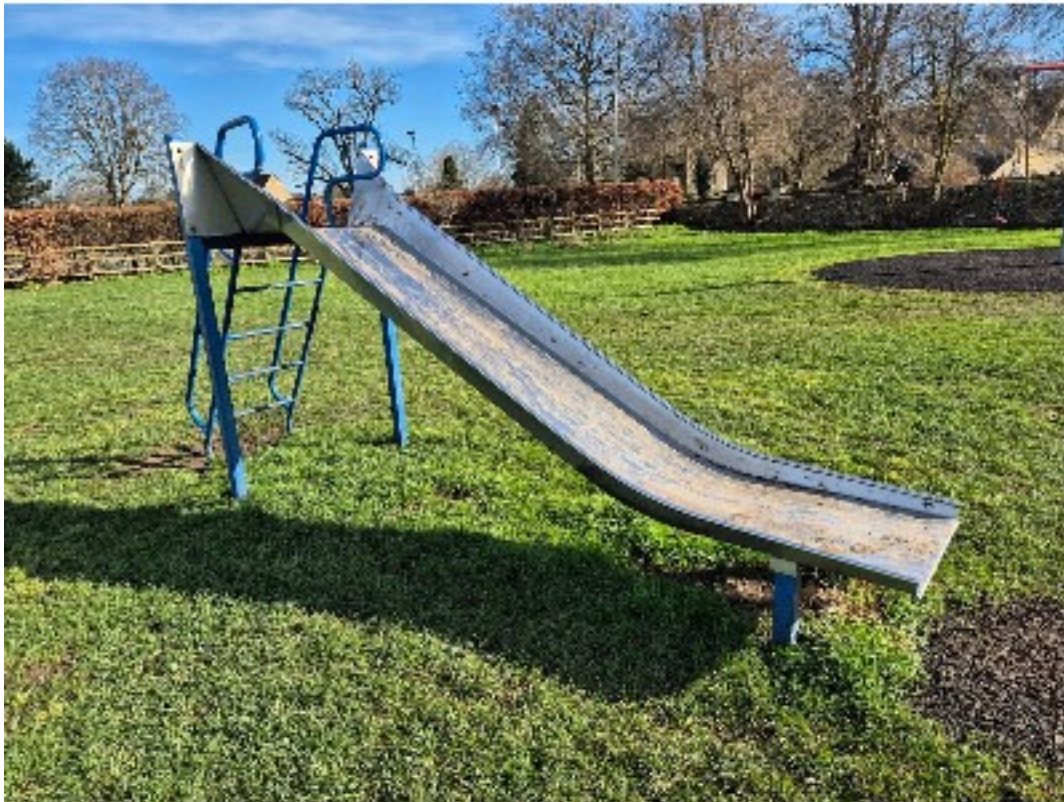
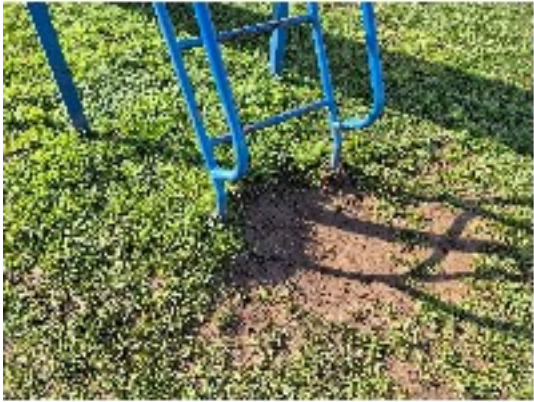
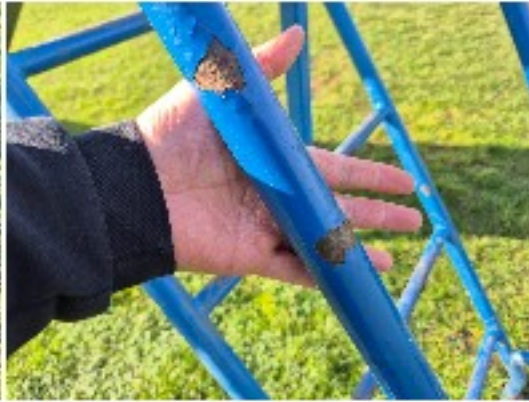
Slide

Finding Two: Parts of the metal frame are starting to rust/corrode

Finding Three: The surface at the base of the steps has eroded

Action(s): Consider treating and repainting.

Consider building up ground level

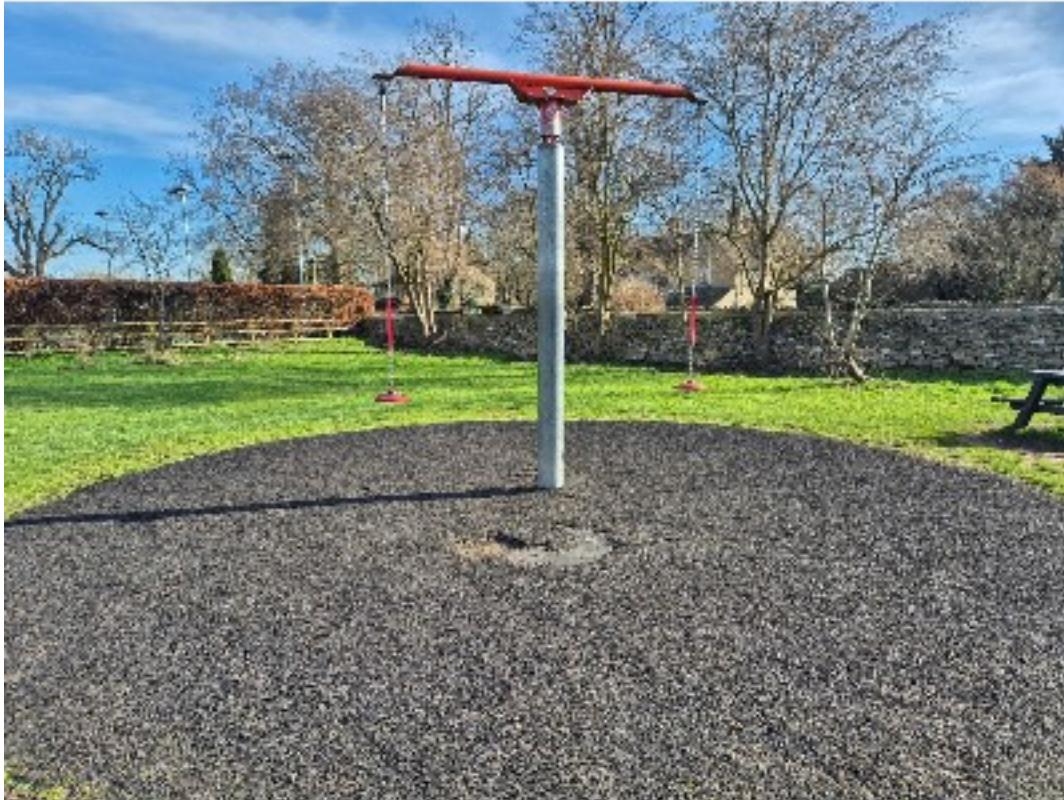
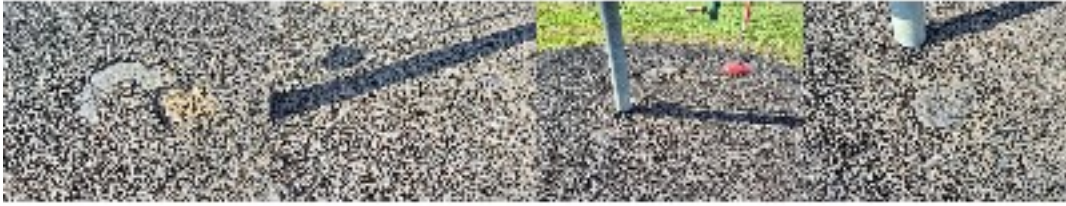
Rotating Swing

Finding Two: The rubber mulch surface is damaged in several areas.

Action(s): Repair/replace as required

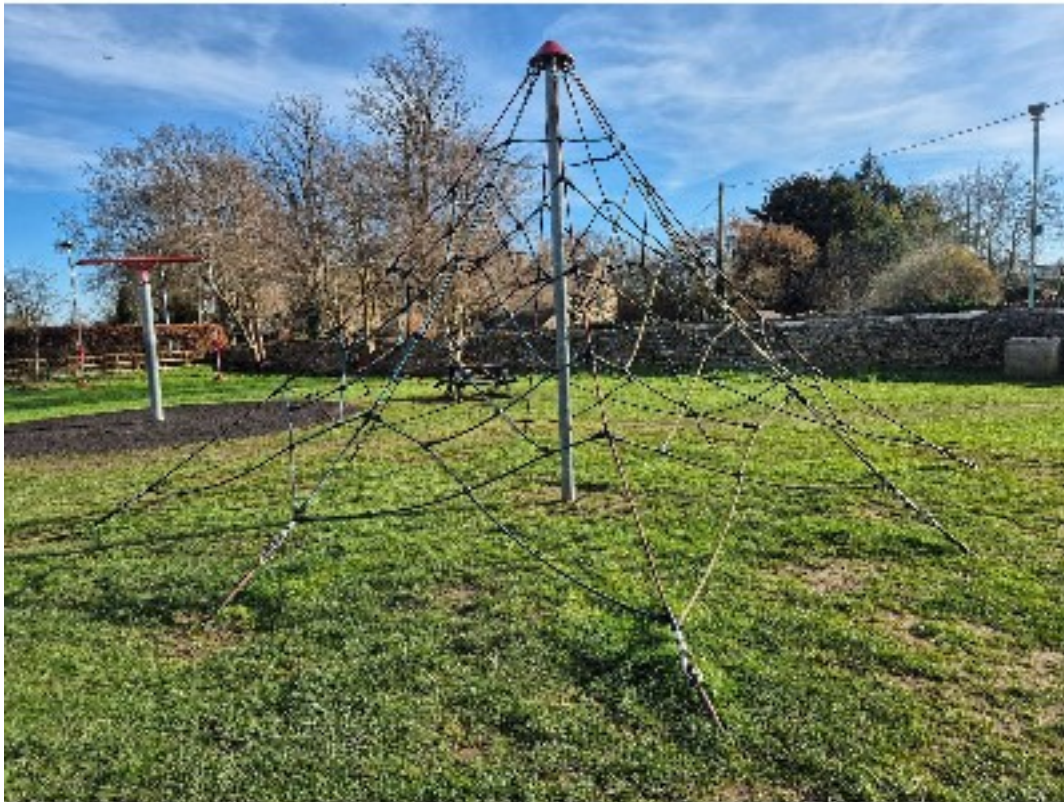
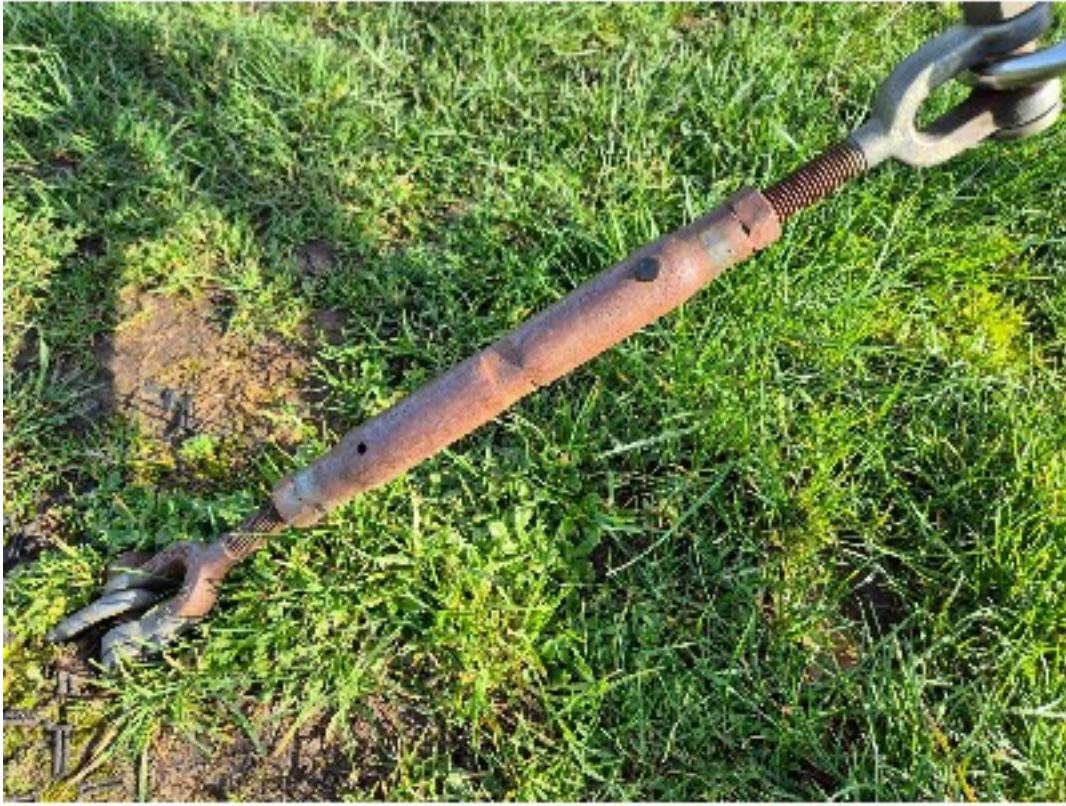
Pyramid Net Climber

Finding Two: The ground adjustable fixing anchors are showing signs of rust/corrosion

Action(s): Monitor use

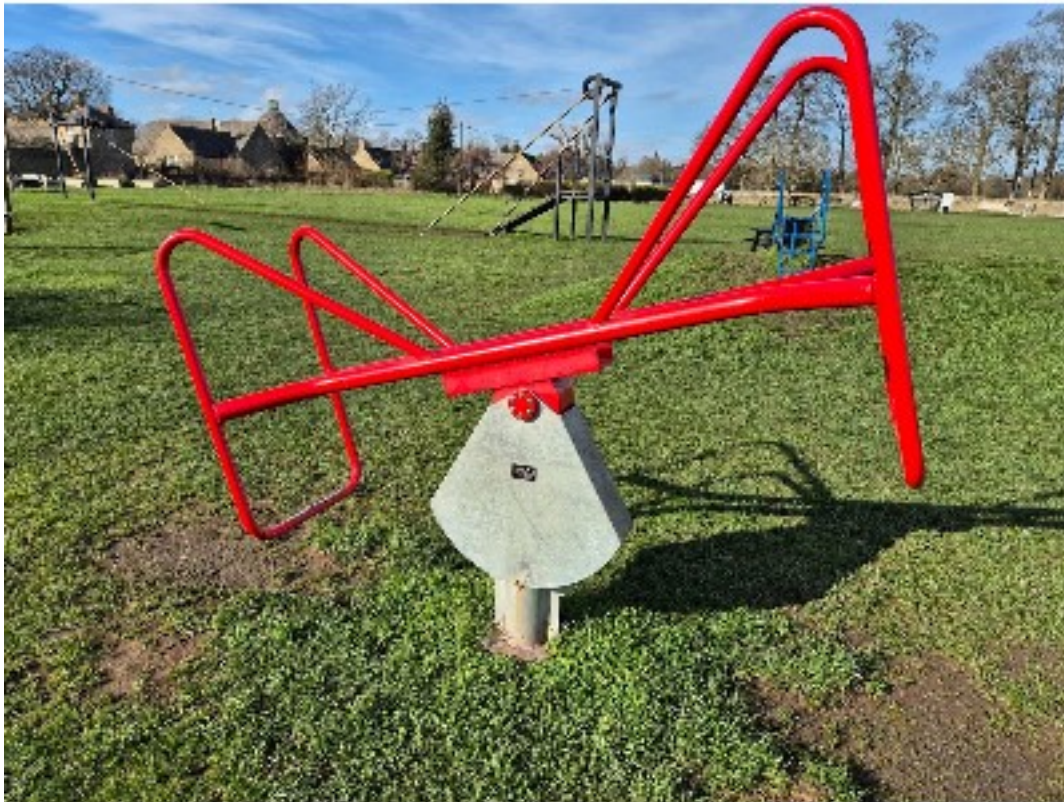
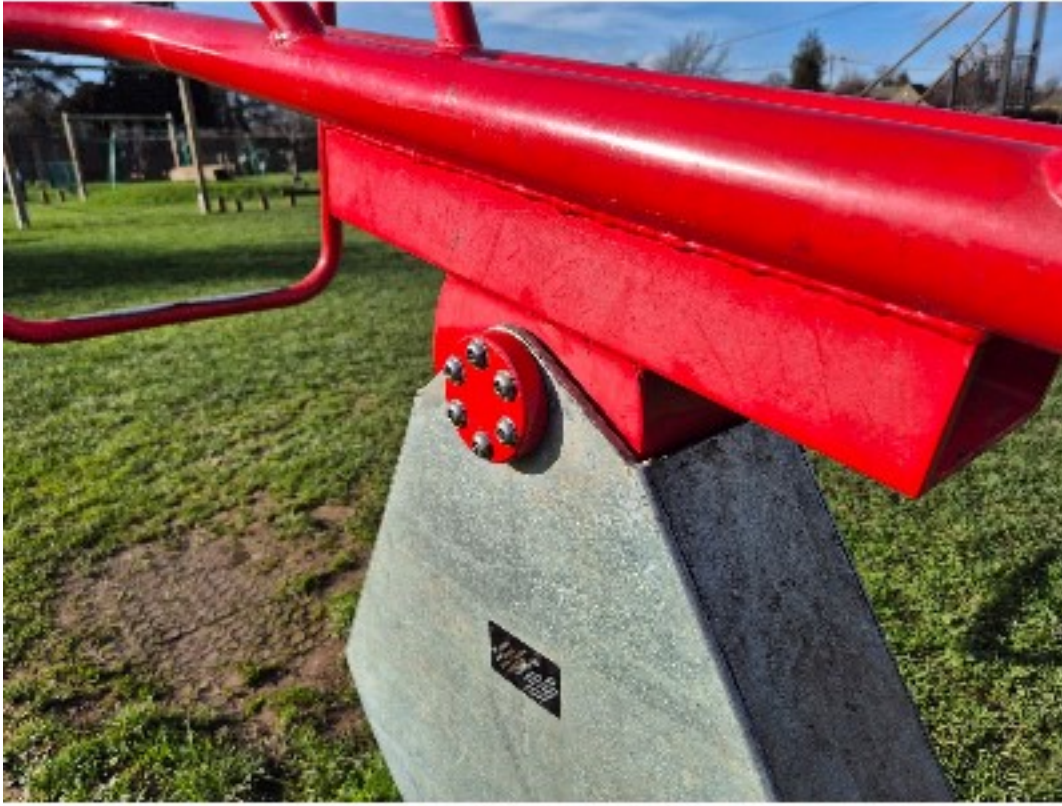
Stand Up See-Saw

Finding Two: There is a lot of play in the central pivot point and there doesn't seem to be any dampening when operating

Action(s): Consider stripping down unit to investigate.

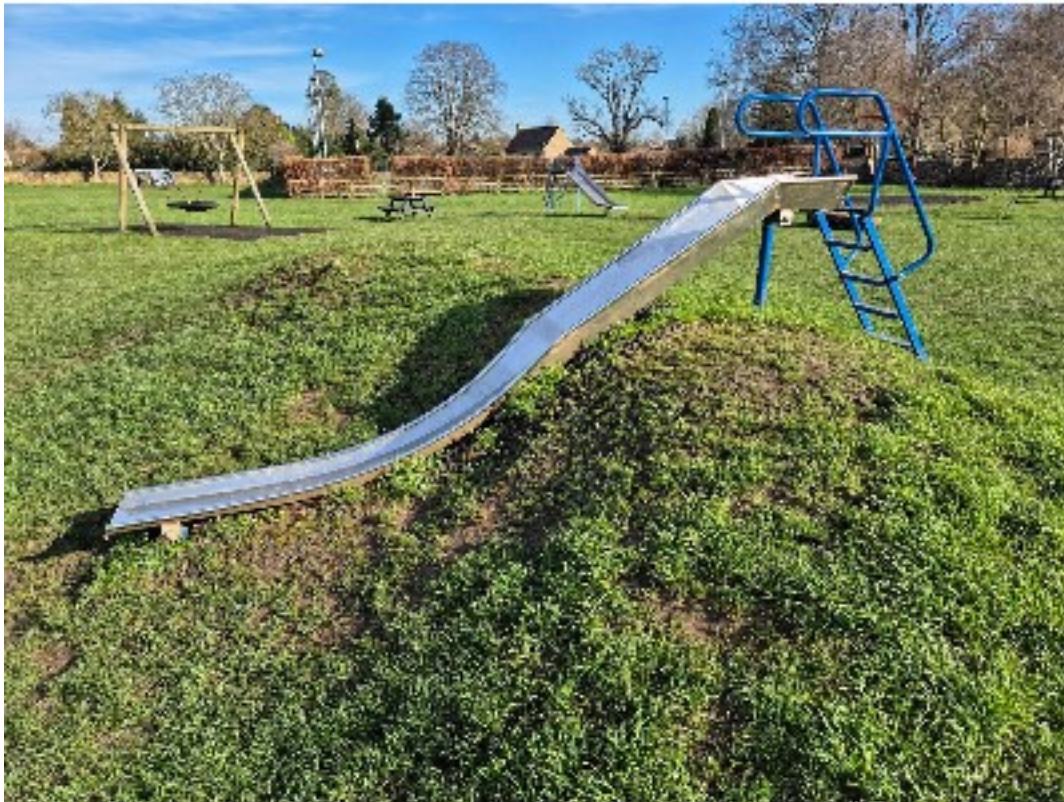
Embankment Slide

Finding Two: There is minor damage to the surface of the slide.

Action(s): Monitor use

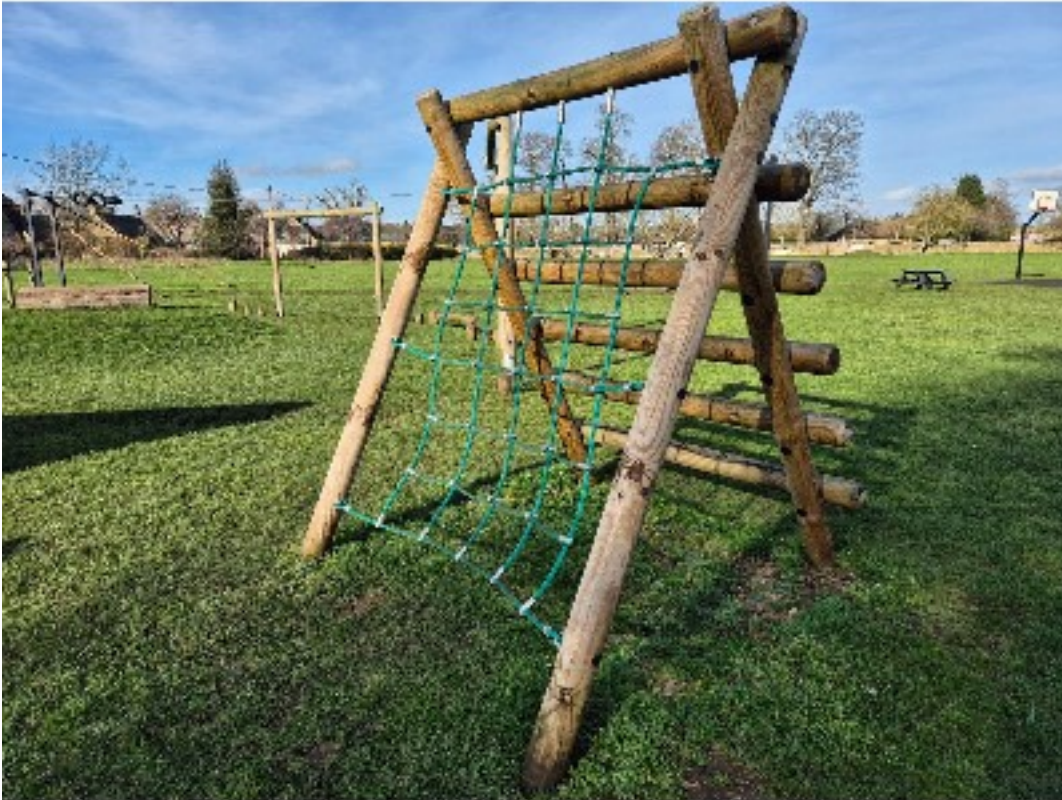
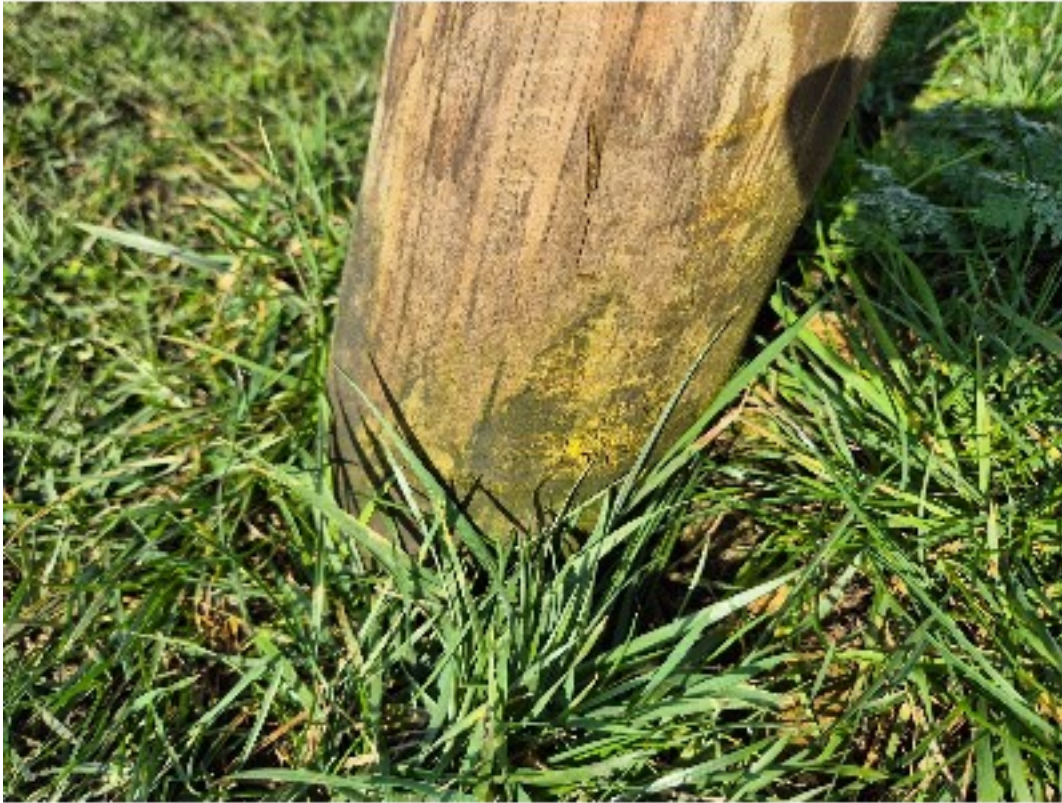
Net Climber

Finding Two: Some of the timbers had been cut into by machinery

Action(s): Monitor for any further deterioration and replace as required

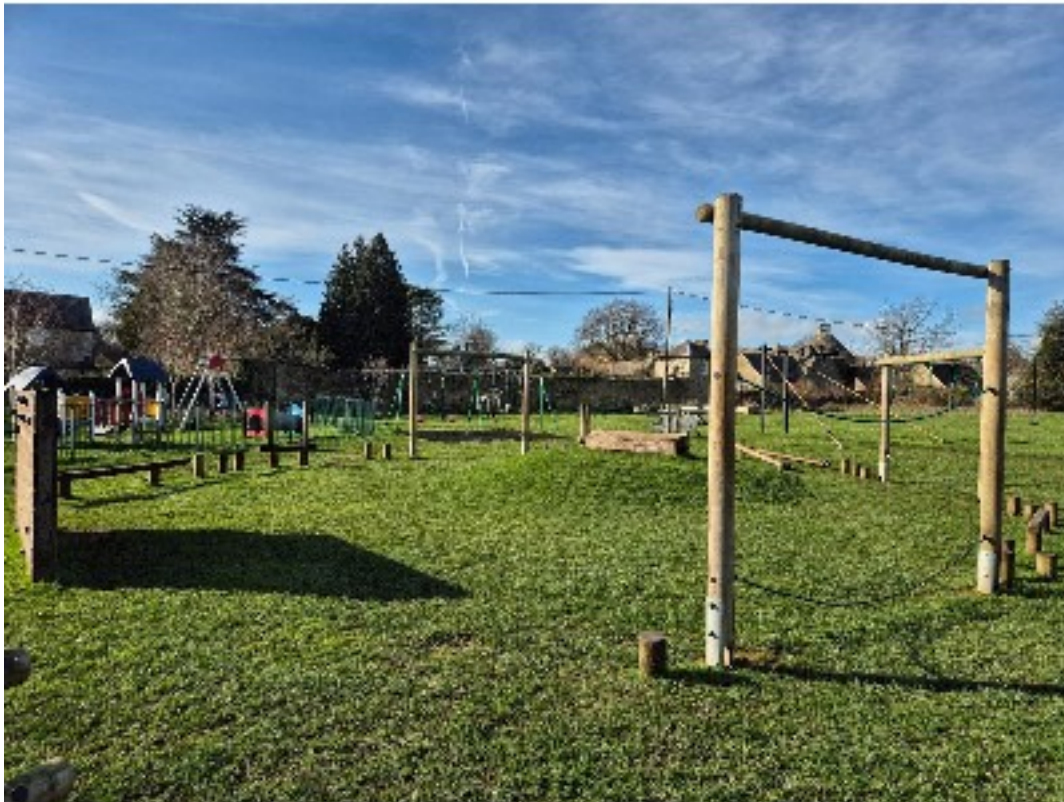
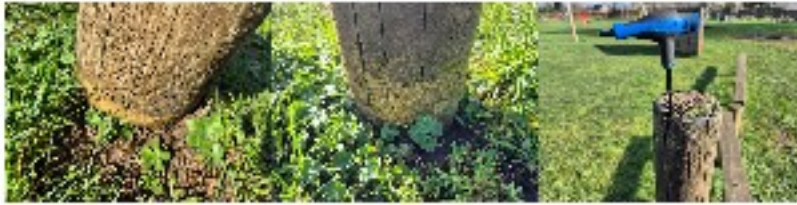
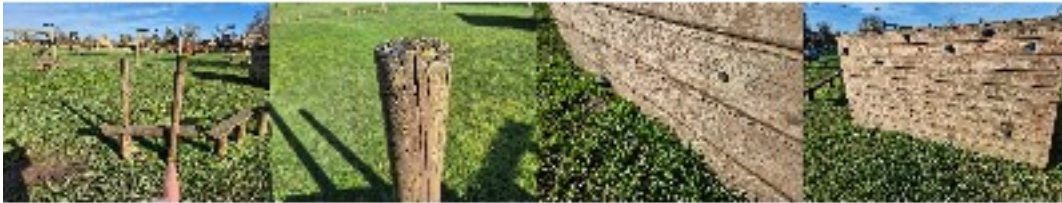
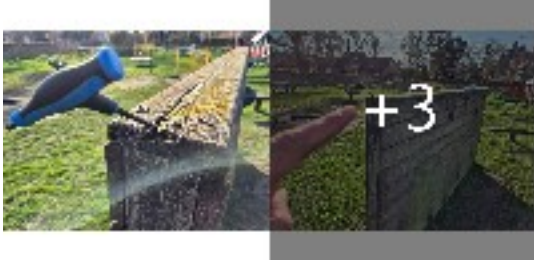
Trim Trail

Finding Two: Some of the timbers had been cut into by machinery

Finding Three: Some of the timbers are showing early signs of fatigue.

Finding Four: Some of the timbers are showing air cracks (referred to as timber shakes).

Finding Five: There are 2 hand grips missing on the climbing wall

Action(s): Monitor for any further deterioration and replace as required

Action(s): Air cracks (timber shakes) are common place. Dull any edges that have the potential to cause splinters

Action(s): Consider replacing missing handgrips.

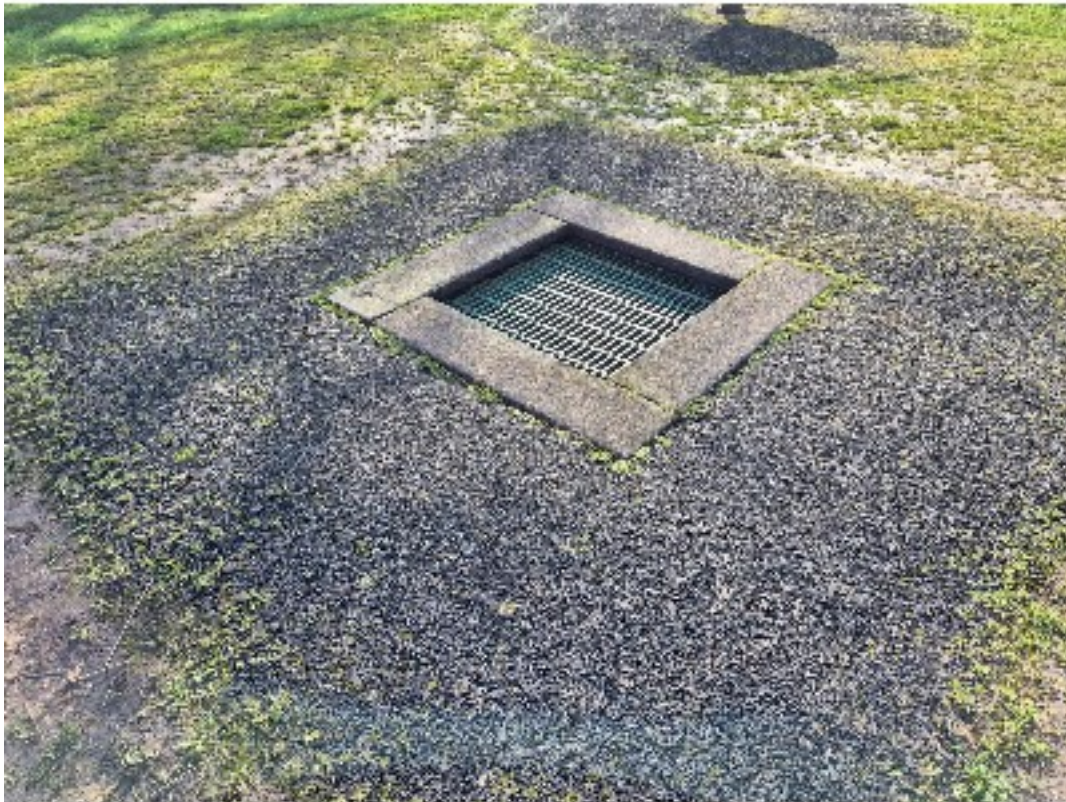
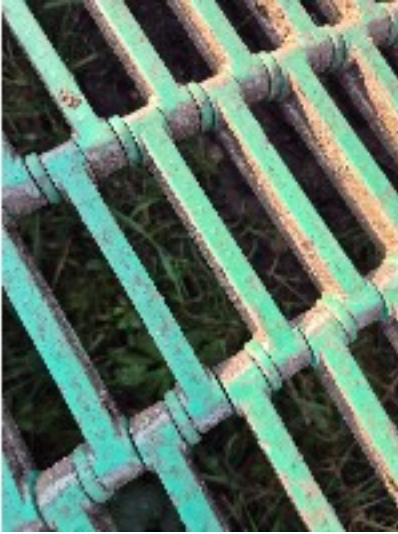
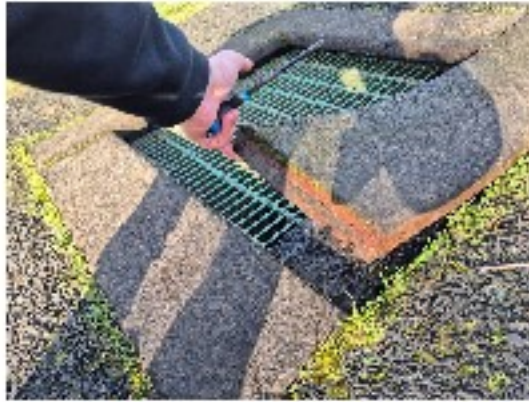
Inground Trampoline

Finding Two: The bed of the trampoline is full of soil and weeds.

Finding Three: One of the wet pour edges has come away from frame

Action(s): Consider clearing out bed of trampoline.

Repair/replace as required

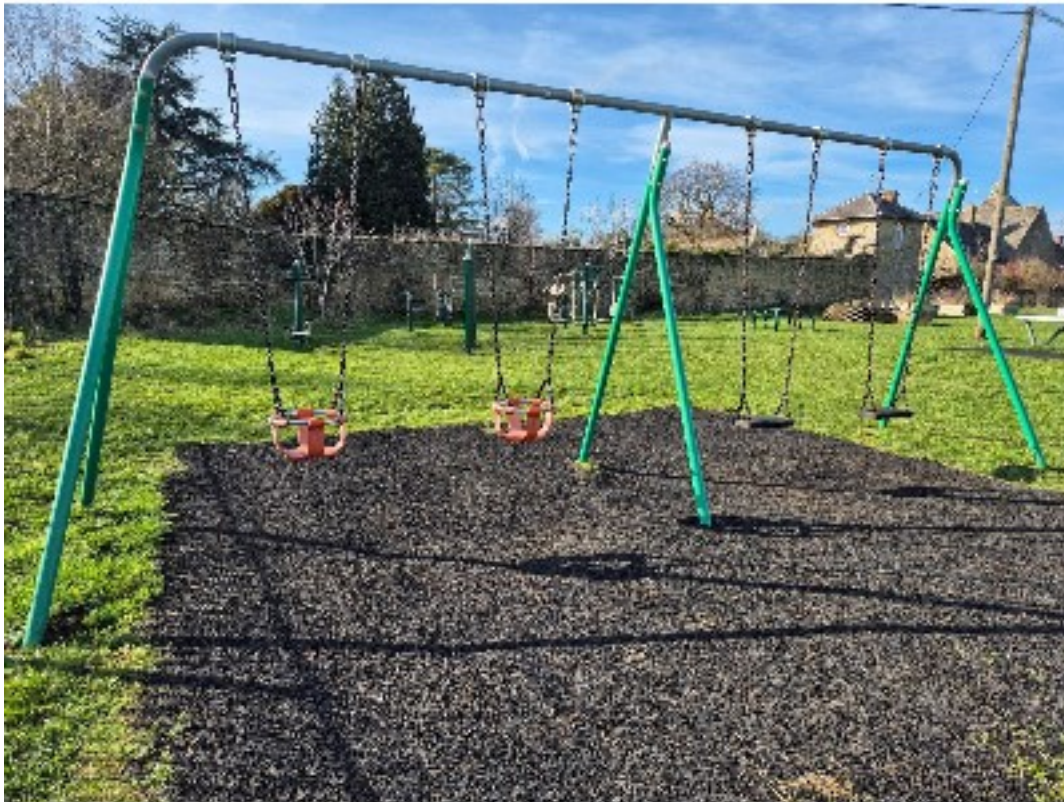
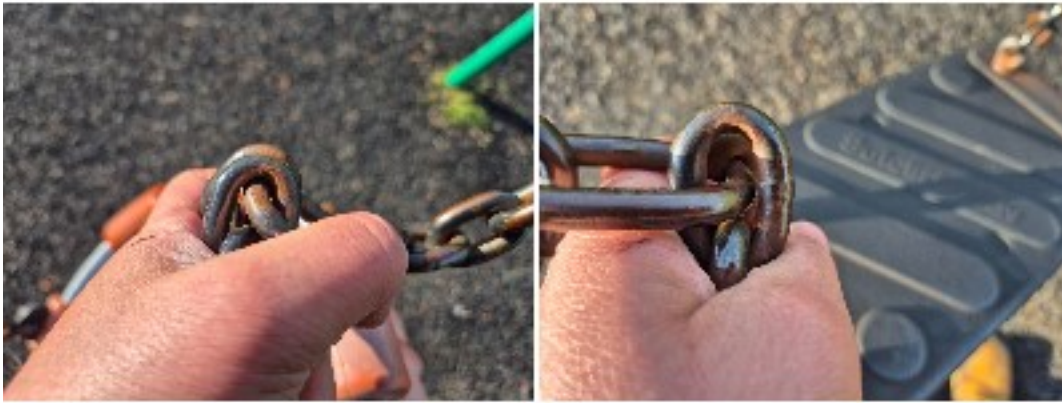
2 Bay Mixed Seat Swing

Finding Two: Therw is minor chain wear to all seats

Action(s): Monitor for any further deterioration and replace as required

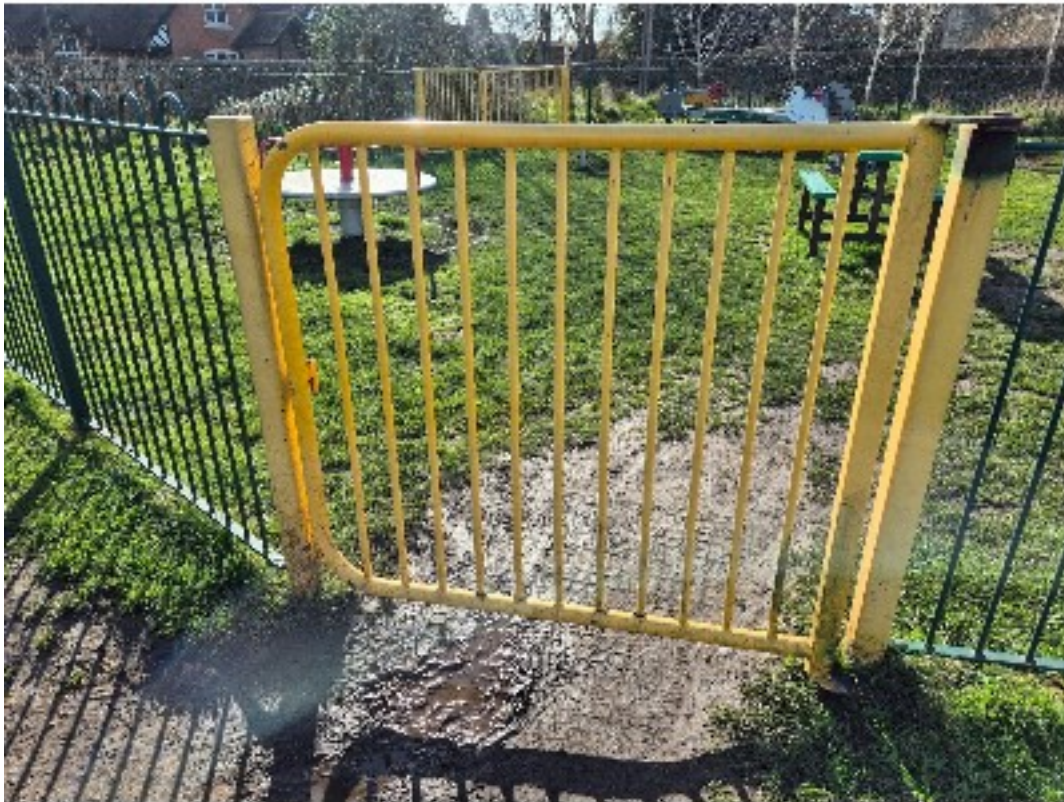
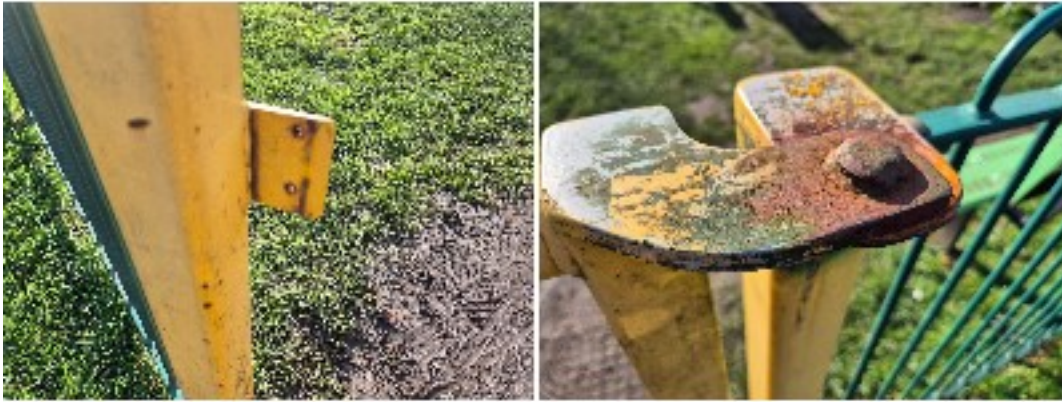
Gate

Finding One: The item is in poor overall condition

Finding Two: The rubber gate buffer was missing from the gate

Finding Three: Parts of the metal is rusty/corroded

Action(s): Repair/replace as required

Action(s): Consider treating and repainting.

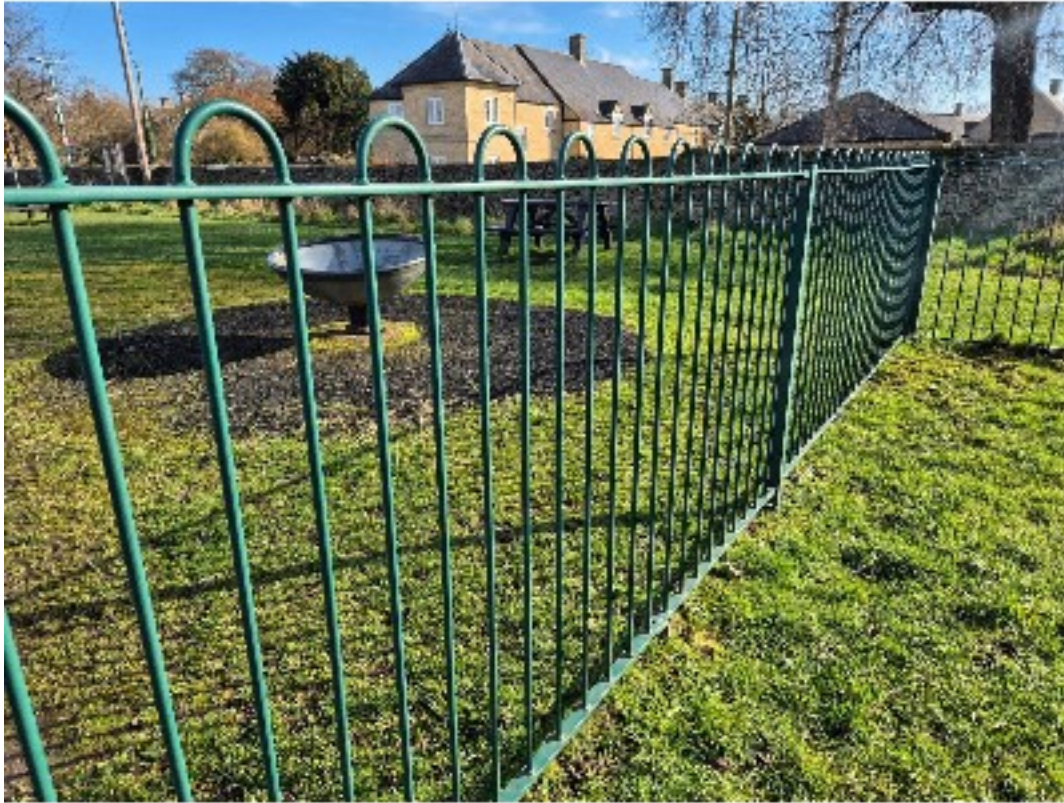
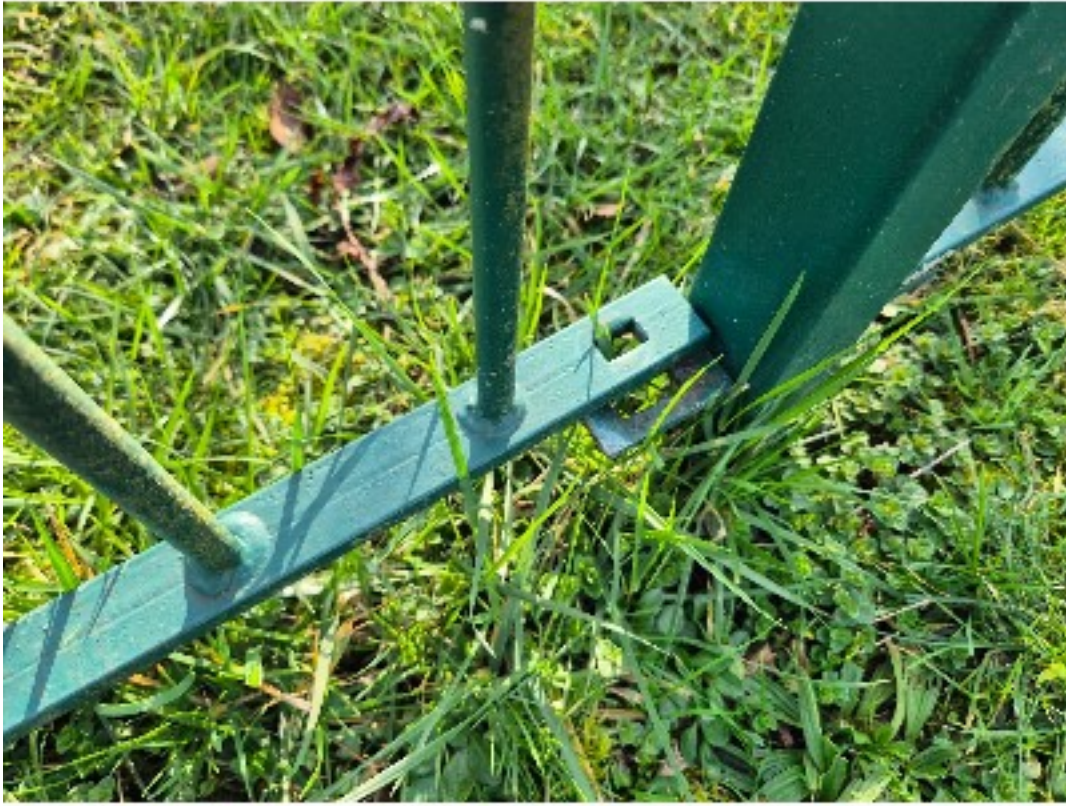
Fencing

Finding Two: There was a fixing missing.

Action(s): This is a low risk finding and no remedial action is required at this time - monitor use

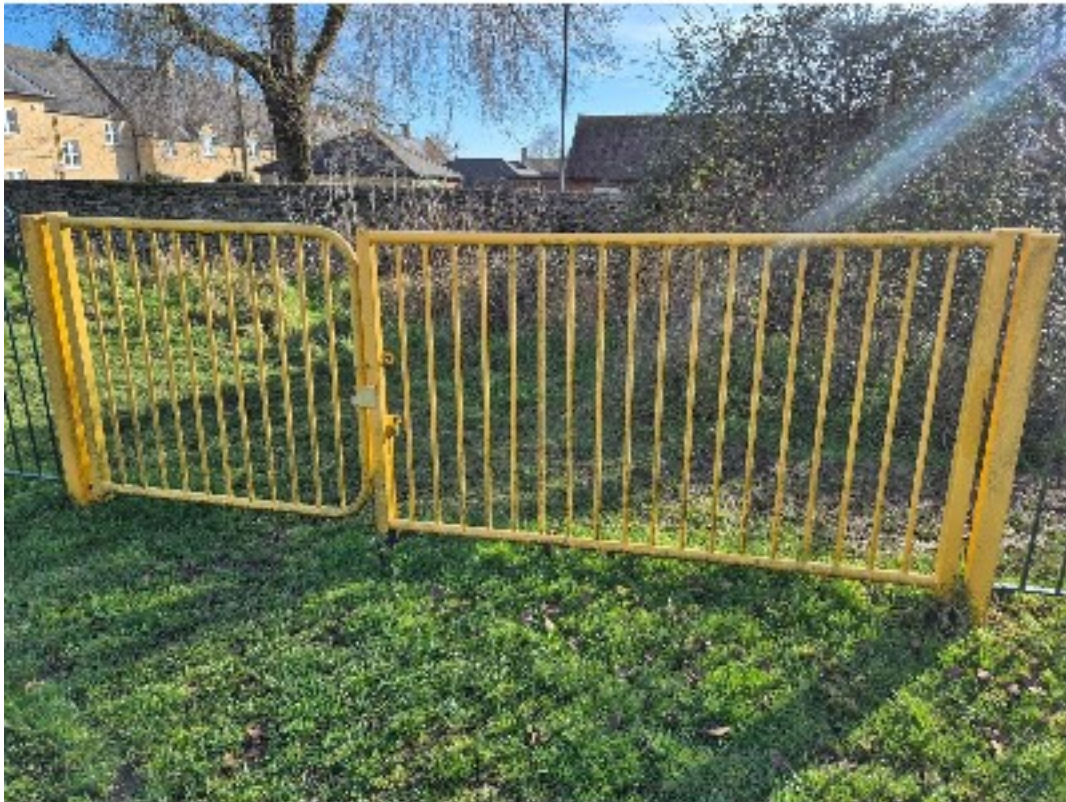
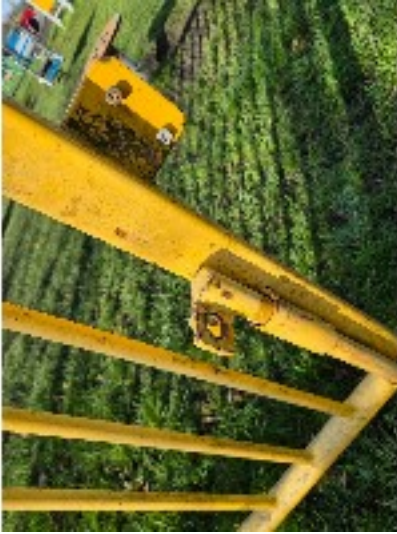
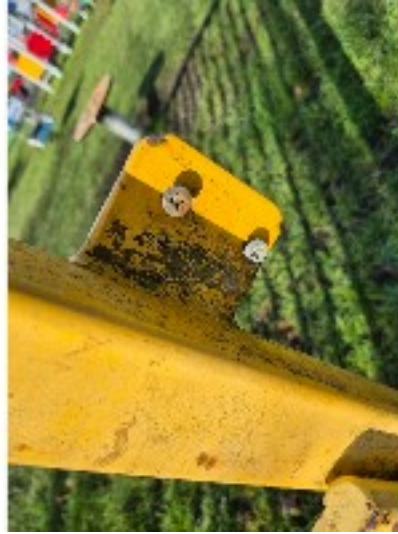
Combination Gate

Finding Two: No padlock present on the vehicle gate.

Finding Three: The rubber gate buffer was missing from gate.

Action(s): Consider replacing padlock.

Repair/replace as required
