Inspection Report For:
Fairford Town Council

Inspection Location:
39989 - The Croft Park

Inspection Date:
24/02/2026

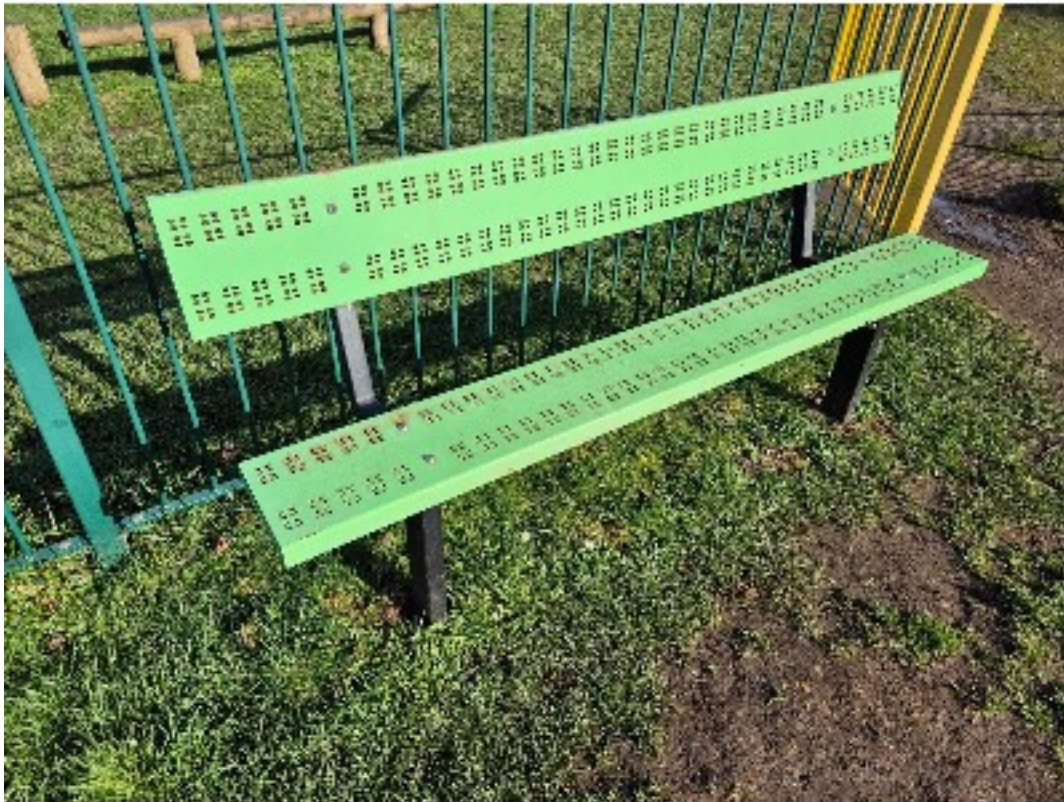
Bench

Finding Two: Parts of the metal work is rusty/corroded

Action(s): Consider treating and repainting.

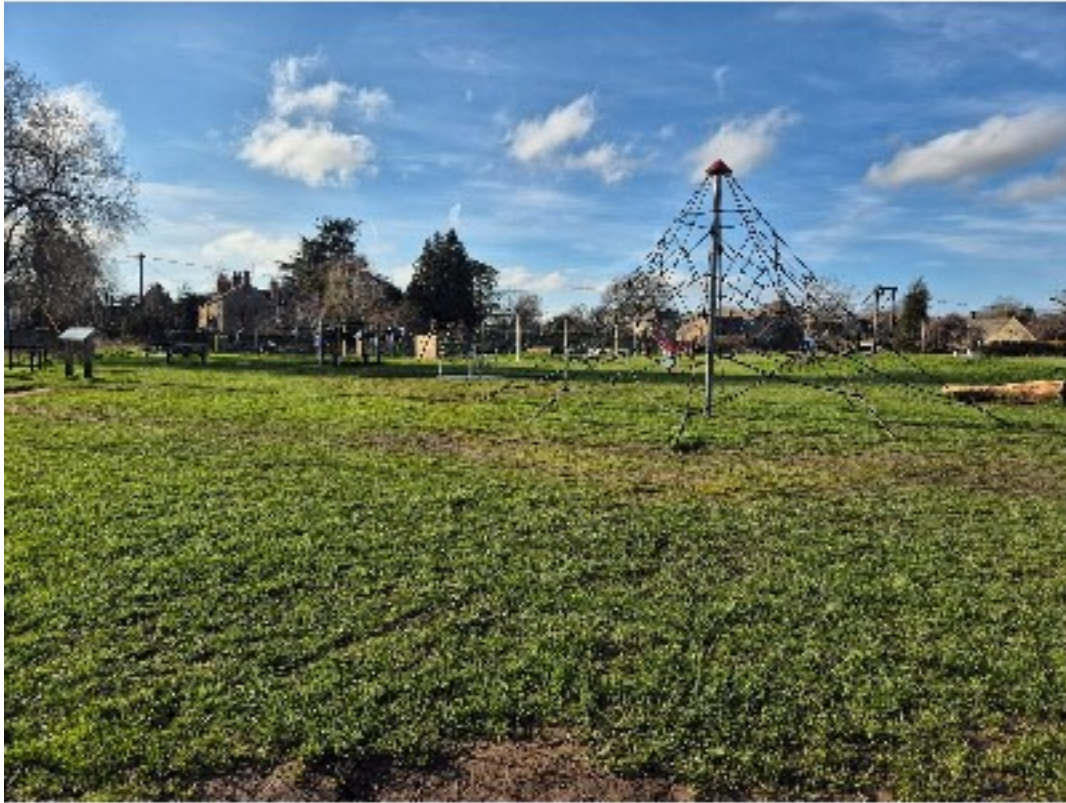
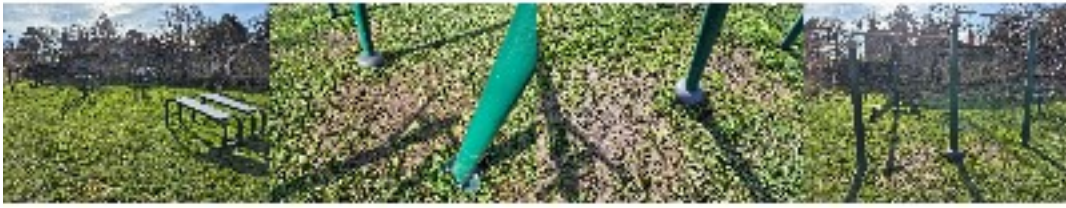
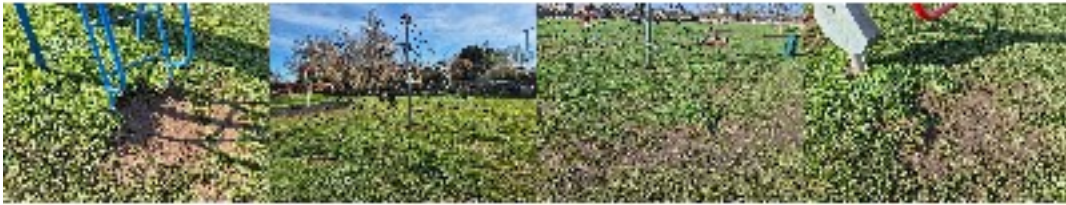
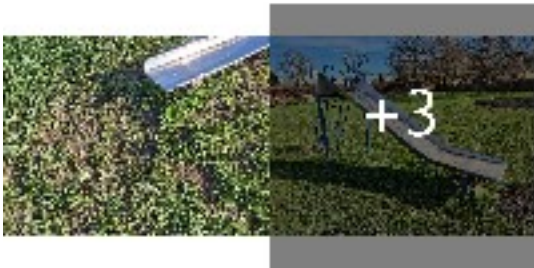
Site General

Finding One: The grass riles have sunk into the ground on several of the units and are unlikely to provide the correct level of impact attenuation

Action(s): Consider relaying replacing, or an alternate surface
