River Coln at Fairford

Water Vole Survey

Report ref: C122/R1/v2

Date: September 2018

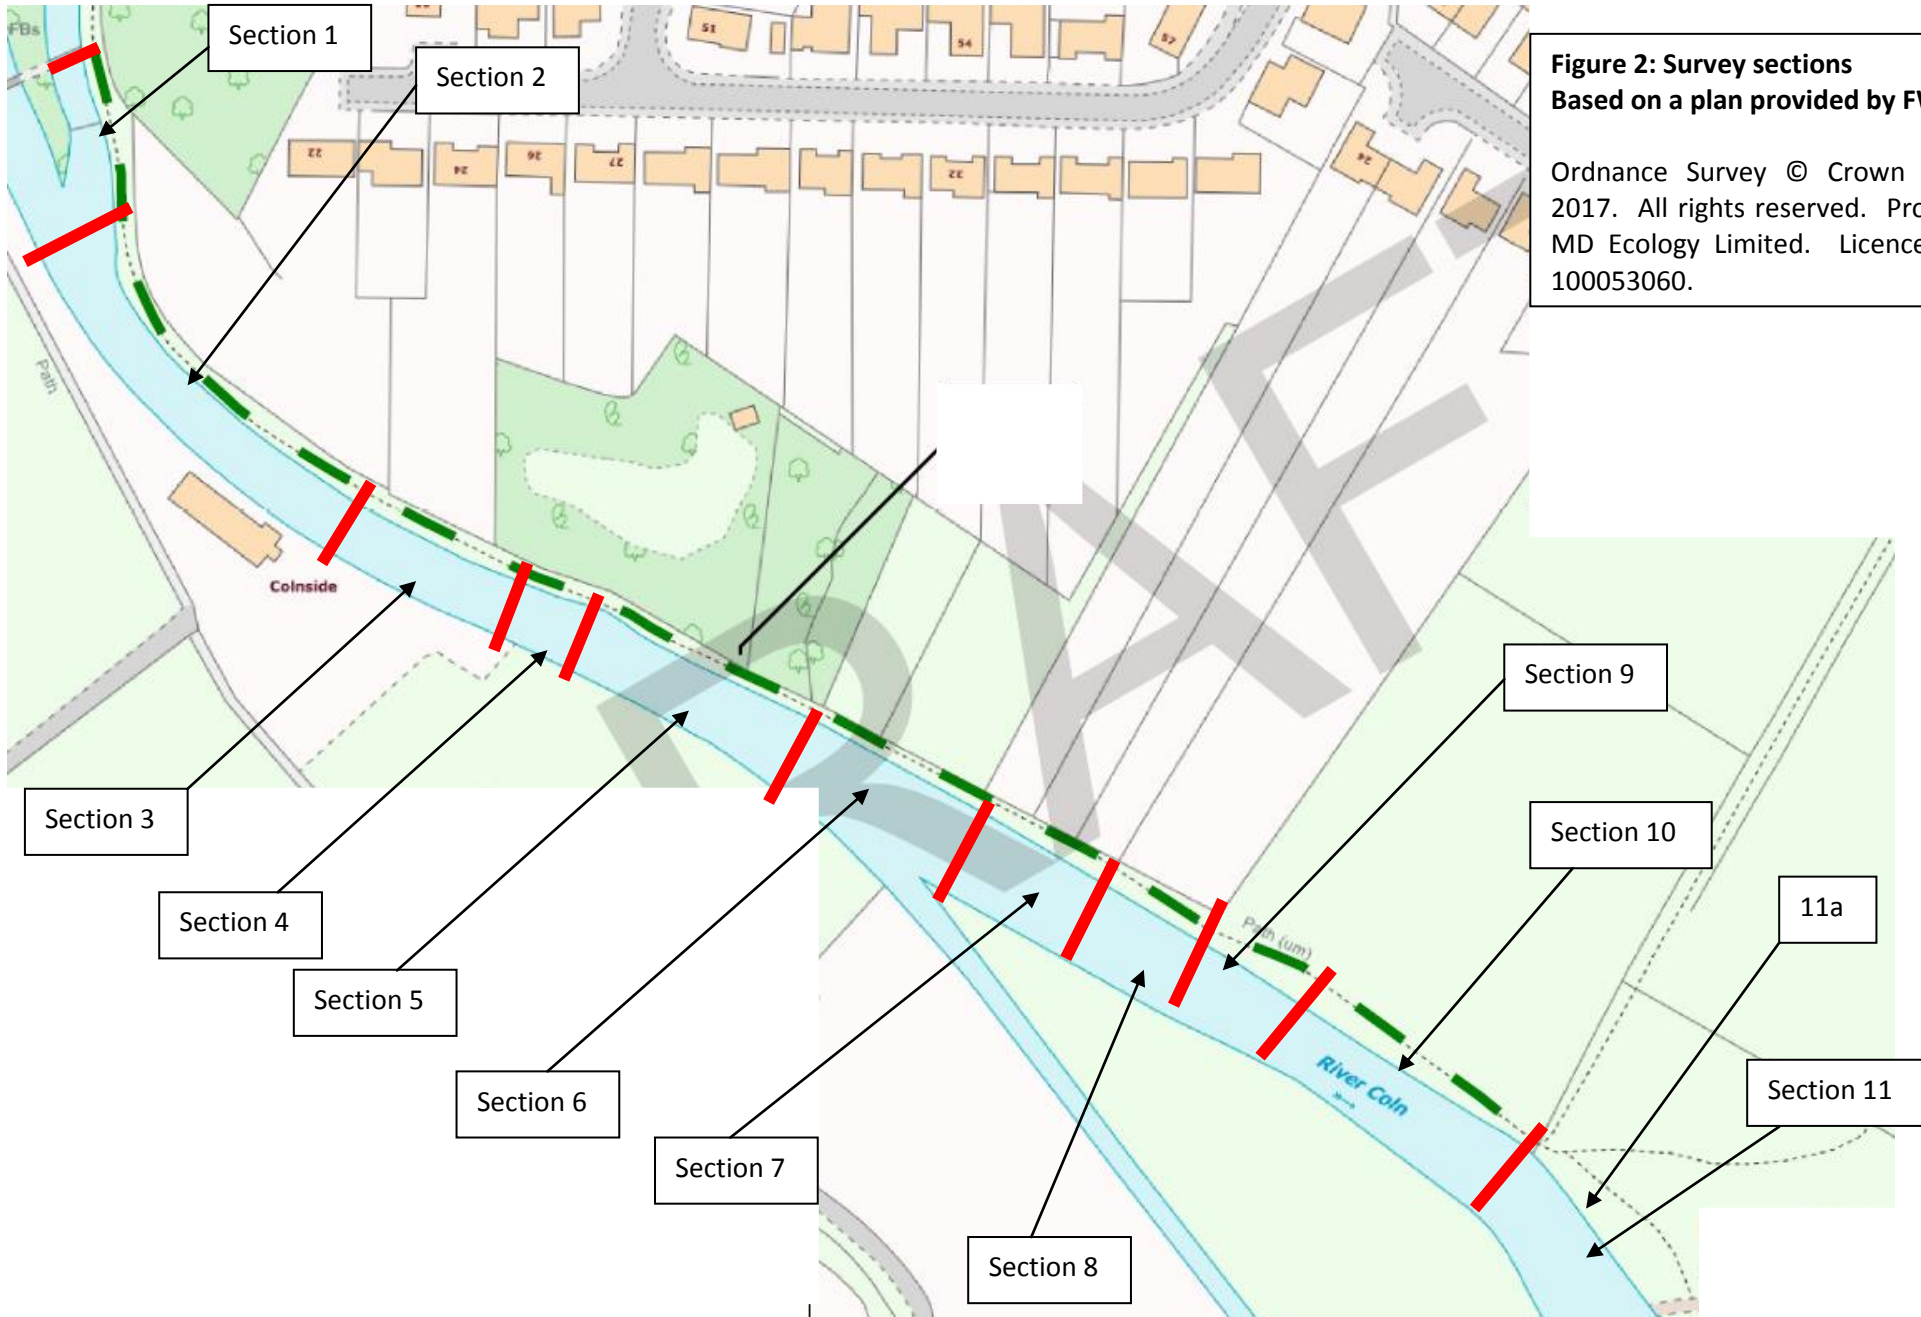
Figure 2: Survey sections
Based on a plan provided by FWAG

- 2.4 The stretch of the river within the site was divided into sections for the purposes of achieving the aims of the study (see Figure 2). The sections were identified based on the likelihood of water vole burrows being present and the likelihood of these being affected by the works (itself a factor of the proximity of the existing footpath to the top and / or toe of the bank).

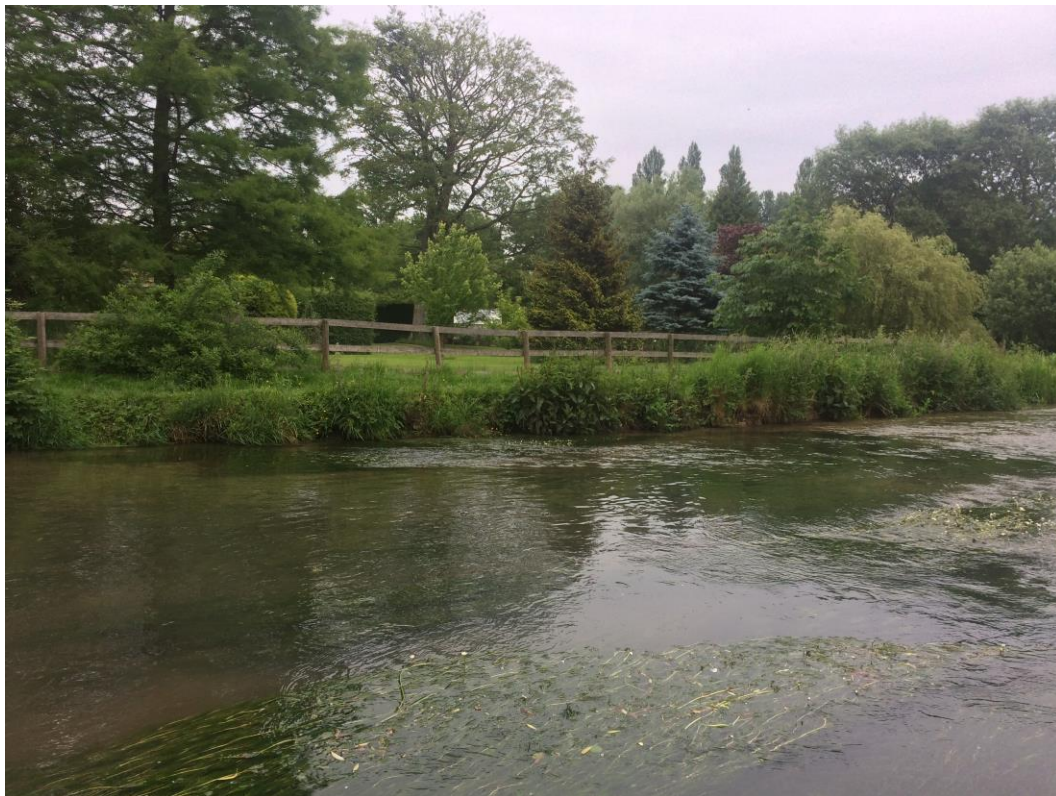
Section 2 (left bank of river, photo taken looking across river)

- 3.5 The results of the late-season survey in September 2018 showed that the core of the colony was located in section 8 and probably also section 9. Certain sections of the left bank from which water vole latrines were absent in June 2018 were clearly occupied by water voles during the September 2018 survey visit (sections 2, 4, 6 and

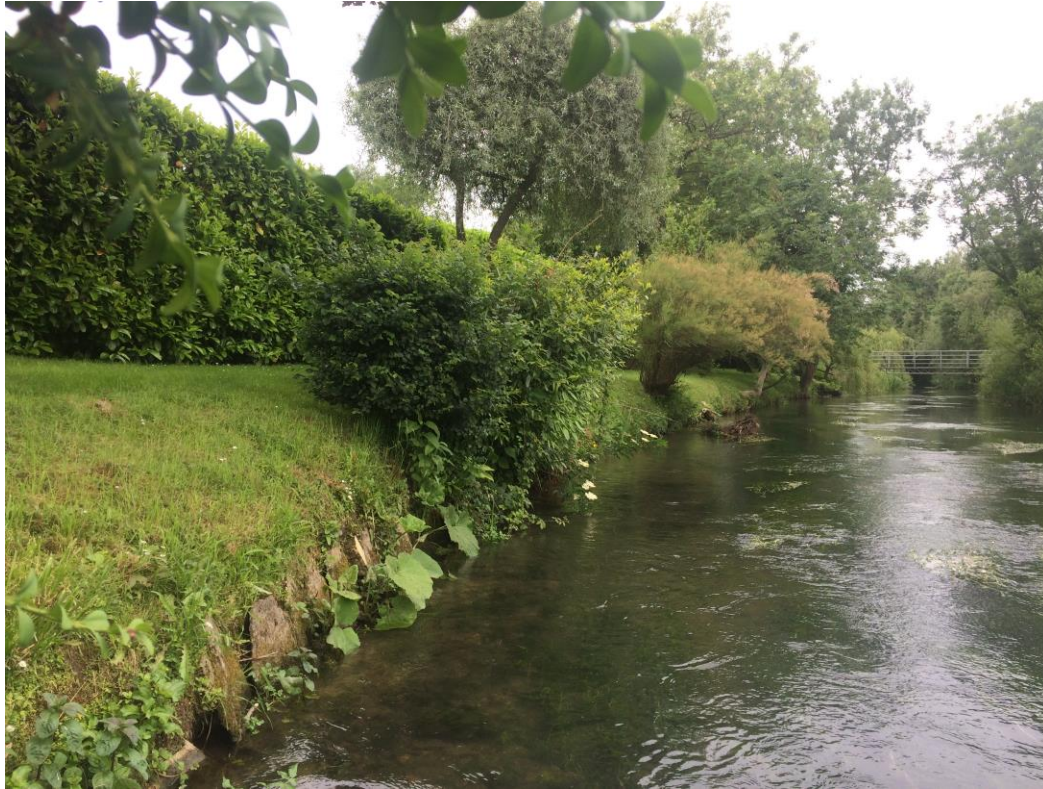
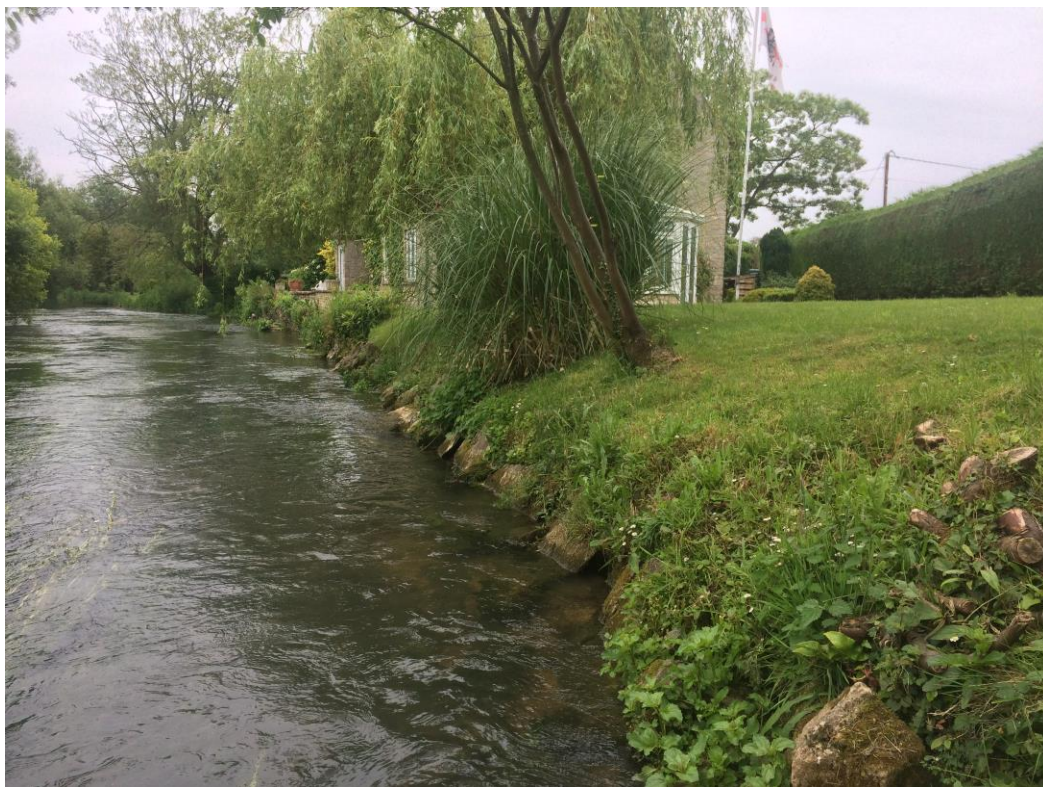
Section 2 (right bank of river, photo taken facing upstream)

Section 2 (right bank of river, photo taken facing downstream)

- Improving the habitat on the right bank of the river in Section 2, where there is little emergent vegetation and the grassy bank is regularly mown by a private landowner.

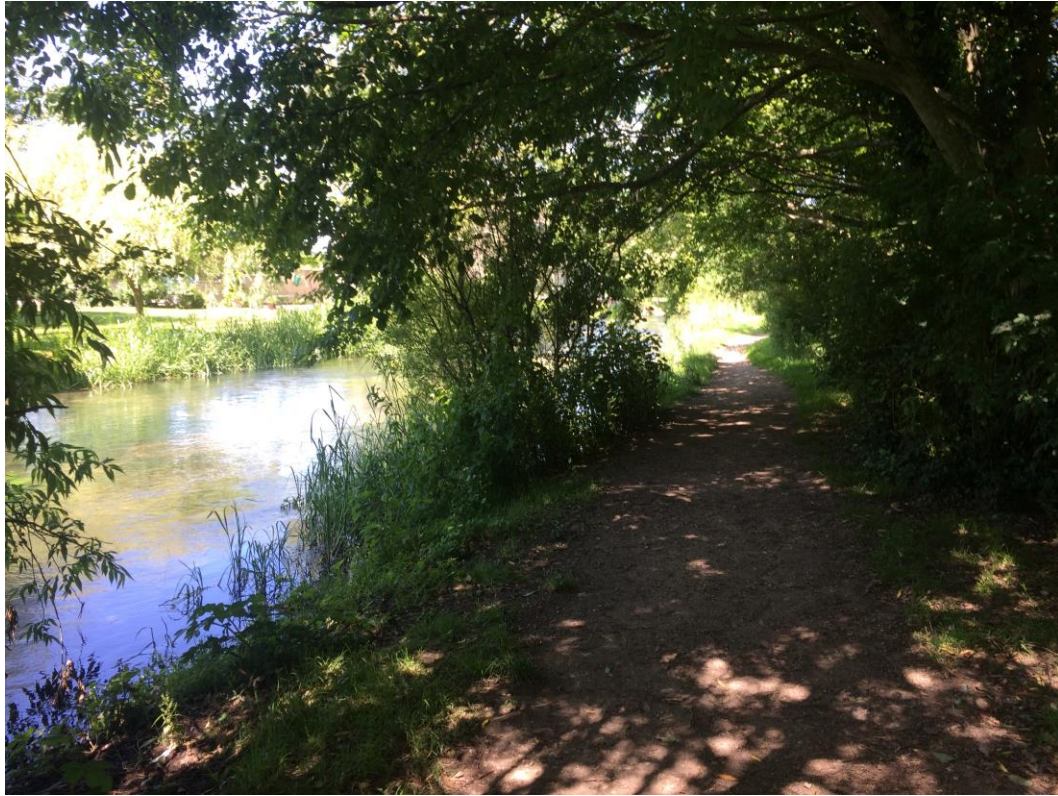
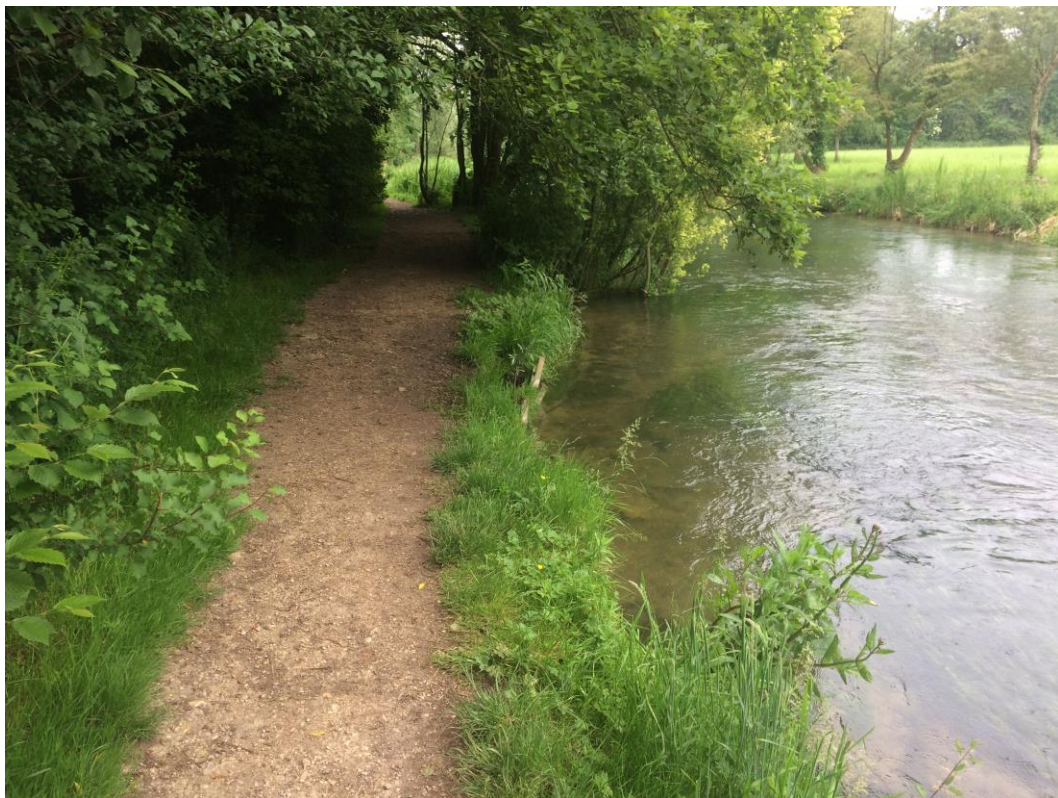
Section 3

3	20m	Relatively poor bankside vegetation due to shading from bankside trees.	June and Sep 2018 – None (on either bank) but water voles are present immediately downstream on the left bank	Medium/ Low	Within 1m of bank top	There is a likelihood of damaging burrows. Displace water voles from this short section by vegetation strimming.

- Works to be timed to take place during spring (March/April) when they are likely to have the least impact on water voles;
 - Water voles to be displaced from short sections where works are most likely to damage burrows, by vegetation strimming 5-10 days in advance of works commencing (Sections 3 and 4, 32m, and Section 6, 15-20m, left bank only in both cases);

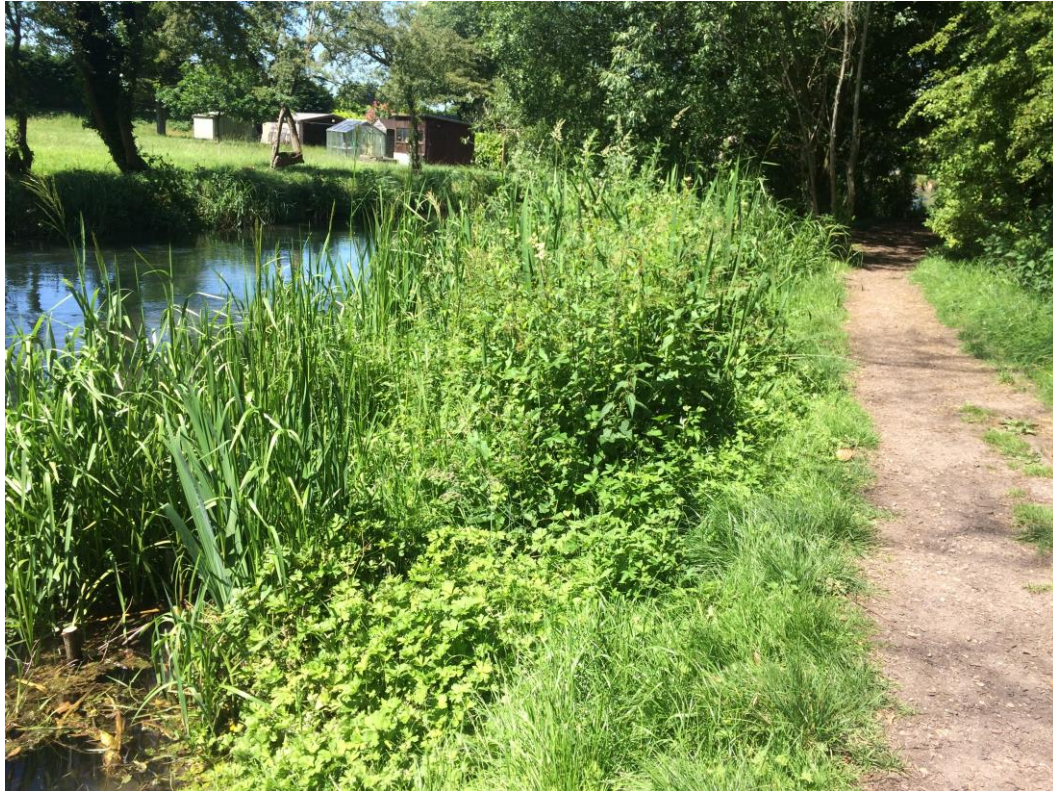
Section 4

Section	Approx. length	Habitat (Left bank)	Water vole field signs	Likelihood of burrows	Path proximity	Recommended approach
4	12m	Good habitat, with a wide fringe of emergent vegetation dominated by yellow flag.	June 2018 – Feeding remains only, no latrines Sep 2018 – 1 latrine and feeding remains on the left bank, no latrines on the right bank	High	Within 1m or 2m of bank top	There is a likelihood of damaging burrows. Displace water voles from this short section by vegetation strimming.
4 / 5	4-5m	Section of bank which has been washed away and repaired with faggots – further bank stabilisation work may be needed.	June and Sep 2018 – None	Low	Within 1m of bank top	Burrows unlikely to be present. Work under ecologist's supervision.
5	30m	Good habitat, with a very wide fringe (5m) of emergent vegetation dominated by reed sweet-grass.	June 2018 – 6 latrines on the left bank (likely to be an under-estimate) along with feeding remains. 15 latrines on the right bank. Sep 2018 – 10 latrines on the left bank (likely to be an under-estimate) along with feeding remains. 5 latrines on the right bank.	Low	1-2m from bank top	The bank profile is very shallow in this location with little height difference between top of bank and water level. The likelihood of damaging burrows is therefore minimal. Work under ecologist's supervision.

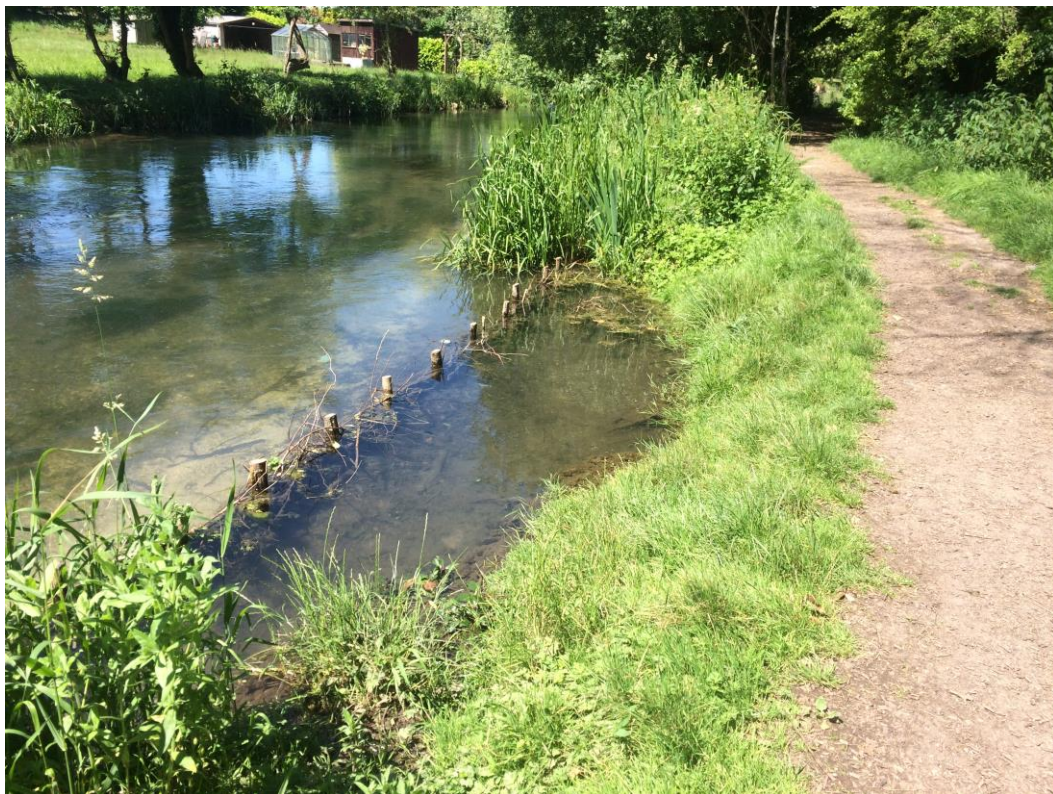
Eroded bank between sections 4 and 5

- 4.6 Small scale works to repair areas of eroded bank are unlikely to have any impacts on water vole burrows and are likely to be beneficial if a suitable bank for burrowing can be created and emergent vegetation introduced at the toe of the bank. Emergent vegetation can be plug planted or introduced in a coir fibre roll (which may be preferable in areas exposed to scouring). Any planted vegetation should be protected from trampling and grazing by wildfowl.

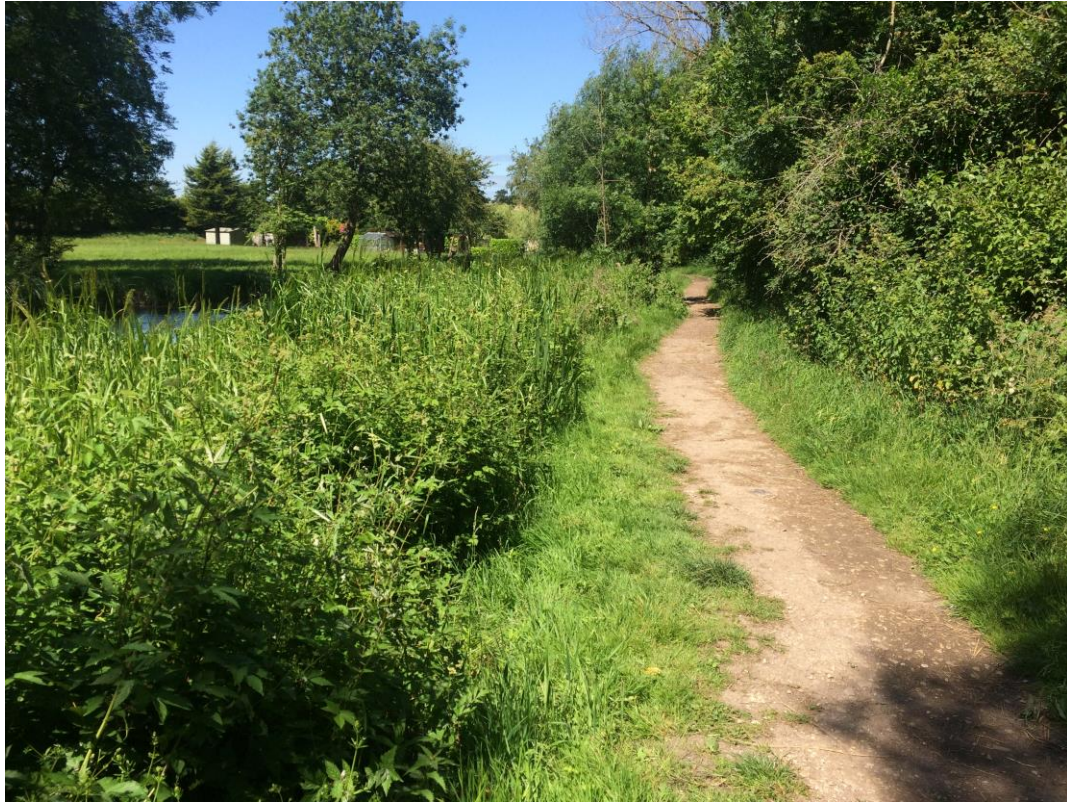
Section 6

Section	Approx. length	Habitat (Left bank)	Water vole field signs	Likelihood of burrows	Path proximity	Recommended approach
6	15-20m	Good habitat, with a wide fringe of emergent vegetation dominated by reed sweet-grass, and bankside vegetation dominated by willowherb and nettles.	June 2018 – Feeding remains and burrows on the left bank, but no latrines. 5 latrines recorded on the right bank. Sep 2018 – 3 latrines and feeding remains recorded on a small island of emergent vegetation which has become established as water levels have dropped (immediately adjacent to the left bank); no signs on the right bank	Confirmed present	Within 1m of bank top	There is a likelihood of damaging burrows (greater than for Section 5, due to the narrower width of emergent vegetation and steeper bank profile in this section). Displace water voles from this short section by vegetation strimming.

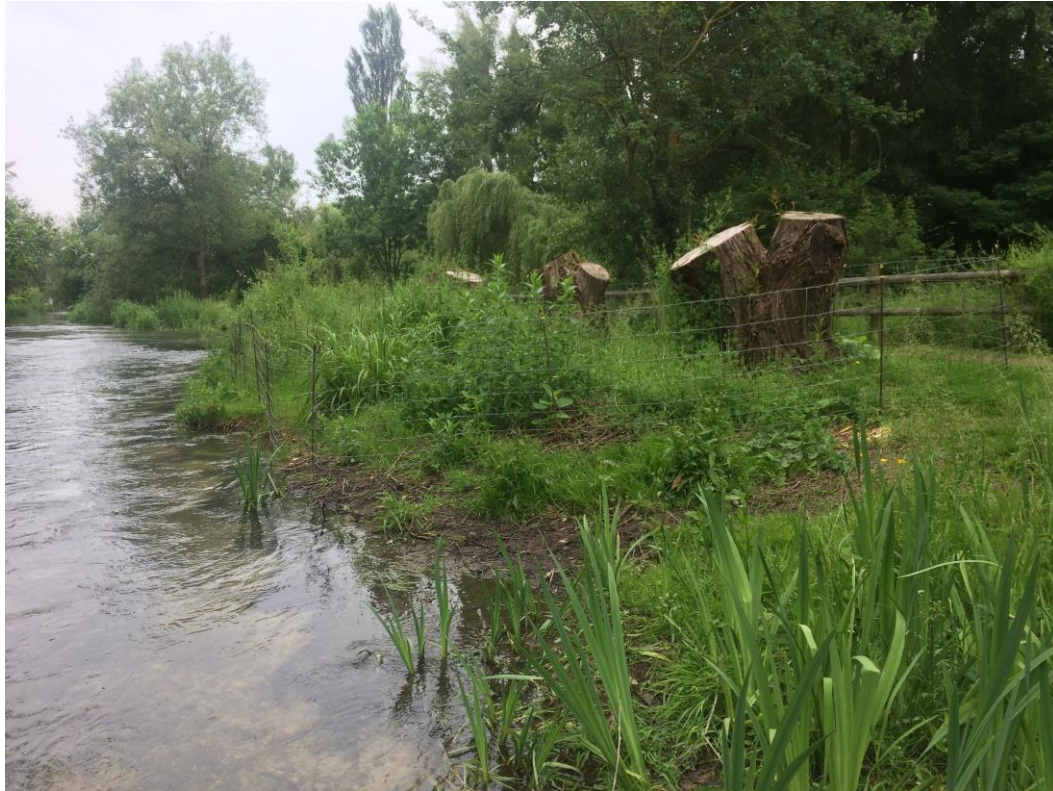
Section	Approx. length	Habitat (Left bank)	Water vole field signs	Likelihood of burrows	Path proximity	Recommended approach
7	20m	Poor habitat with emergent vegetation only present in occasional patches. Several recently felled willow pollards is present in this section which are likely to have shaded this section until recently.	June 2018 – None (on either bank) Sep 2018 – 1 burrow and 1 latrine recorded on the left bank where the path is 3-4m from the bank face; no signs recorded on the right bank	Low	3m from toe of bank	Given the shallow bank profile, lack of field signs in June 2018, and distance of the path from the channel, the likelihood of damaging burrows (assuming a no-dig approach) is minimal, provided that works take place in spring when this section is less likely to be used by water voles. Work under ecologist's supervision.
8	15m	Good habitat, with a wide fringe of emergent vegetation dominated by yellow flag and reed sweet-grass.	June 2018 – Very high density of field signs: 13 latrines (left bank) and a significant number of piles of feeding remains. Feeding remains but no latrines on the right bank. Sep 2018 – very high density of field signs – at least 20 well-established latrines and feeding remains, suggesting this is the core of the colony. 4 latrines on the right bank	High	3m from top of bank	Given the distance of the path from the channel the likelihood of damaging burrows (assuming a no-dig approach) is minimal. Work under ecologist's supervision.

Section 7 (river, left bank, photo taken when facing upstream)

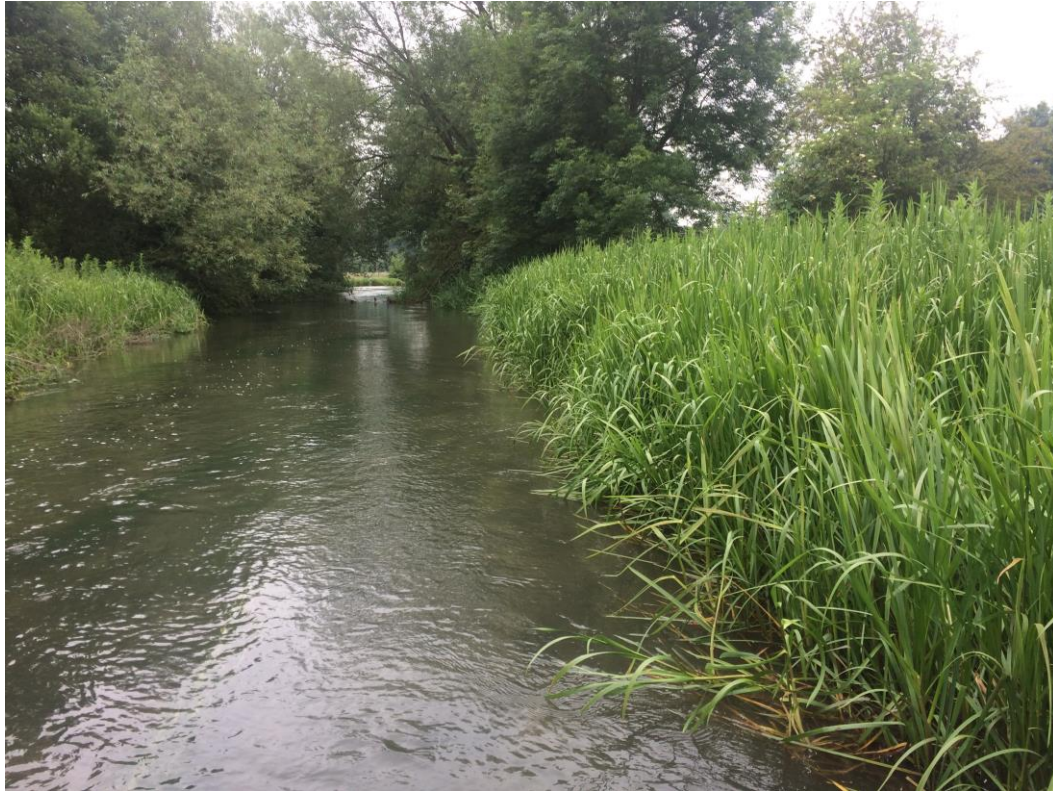
Sections 8 and 9 (river, photo taken facing downstream)

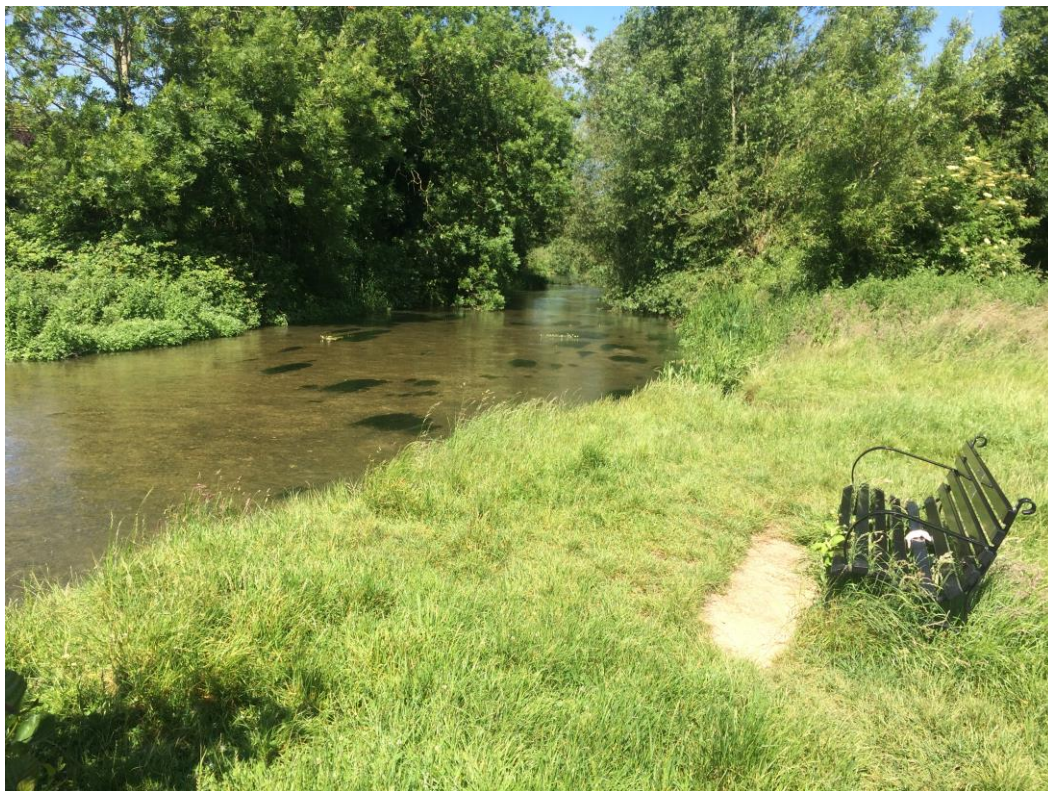
Section 11

11	15-20m	Poor habitat in general as the bank is undercut and lacks emergent vegetation.	June and Sep 2018 – None	Low	More than 3m	Given the lack of field signs and distance of the path from the channel, the likelihood of damaging burrows (assuming a no-dig approach) is minimal. Work under ecologist's supervision.

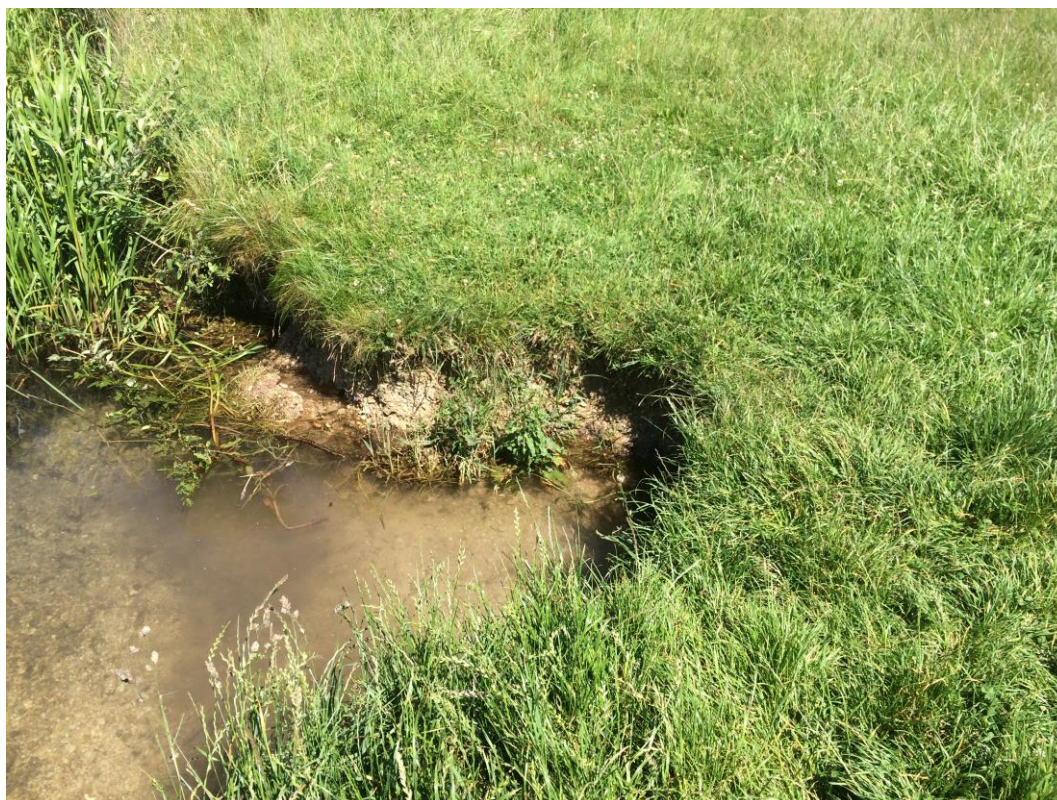
Section	Approx. length	Habitat (Left bank)	Water vole field signs	Likelihood of burrows	Path proximity	Recommended approach
11a	1m	Eroded section of bank, which lacks emergent vegetation.	June and Sep 2018 – None	Absent	n/a	Burrows unlikely to be present. Work under ecologist's supervision.

Eroded bank at 11a
