River Coln at Fairford

Water Vole Monitoring Survey

Report ref: C122/MR19/v1

Date: October 2019

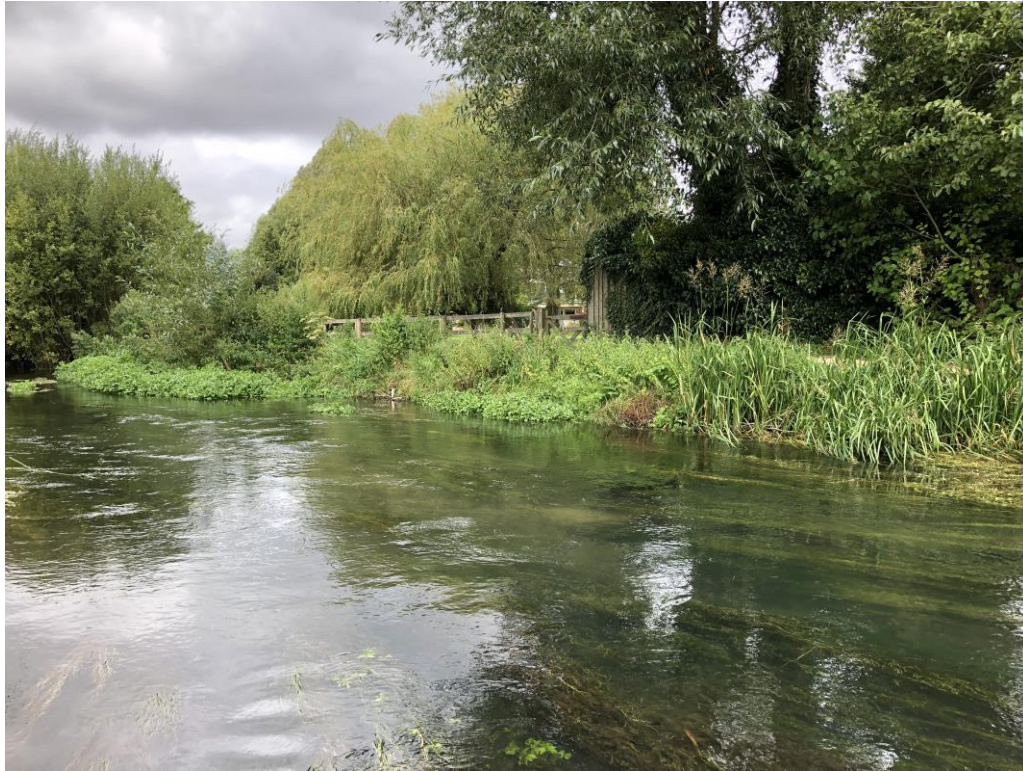
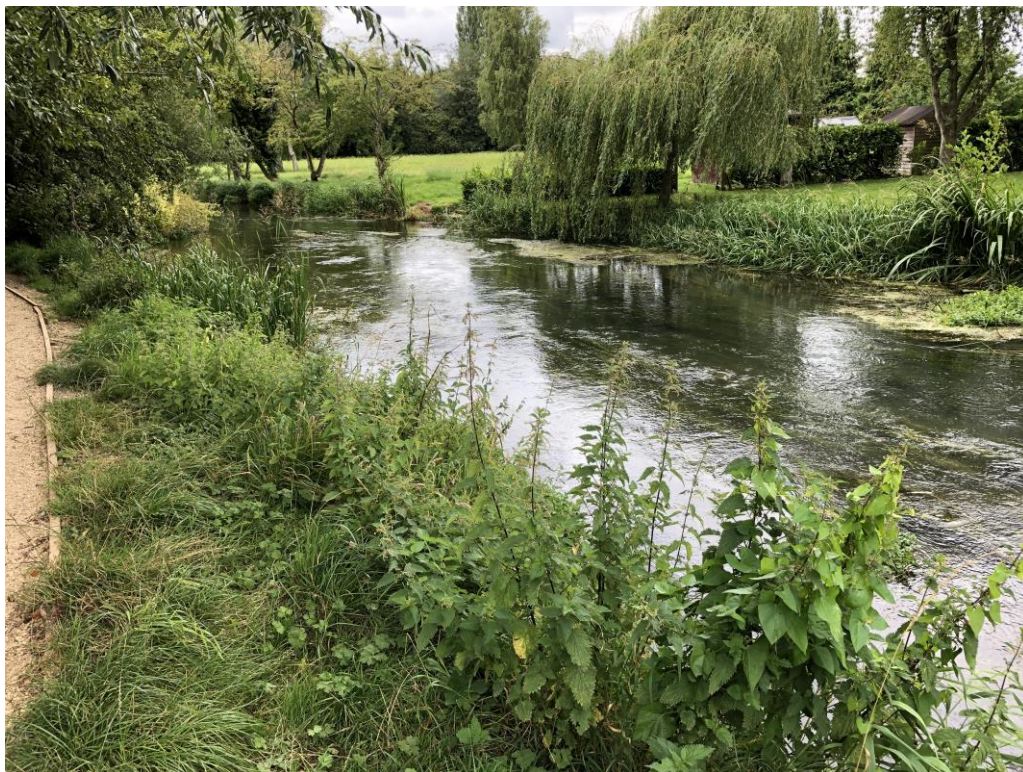
- 3.4 The areas of restored habitat were generally found to be developing well. Faggoting and coir fibre rolls had been installed in four locations:
- 1) In Section 3, where water voles were displaced and habitat restoration and habitat improvement works were proposed – habitat is still developing, no remediation works considered necessary;

Section 3; habitat recovering and water voles present

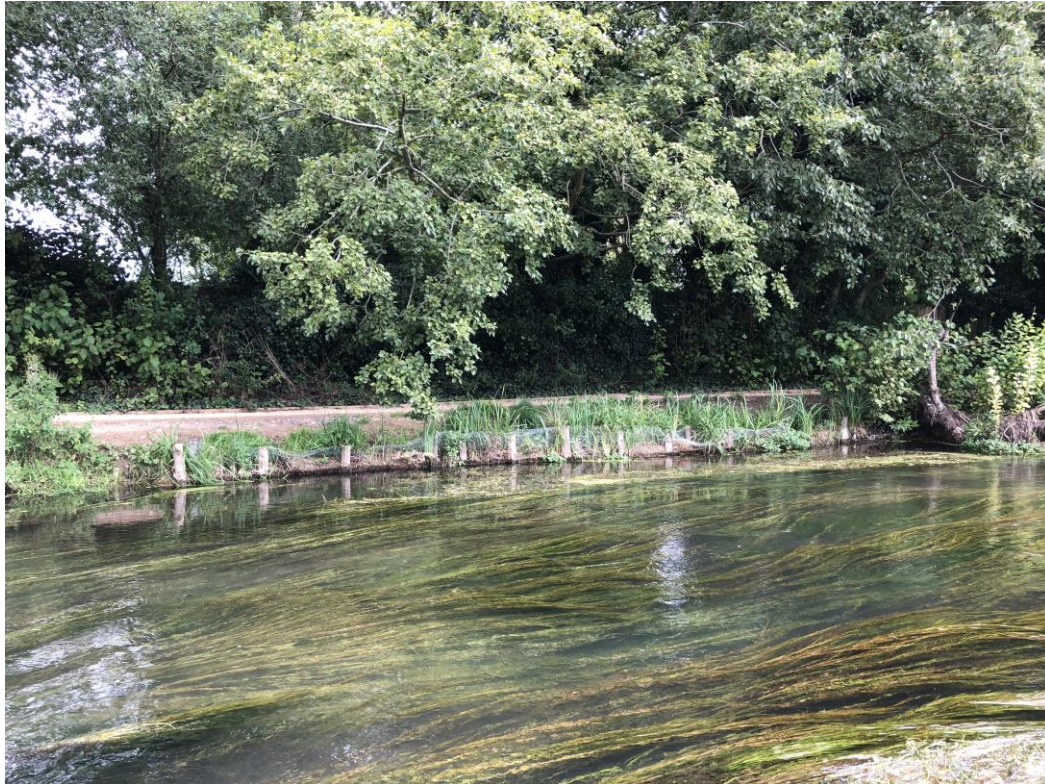
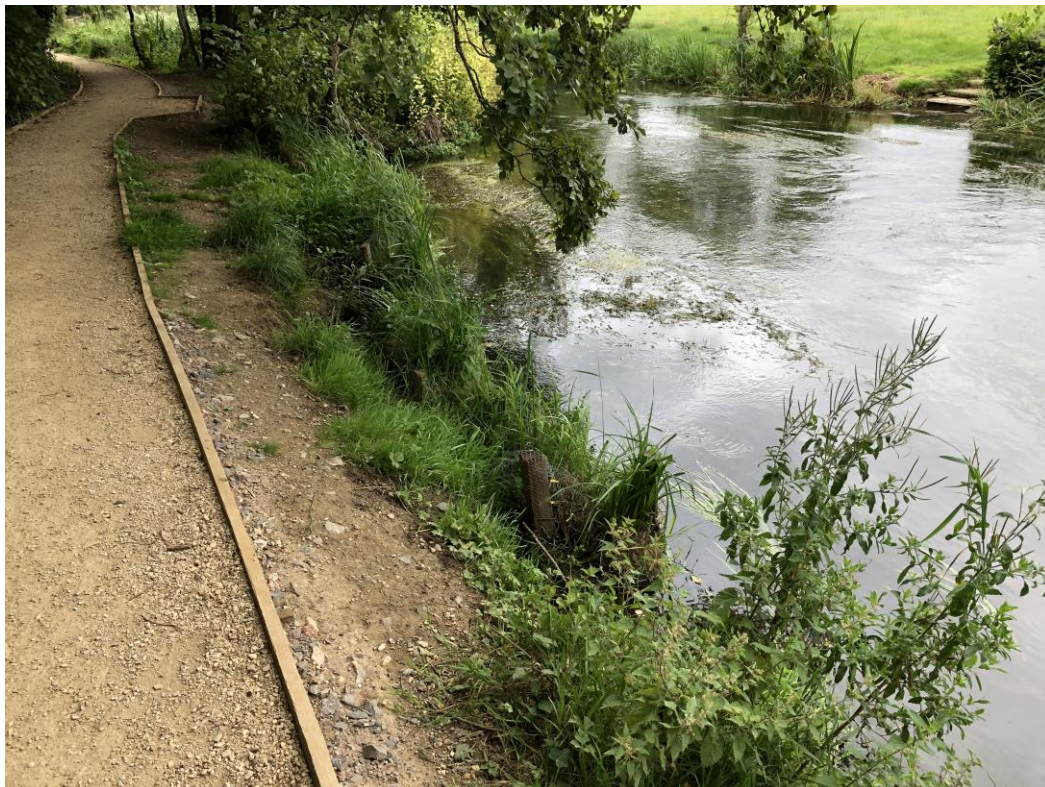
Coir fibre rolls installed in Section 3 where displacement took place; vegetation still establishing

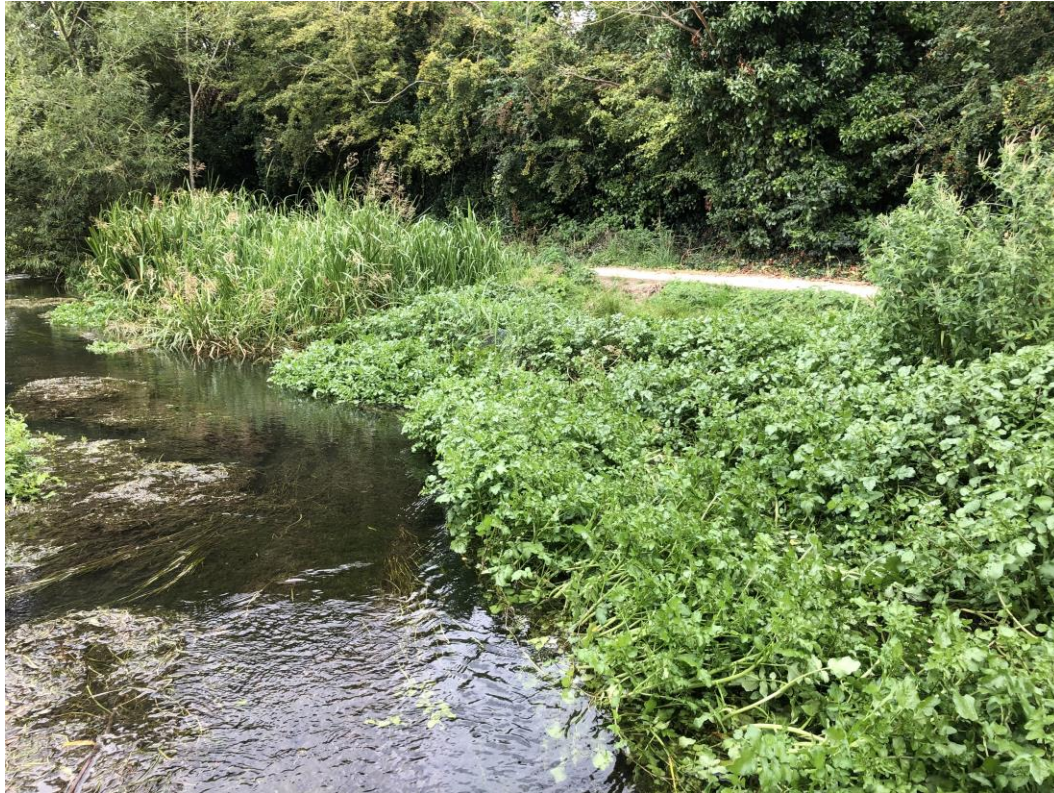
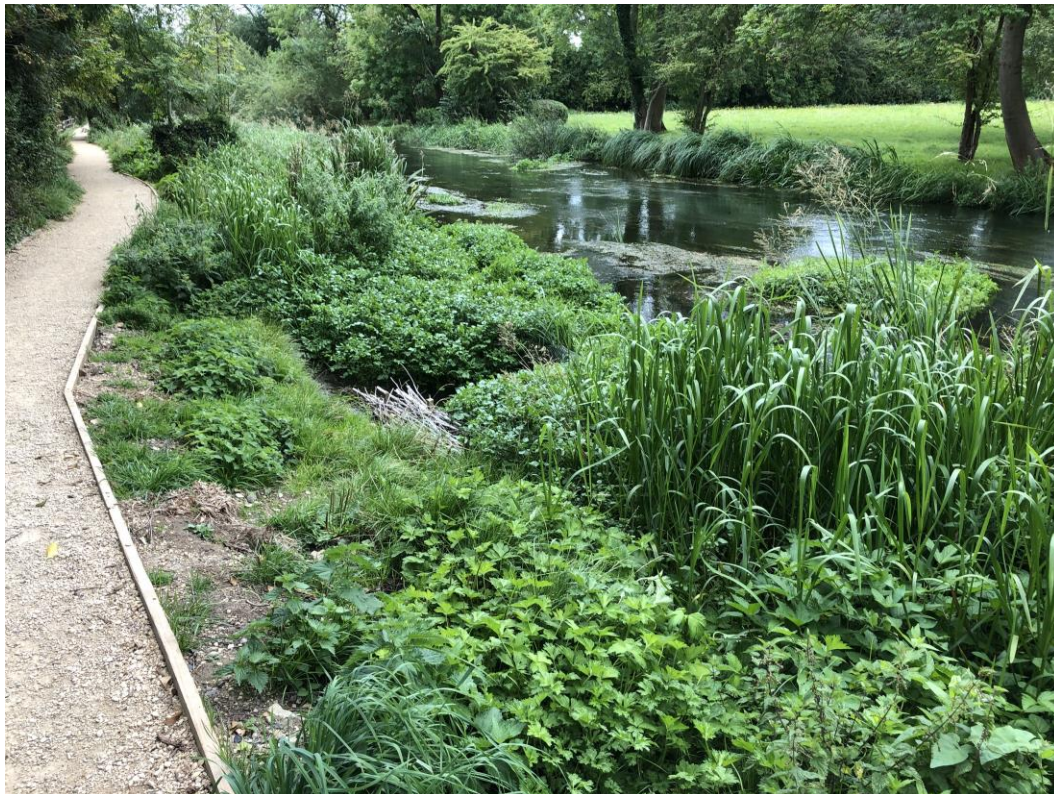
- 2) In Section 4/5, where habitat improvement works were proposed – habitat has established quickly and water voles are already present, no remediation works considered necessary;

Coir fibre rolls installed in Section 4/5; water voles present

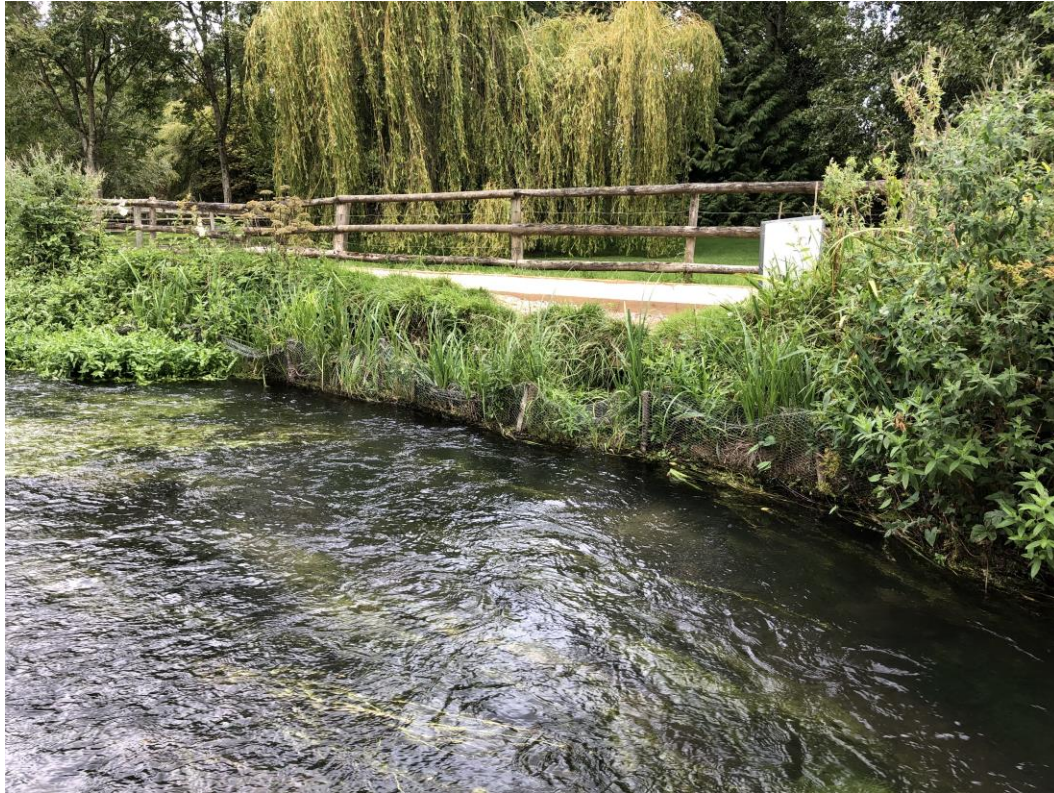
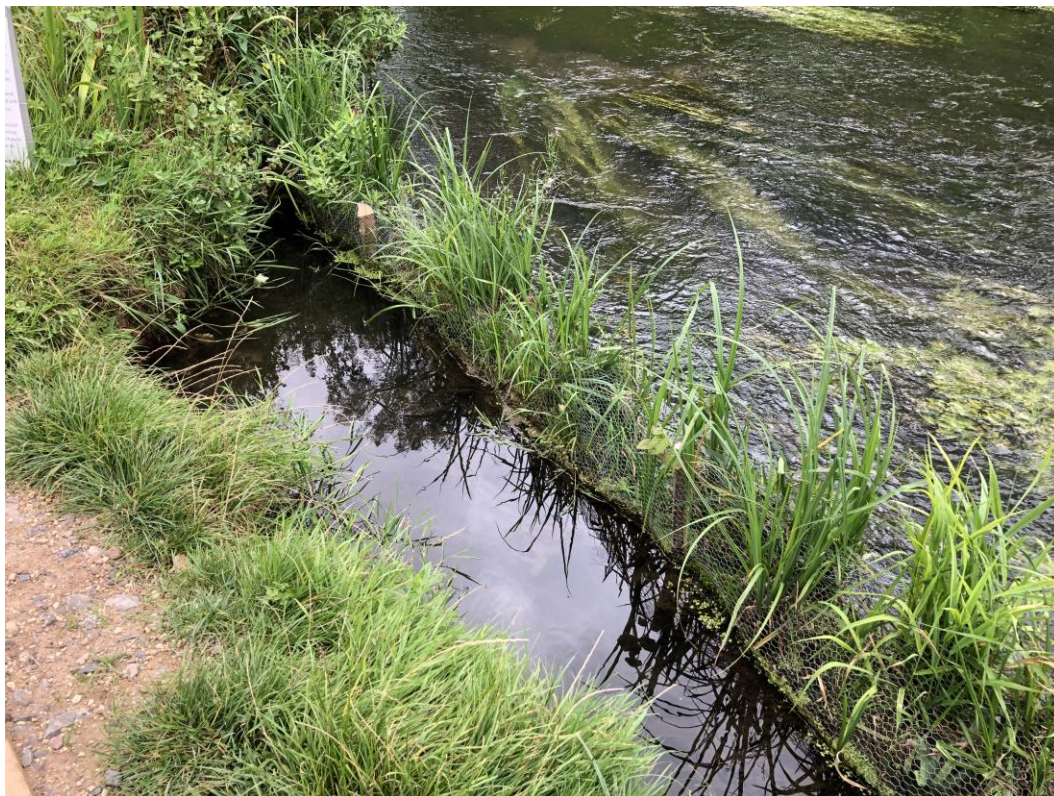
- 3) In Section 6, where water voles were displaced and habitat restoration was proposed – habitat is still developing, no remediation works considered necessary;

Coir fibre rolls installed in Section 6 where displacement took place; vegetation still establishing

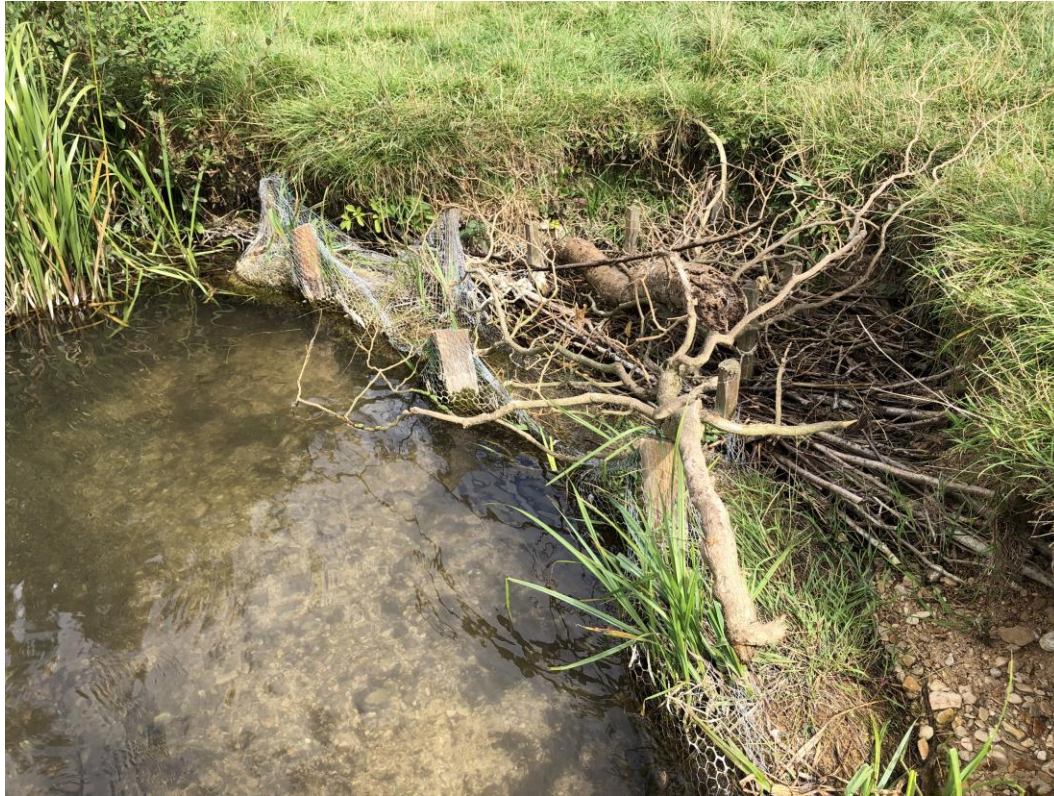
- 4) In Section 11a, where habitat improvement works were proposed – coir fibre roll has been damaged, but further damage is likely to occur unless the area is fenced off; a further review in 2020 is recommended.

- 4.2 Bankside restoration works have been partially successful, although more time is required for the vegetation to develop fully in these areas. The only exception is in Section 11a, where the installed coir fibre roll (a 3m length) has been damaged. The need for remediation works at this location (or elsewhere) will be reviewed following the 2020 monitoring visit.

Damaged coir fibre roll installed in front of eroded bank at 11a

- 4.4 It would also be appropriate to review whether fencing is required to restrict access to the river by people and/or dogs in locations where damage to the banks has occurred, to encourage the regrowth of vegetation in these areas.

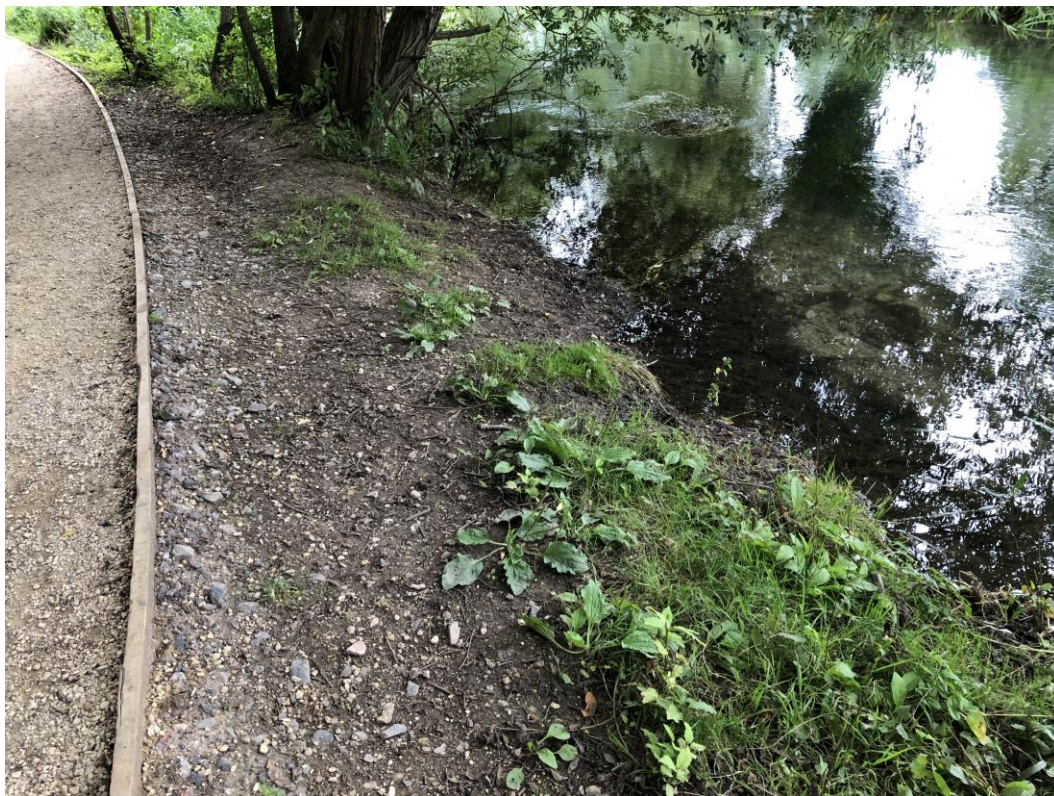
Section 4 – area of damage to bank
