River Coln at Fairford

Water Vole Monitoring Survey

Report ref: C122/MR20/v1

Date: September 2020

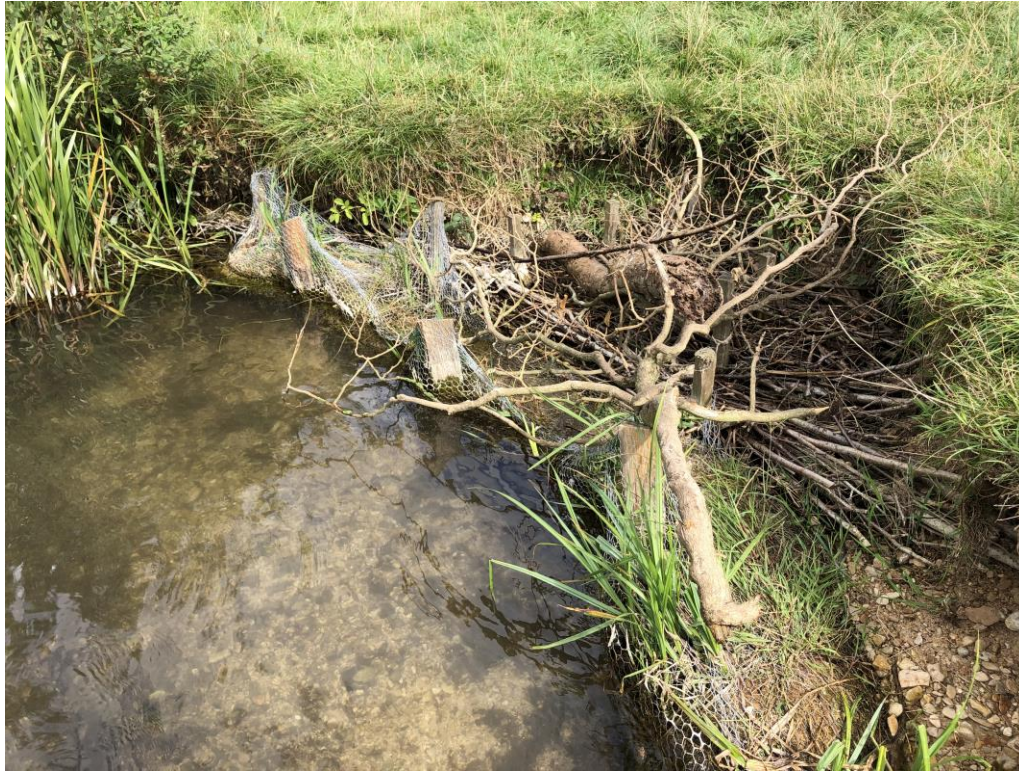
Damaged coir fibre roll installed in front of eroded bank at 11a (September 2019)

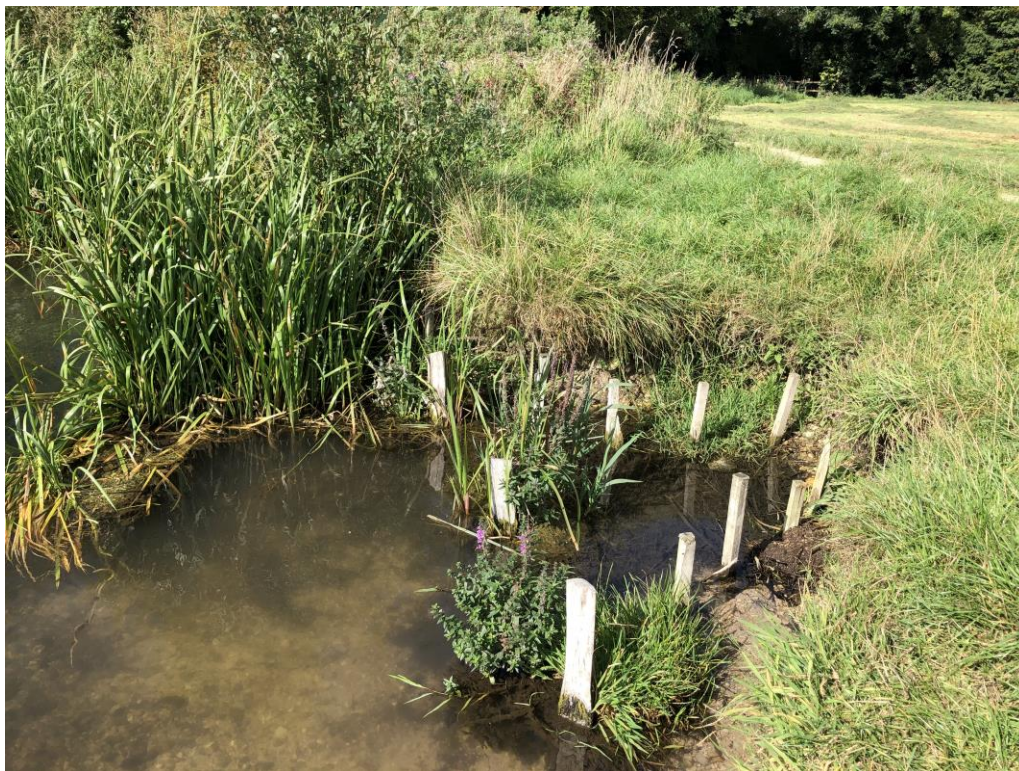
Additional coir roll added, and vegetation at 11a is starting to recover (September 2020)

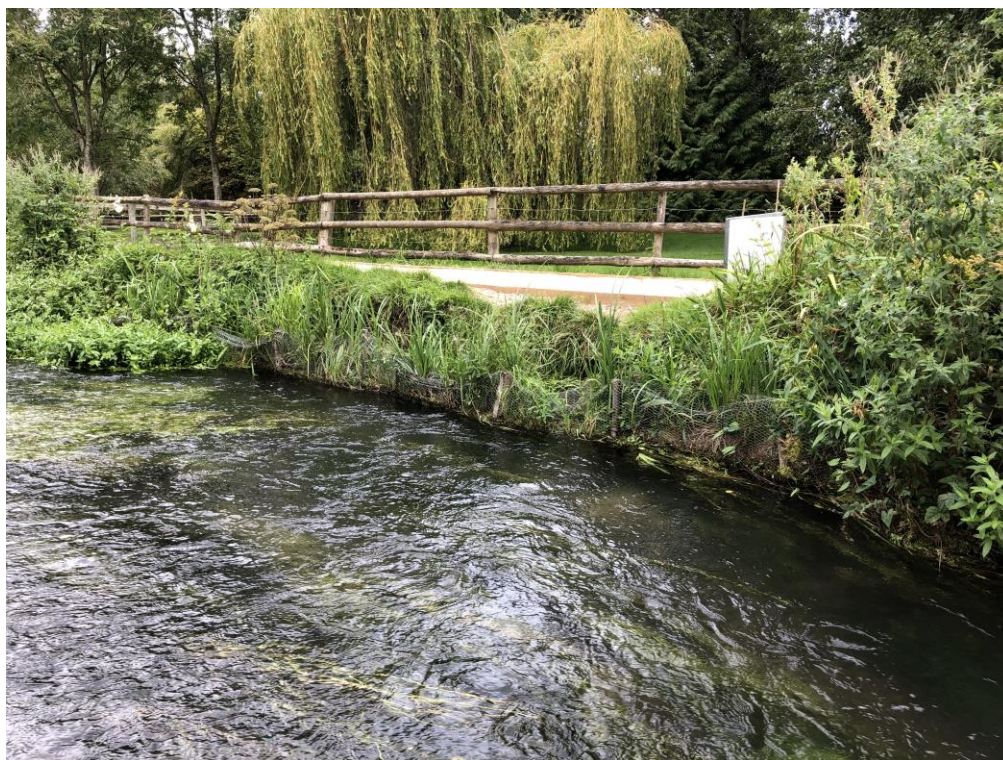
Coir fibre rolls installed in Section 6 where displacement took place; vegetation still establishing in September 2019

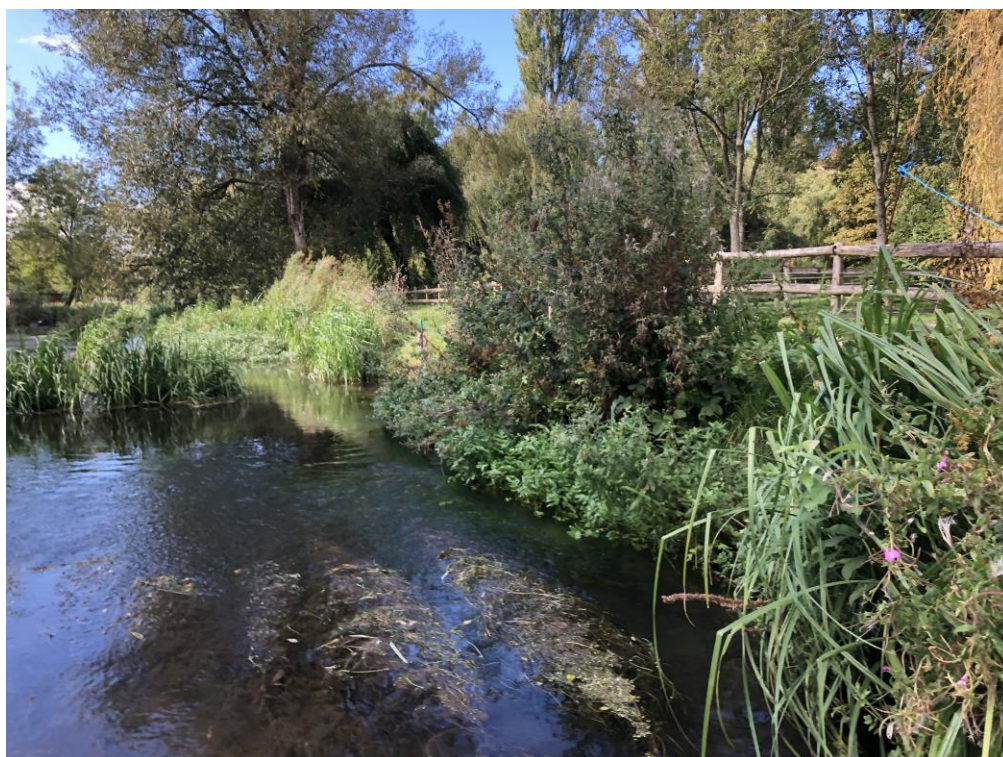
Coir fibre rolls installed in Section 6 where displacement took place; vegetation is well-established by September 2020 and water voles are present
