River Coln at Fairford

Water Vole Monitoring Survey

Report ref: C122/MR21/v1

Date: September 2021

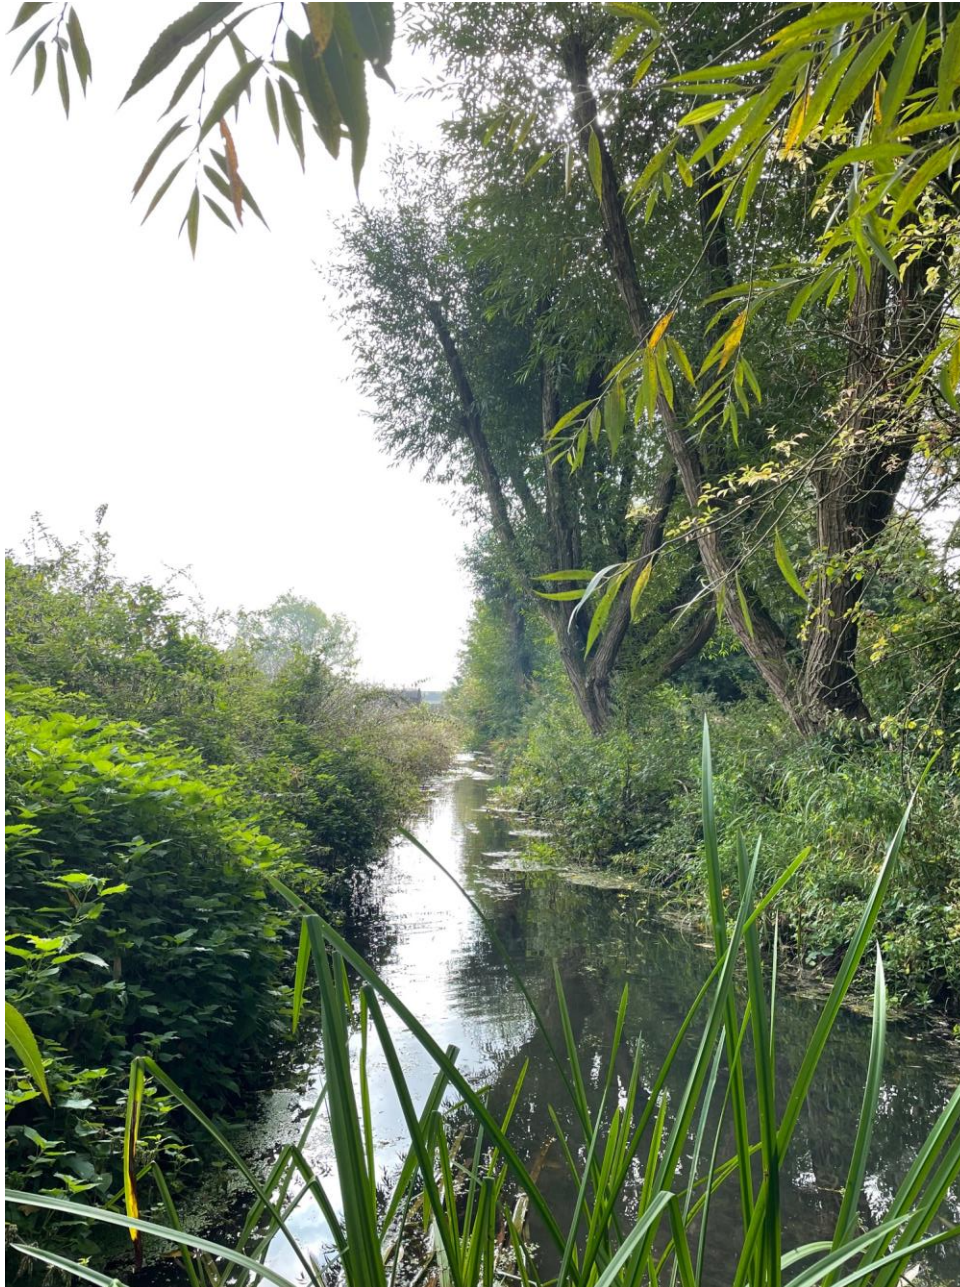
- 4.3 As part of the same project, habitat improvements for water voles within a side branch of the river (on the opposite bank to the path) have been undertaken. These works appear to have been successful in opening up the channel to more light, encouraging the growth of emergent vegetation. Water voles were recorded throughout the side channel in 2021.

Side channel where off-site habitat improvement works have been undertaken

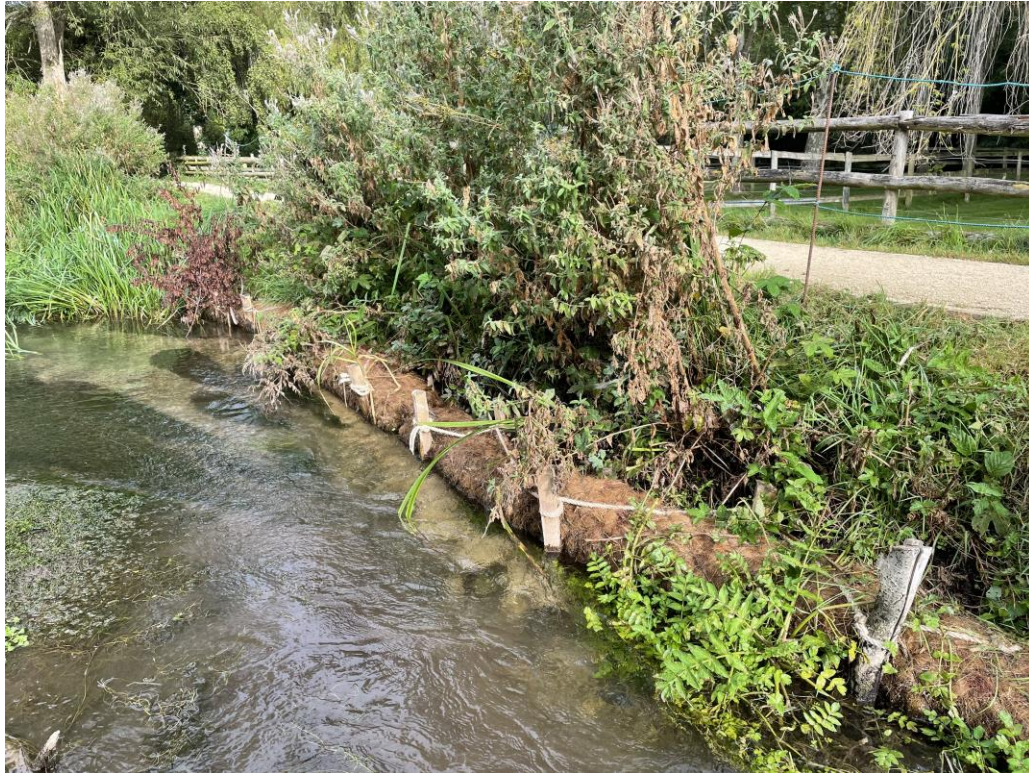
- 3.5 The areas of restored habitat were generally found to be developing well. Faggoting and coir fibre rolls had been installed in four locations:
 - 1) In Section 3, where water voles were displaced and habitat restoration and habitat improvement works were proposed – the habitat had developed well except where dogs enter the channel, and water voles were present;

- 2) In Section 4/5, where habitat improvement works were proposed – the habitat had established quickly and water voles were present;
 - 3) In Section 6, where water voles were displaced and habitat restoration was proposed – the habitat had developed well and water voles were present;

- 4) In Section 11a, where habitat improvement works were proposed – the habitat appeared unlikely to develop fully, due to dogs entering the water.
- 3.6 No remediation works are considered necessary at any of these locations.

Restored section of bank showing coir fibre roll; vegetation on the roll has established well in some places but not in others

- 4.2 Bankside restoration works have been partially successful and no further benefits are considered likely to be achievable. No remediation works are considered necessary.

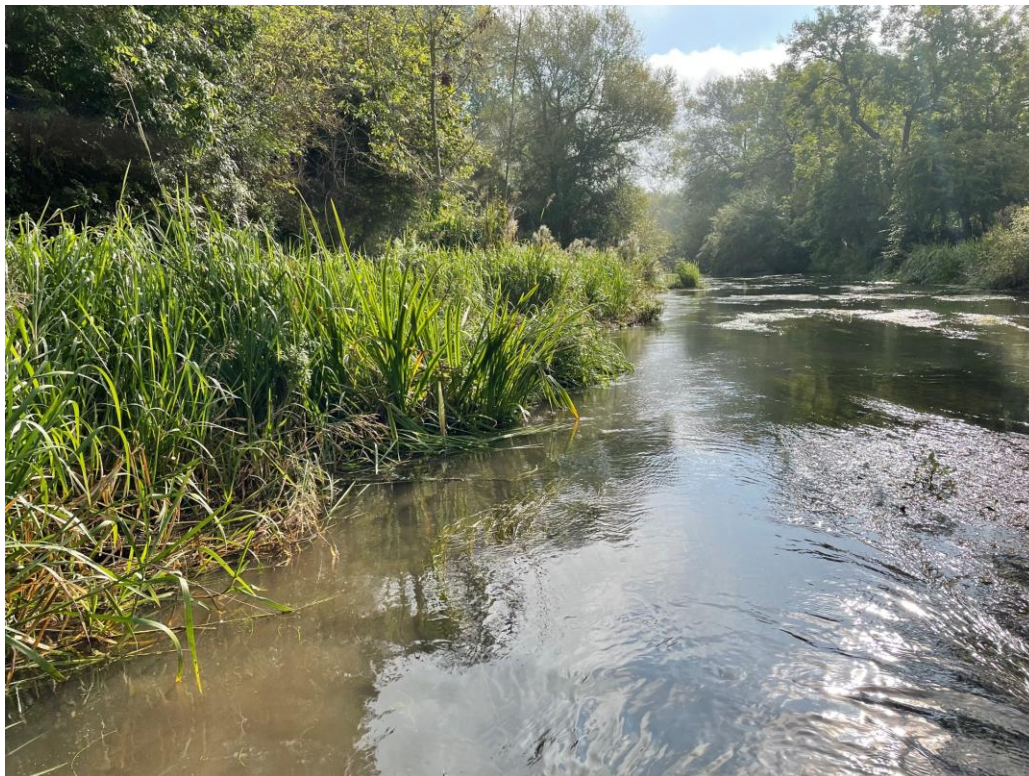
- 3.4 The level of water vole activity within the site has increased significantly in comparison with previous surveys, with the number of latrines recorded in 2021 being approximately double that recorded in previous years. The left bank of the river within Section 5 was found to have a particularly high density of water vole latrines, with approximately one latrine per metre of bankside, which is comparable with the highest densities likely to be found anywhere within the UK.

5	45m	None	38	12	14	7	10	7	10	5	Good habitat, with a very wide fringe (5m) of emergent vegetation dominated by reed sweet-grass.	Good habitat, with a very wide fringe (5m) of emergent vegetation dominated by reed sweet-grass.	Significant increase in relative density of water voles

Section 5 of the river – the left bank supports a very high density of water voles
