River Coln at Fairford

Water Vole Monitoring Survey

Report ref: C122/MR19/v1

Date: October 2019

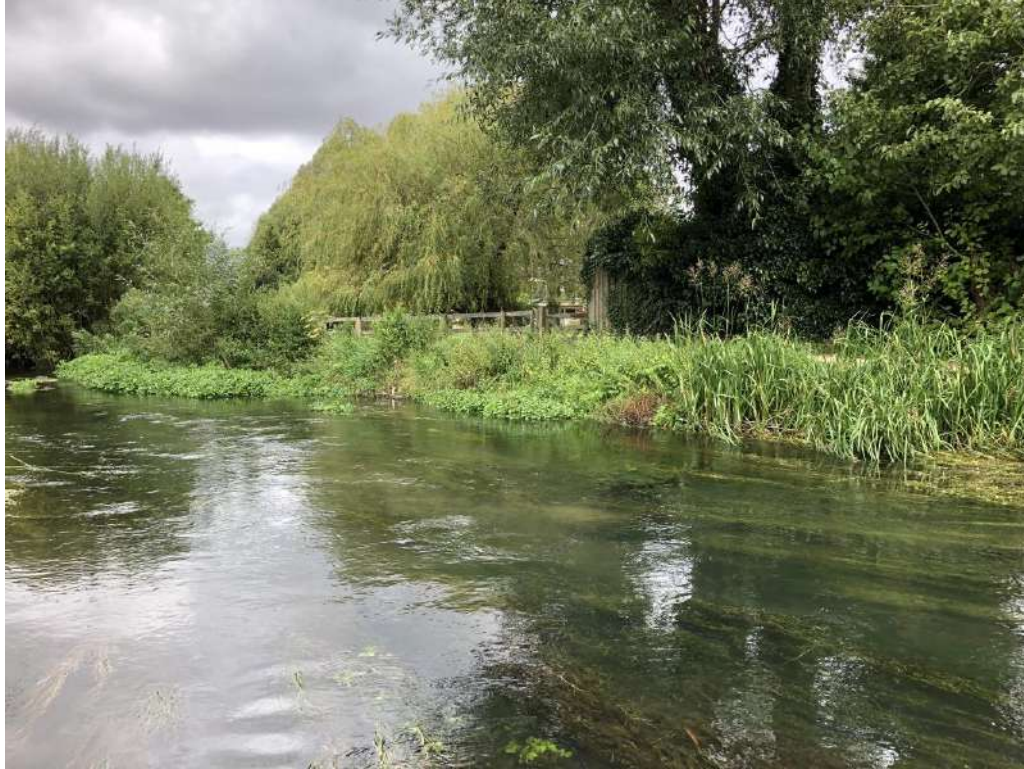
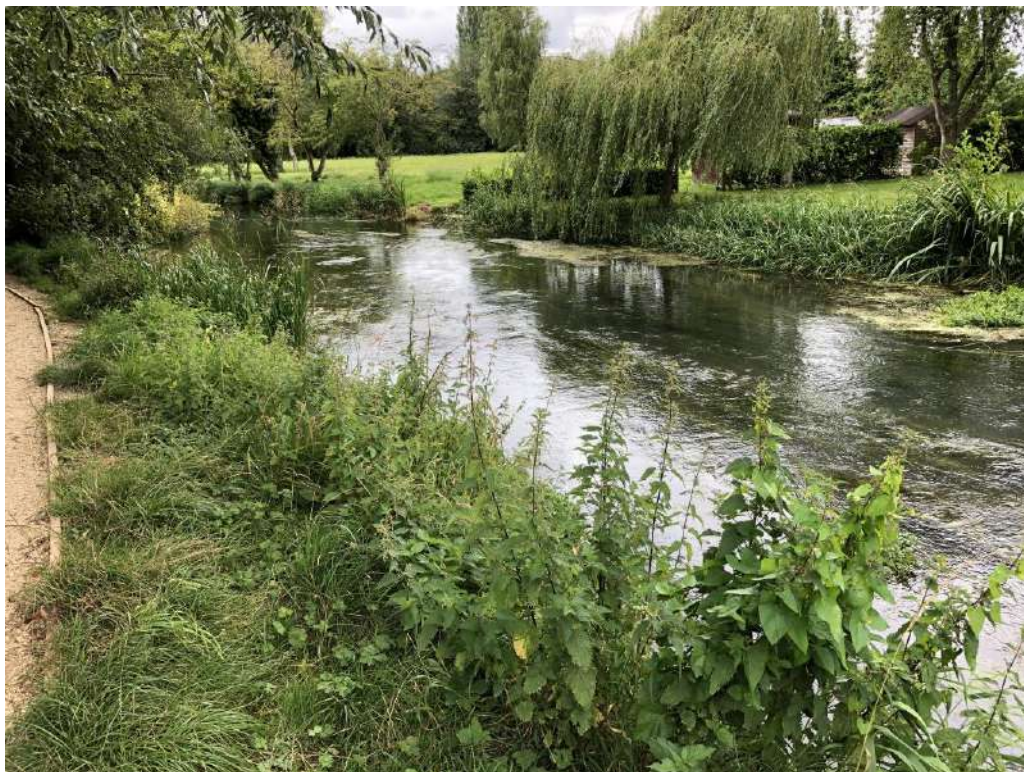
- 3.4 The areas of restored habitat were generally found to be developing well. Faggoting and coir fibre rolls had been installed in four locations:
- 1) In Section 3, where water voles were displaced and habitat restoration and habitat improvement works were proposed – habitat is still developing, no remediation works considered necessary;

3	30m	Displacement and subsequent restoration of bank using faggots and coir fibre rolls	1 latrine on the left bank and 3 latrines on the right bank.	Generally improved habitat from pre-planted coir fibre rolls; better habitat than was the case in 2018.	None (on either bank)	Relatively poor bankside vegetation due to shading from bankside trees.	Minor increase in relative density of water voles (+4 latrines)

Section 3; habitat recovering and water voles present

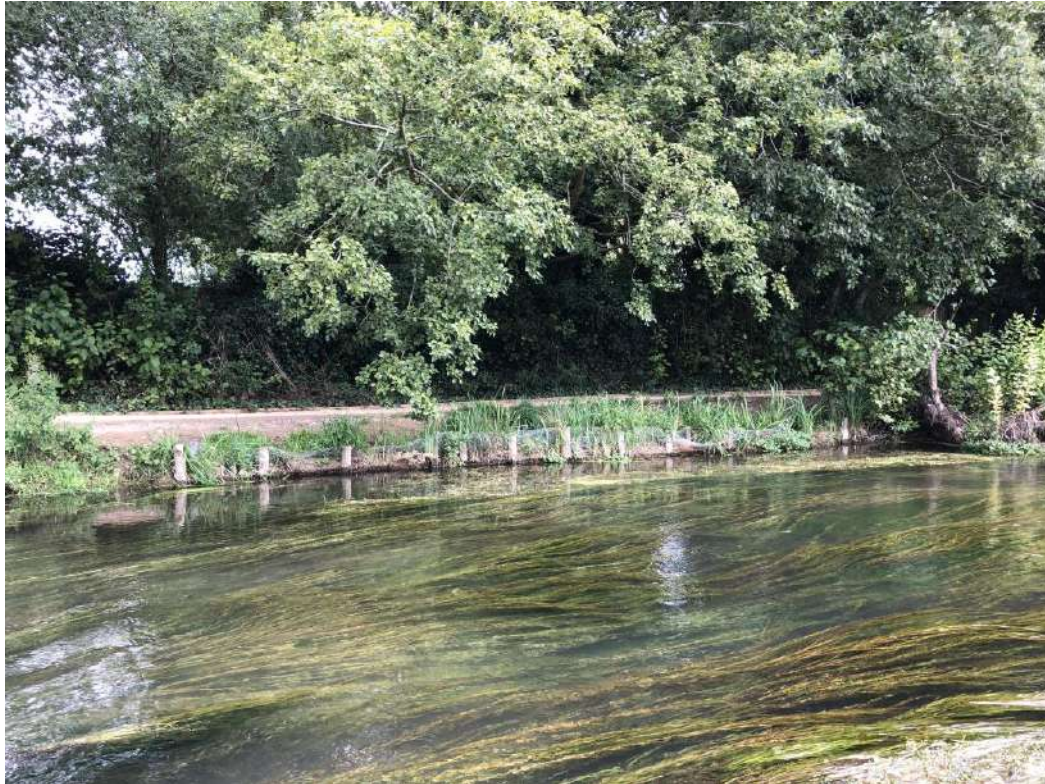
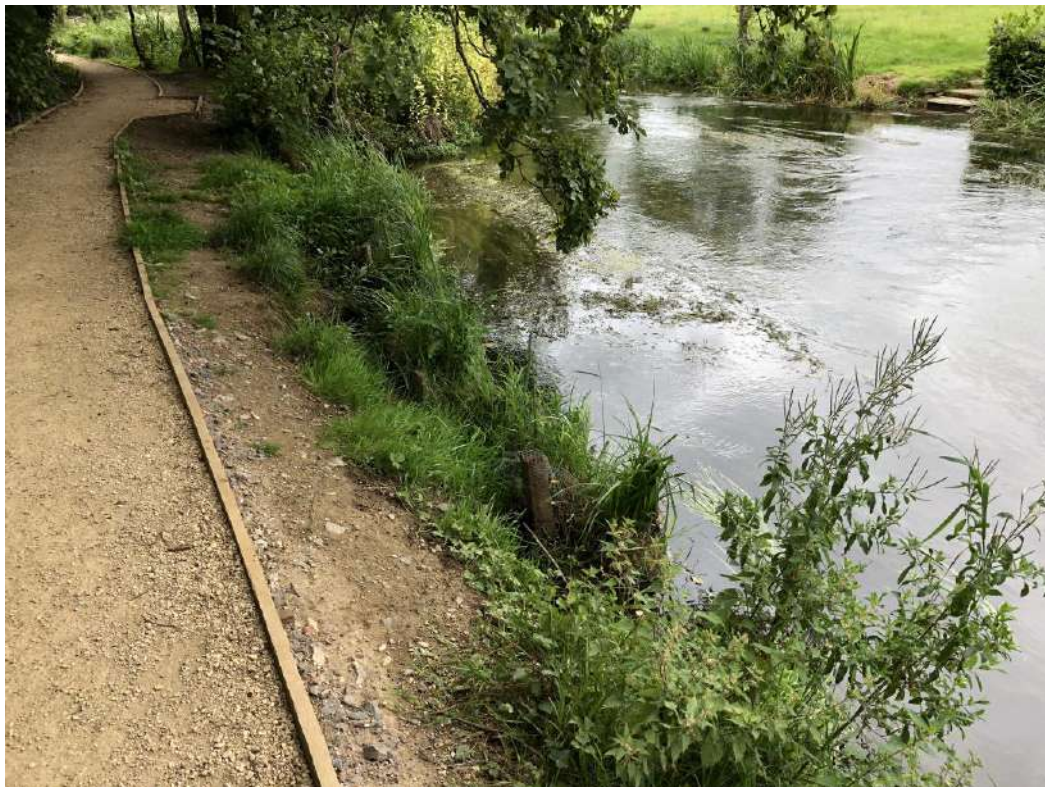
Coir fibre rolls installed in Section 3 where displacement took place; vegetation still establishing

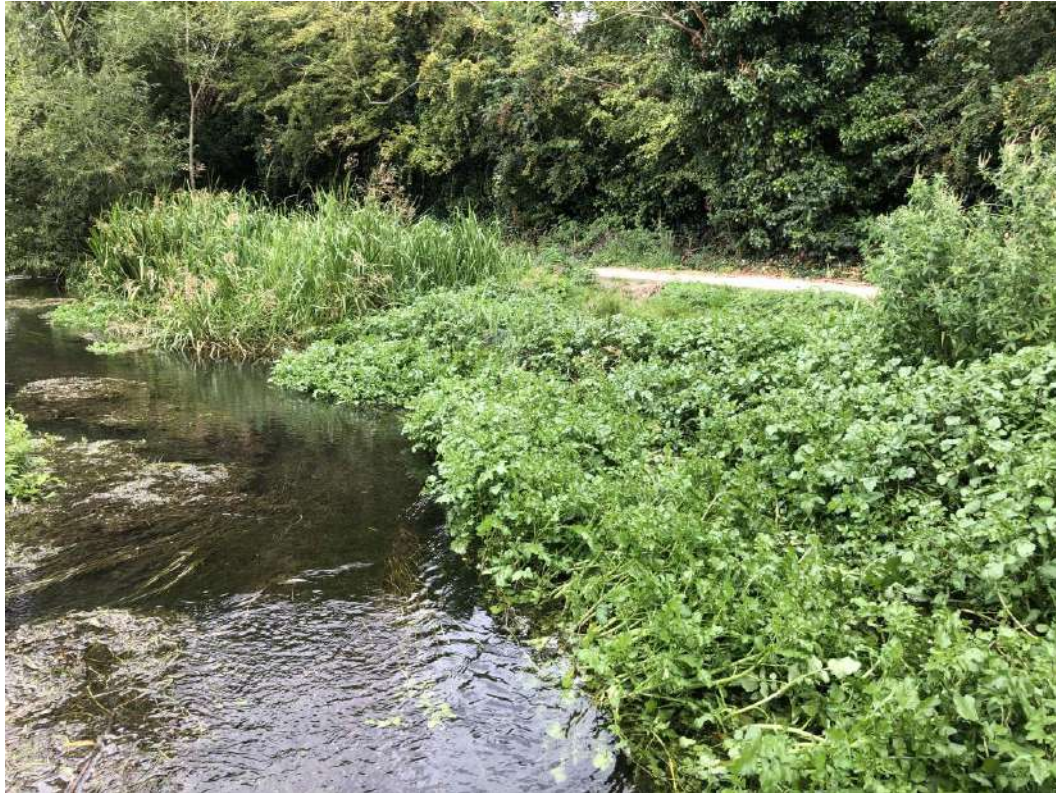
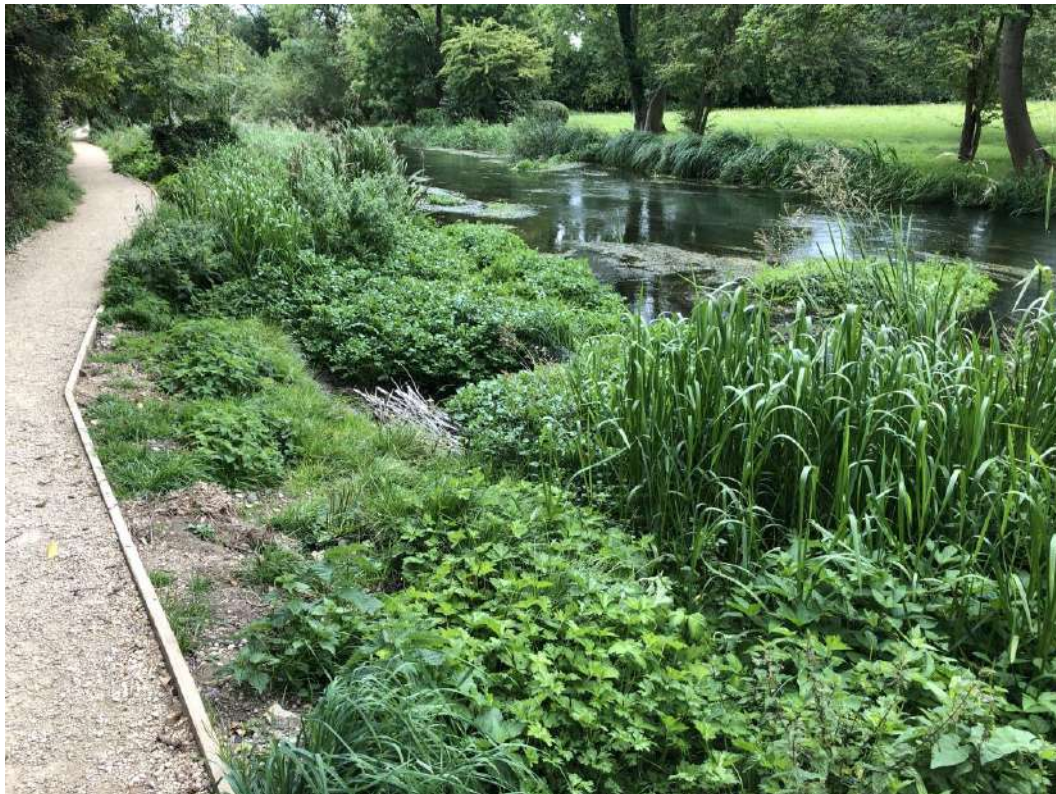
- 2) In Section 4/5, where habitat improvement works were proposed – habitat has established quickly and water voles are already present, no remediation works considered necessary;

Coir fibre rolls installed in Section 4/5; water voles present

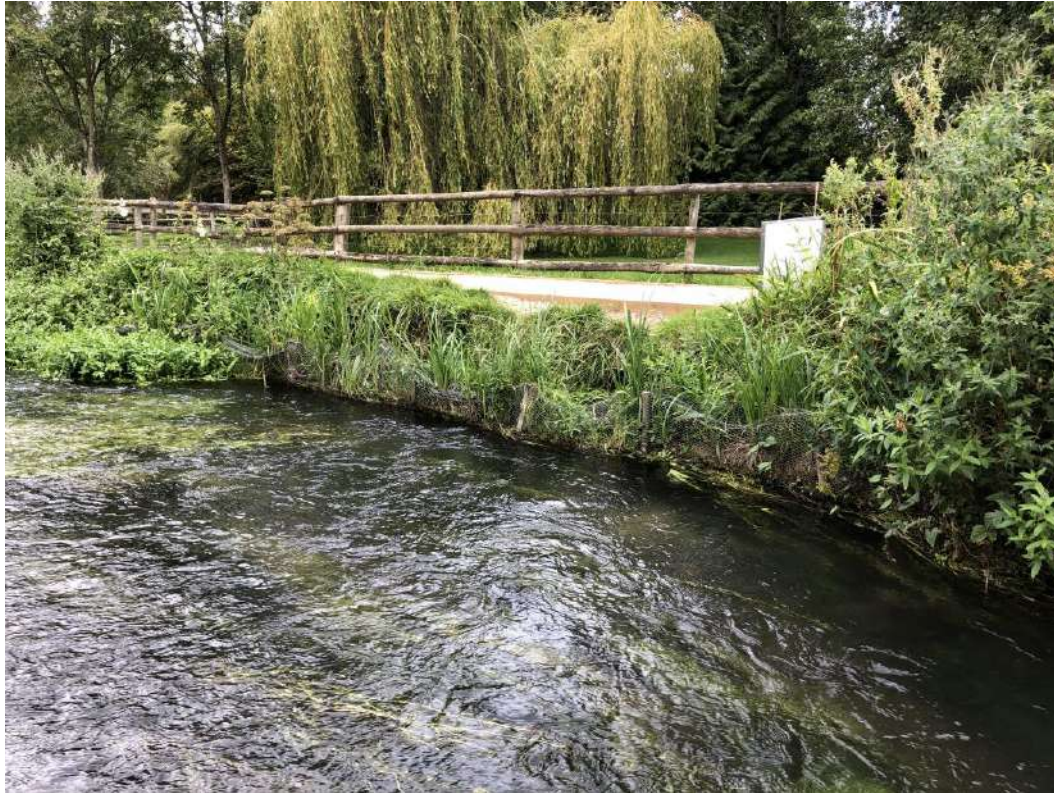
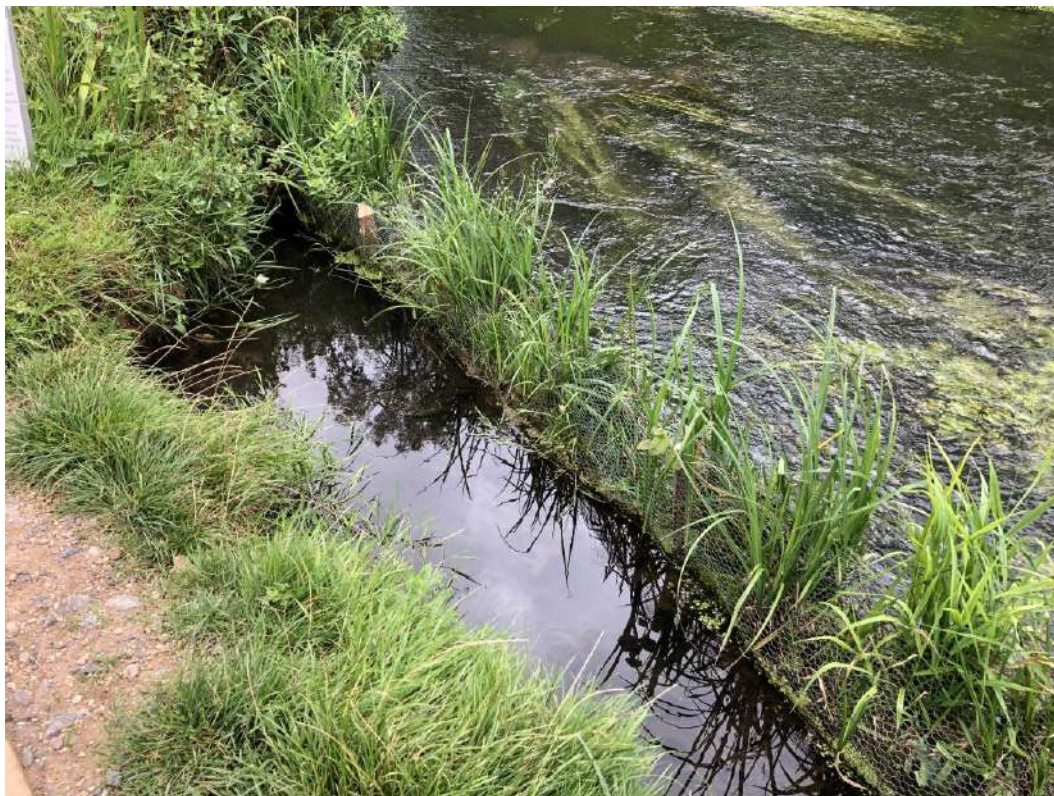
- 3) In Section 6, where water voles were displaced and habitat restoration was proposed – habitat is still developing, no remediation works considered necessary;

Coir fibre rolls installed in Section 6 where displacement took place; vegetation still establishing

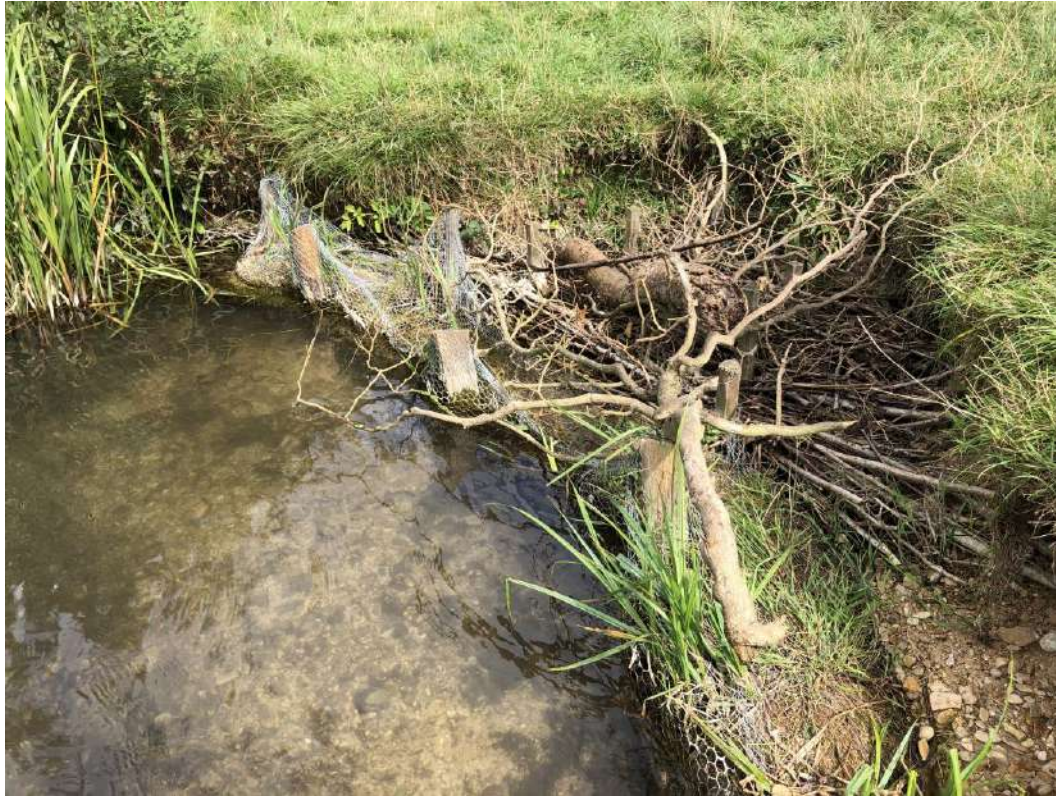
- 4) In Section 11a, where habitat improvement works were proposed – coir fibre roll has been damaged, but further damage is likely to occur unless the area is fenced off; a further review in 2020 is recommended.

- 4.2 Bankside restoration works have been partially successful, although more time is required for the vegetation to develop fully in these areas. The only exception is in Section 11a, where the installed coir fibre roll (a 3m length) has been damaged. The need for remediation works at this location (or elsewhere) will be reviewed following the 2020 monitoring visit.

Damaged coir fibre roll installed in front of eroded bank at 11a

- 4.4 It would also be appropriate to review whether fencing is required to restrict access to the river by people and/or dogs in locations where damage to the banks has occurred, to encourage the regrowth of vegetation in these areas.

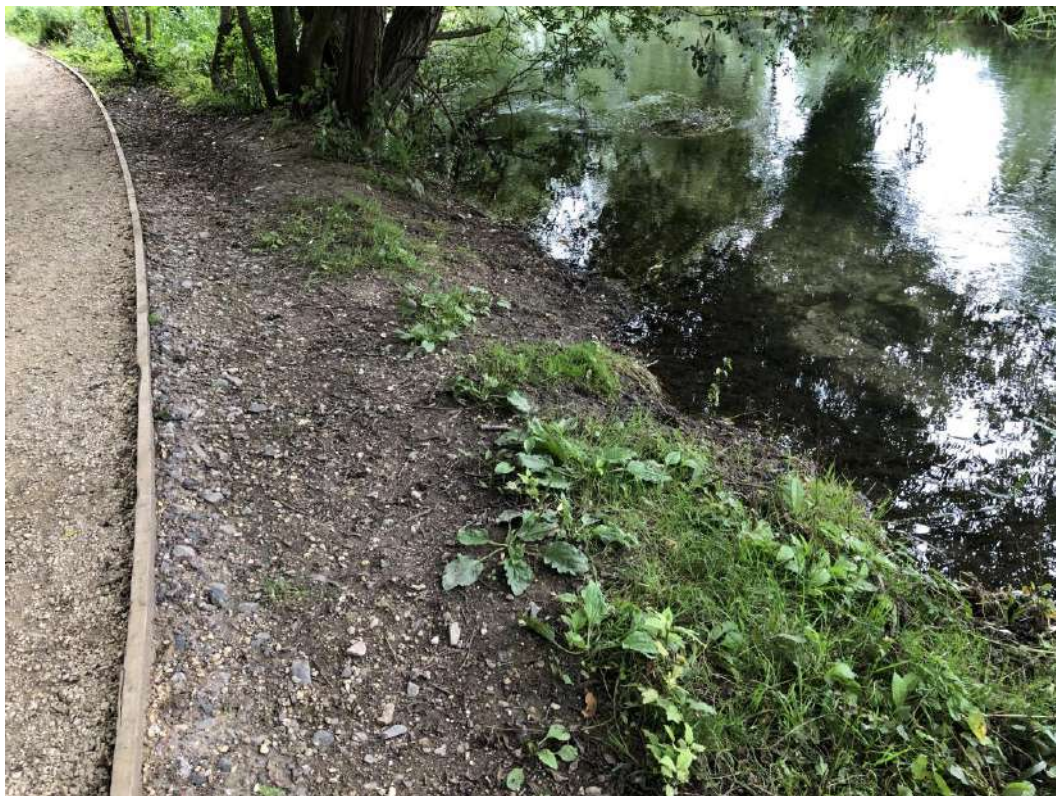
Section	Approx. length	Works undertaken to bank face (left bank)	Water vole field signs recorded in September 2019	Description of habitat (Left bank) in 2019	Water vole field signs recorded in September 2018	Description of habitat (Left bank) in 2018	Comparison of 2019 status with pre-works (2018)
4	20m	Displacement; no restoration needed	2 latrines and feeding signs on the left bank, 4 latrines and feeding signs on the right bank	Good habitat, with a wide fringe of emergent vegetation dominated by yellow flag. There is a small area of habitat degradation where dogs enter/exit the river	1 latrine and feeding remains on the left bank, no latrines on the right bank	Good habitat, with a wide fringe of emergent vegetation dominated by yellow flag.	Minor increase in relative density of water voles (+5 latrines)
4 / 5	9m	Habitat improvement works (as proposed in the licence application)	2 latrines on the coir fibre roll installed on the left bank	Vegetation has established well within the coir fibre roll; improved habitat as a result	None	Section of bank which has been washed away and repaired with faggots – further bank stabilisation work may be needed.	Minor increase in relative density of water voles (+2 latrines)

Section 4 – area of damage to bank
