River Coln at Fairford

Water Vole Monitoring Survey

Report ref: C122/MR20/v1

Date: September 2020

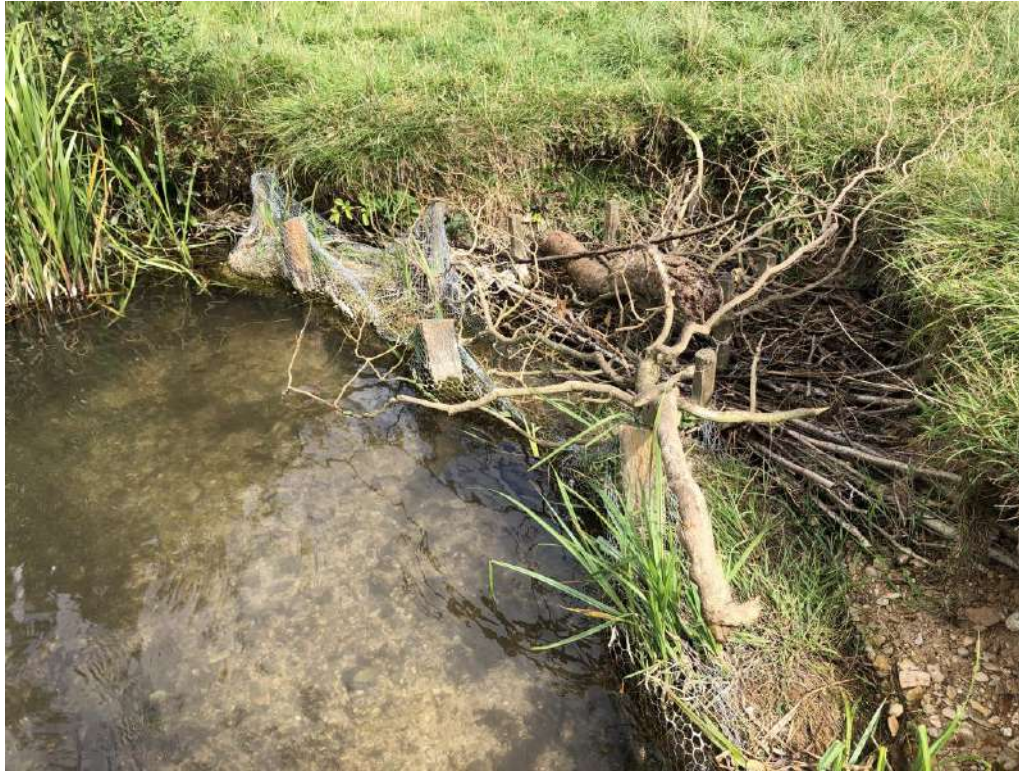
| Section | Approx. length | Works undertaken to bank face (left bank) | Number of latrines recorded | | | | | | Description of habitat (Left bank) in 2020 | Description of habitat (Left bank) in 2019 | Description of habitat (Left bank) in 2018 | Comparison of 2020 status with pre-works (2018) |
|---|---|--|---|---|---|---|---|---|--|---|--|---|
| 11a | 3m | Habitat improvement works (as proposed in the licence application) | 0 | 0 | 0 | 0 | 0 | 0 | Habitat is recovering | Coir fibre roll has been installed but has been damaged, probably by people and/or dogs getting in and out of the river | Eroded section of bank, which lacks emergent vegetation. | No change |

Damaged coir fibre roll installed in front of eroded bank at 11a (September 2019)

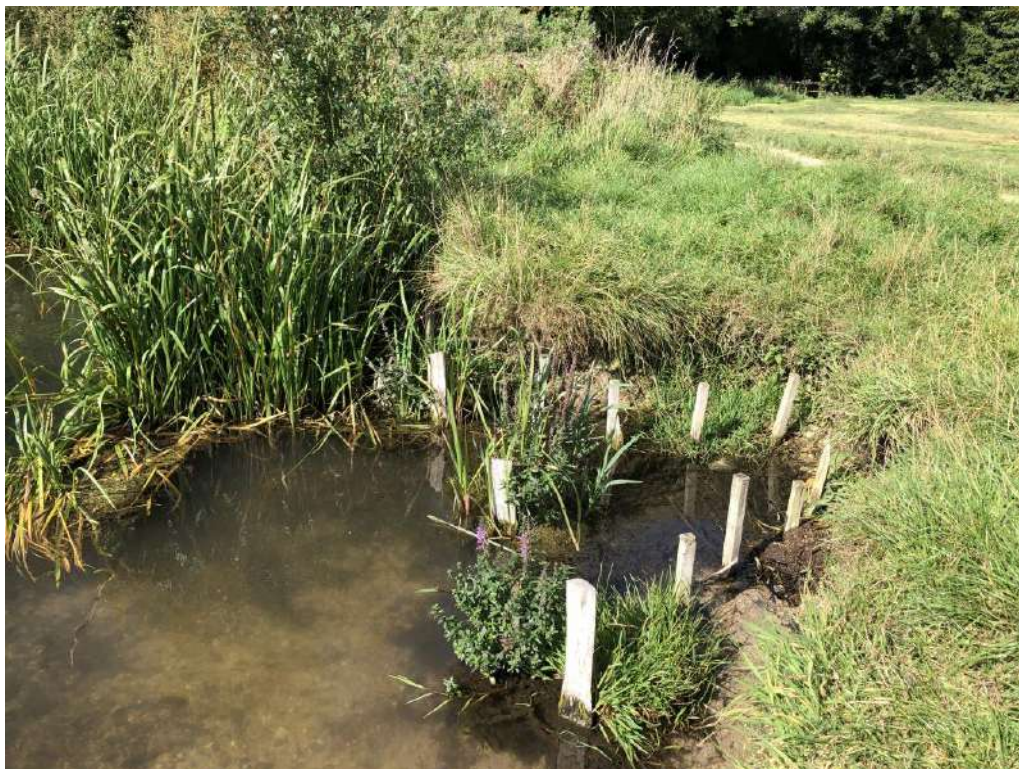
- 3) In Section 6, where water voles were displaced and habitat restoration was proposed – habitat has developed well and water voles are now present, no remediation works considered necessary;
 - 4) In Section 11a, where habitat improvement works were proposed – the habitat is still developing, due to initial damage in 2019, no remediation works considered necessary.
- 3.7 Otter (*Lutra lutra*) spraint was recorded throughout the site; no field signs of American mink (*Neovison vison*) were recorded.

Additional coir roll added, and vegetation at 11a is starting to recover (September 2020)

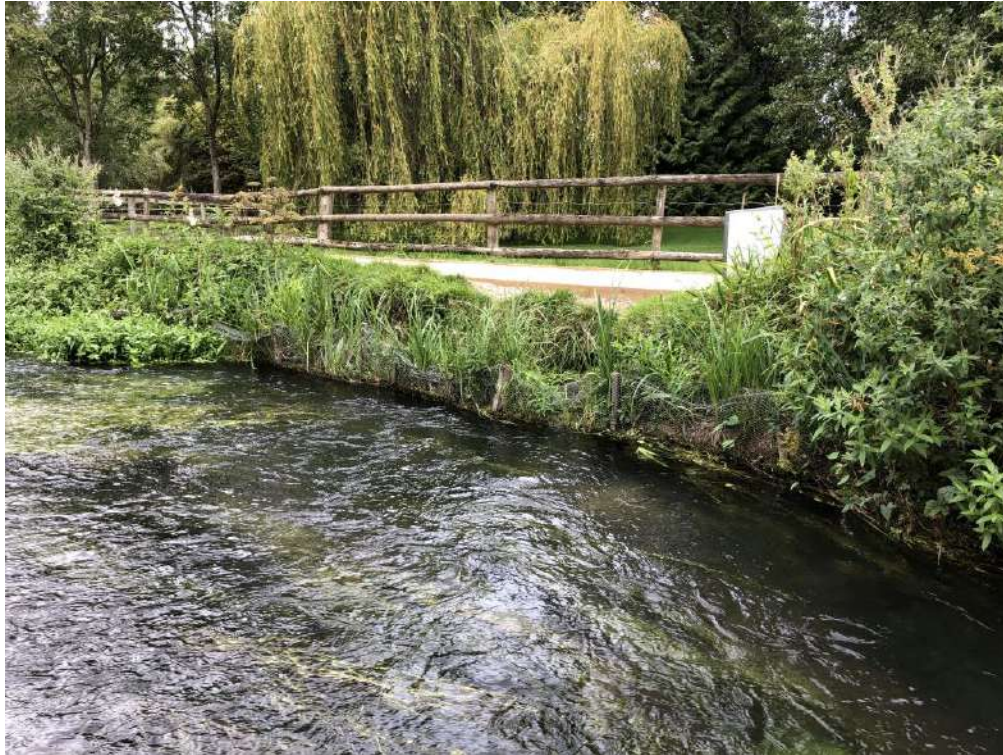
Coir fibre rolls installed in Section 6 where displacement took place; vegetation still establishing in September 2019

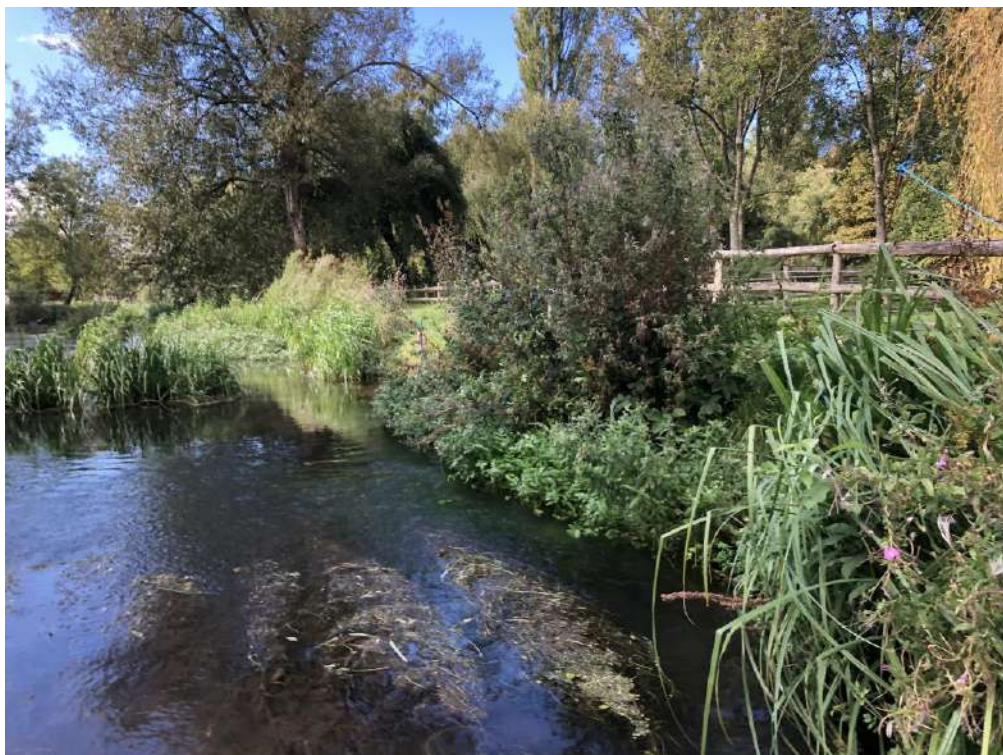
| Section | Approx. length | Works undertaken to bank face (left bank) | Number of latrines recorded | | | | | | Description of habitat (Left bank) in 2020 | Description of habitat (Left bank) in 2019 | Description of habitat (Left bank) in 2018 | Comparison of 2020 status with pre-works (2018) |
|---|---|--|---|---|---|---|---|---|--|--|---|---|
| 6 | 30-40m | Displacement and subsequent restoration of bank using faggots and coir fibre rolls | 4 | 0 | 0 | 0 | 3 | 0 | Habitat has developed well, with a narrow fringe of emergent vegetation now present in front of the undercut banks which provide good burrowing opportunities. | Coir fibre rolls installed, vegetation is still establishing and therefore less suitable than was the case in 2018 | Good habitat, with a wide fringe of emergent vegetation dominated by reed sweet-grass, and bankside vegetation dominated by willowherb and nettles. | Minor increase in number of latrines but does not affect relative density |

Coir fibre rolls installed in Section 6 where displacement took place; vegetation is well-established by September 2020 and water voles are present
