# **River Coln at Fairford**

## **Water Vole Monitoring Survey**

**Report ref: C122/MR21/v1**

**Date: September 2021**

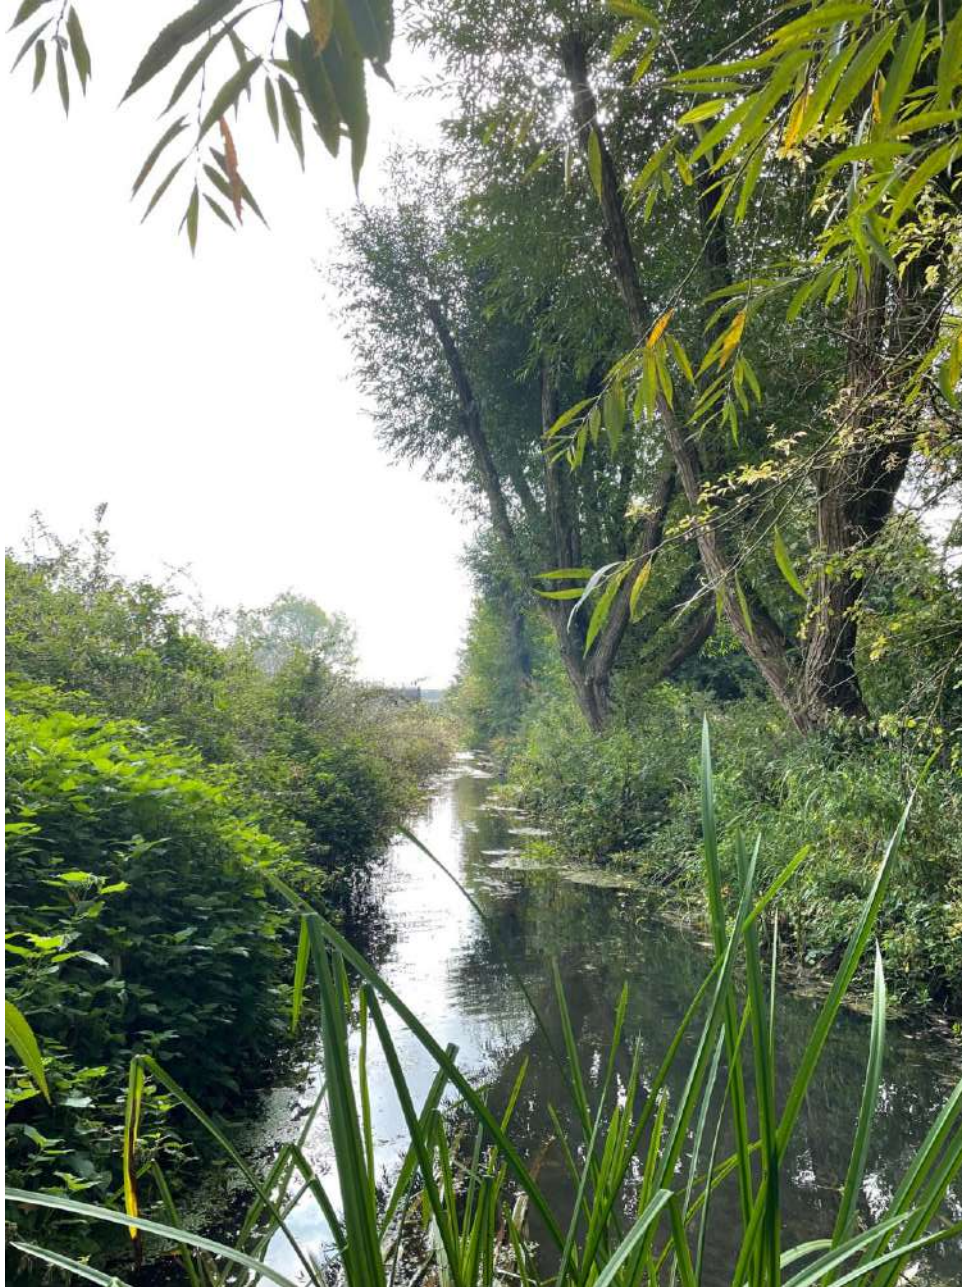
- 4.3 As part of the same project, habitat improvements for water voles within a side branch of the river (on the opposite bank to the path) have been undertaken. These works appear to have been successful in opening up the channel to more light, encouraging the growth of emergent vegetation. Water voles were recorded throughout the side channel in 2021.

Side channel where off-site habitat improvement works have been undertaken

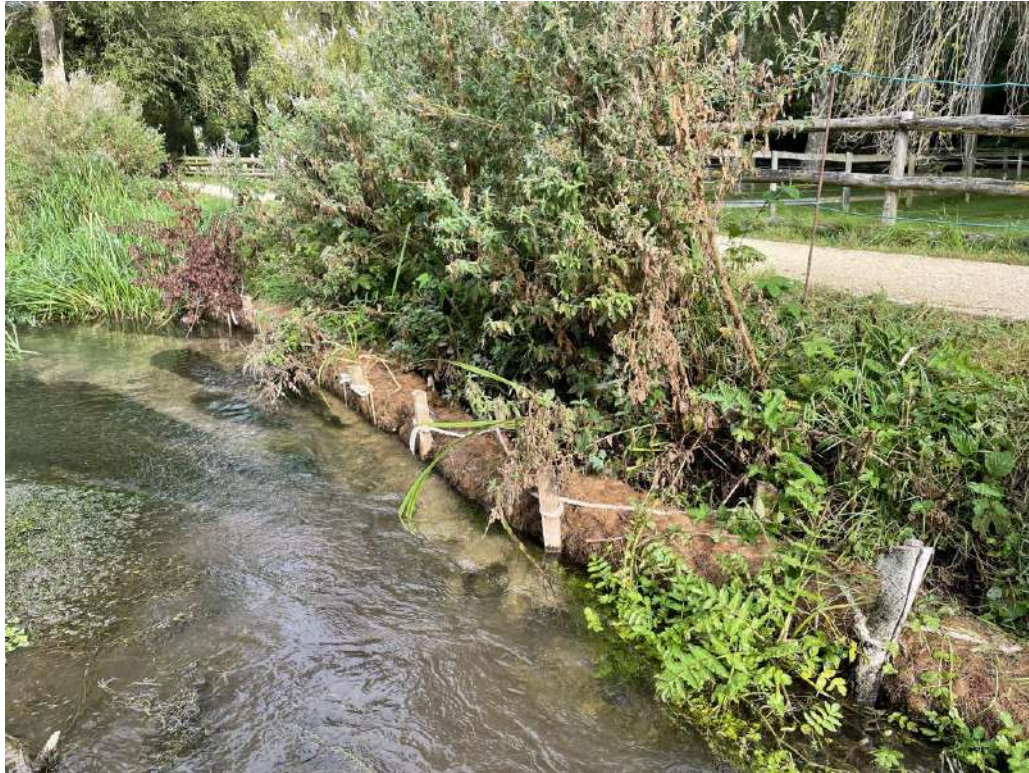
- 3.5 The areas of restored habitat were generally found to be developing well. Faggoting and coir fibre rolls had been installed in four locations:
- 1) In Section 3, where water voles were displaced and habitat restoration and habitat improvement works were proposed – the habitat had developed well except where dogs enter the channel, and water voles were present;

- 2) In Section 4/5, where habitat improvement works were proposed – the habitat had established quickly and water voles were present;
  - 3) In Section 6, where water voles were displaced and habitat restoration was proposed – the habitat had developed well and water voles were present;

- 4) In Section 11a, where habitat improvement works were proposed – the habitat appeared unlikely to develop fully, due to dogs entering the water.
- 3.6 No remediation works are considered necessary at any of these locations.

Restored section of bank showing coir fibre roll; vegetation on the roll has established well in some places but not in others

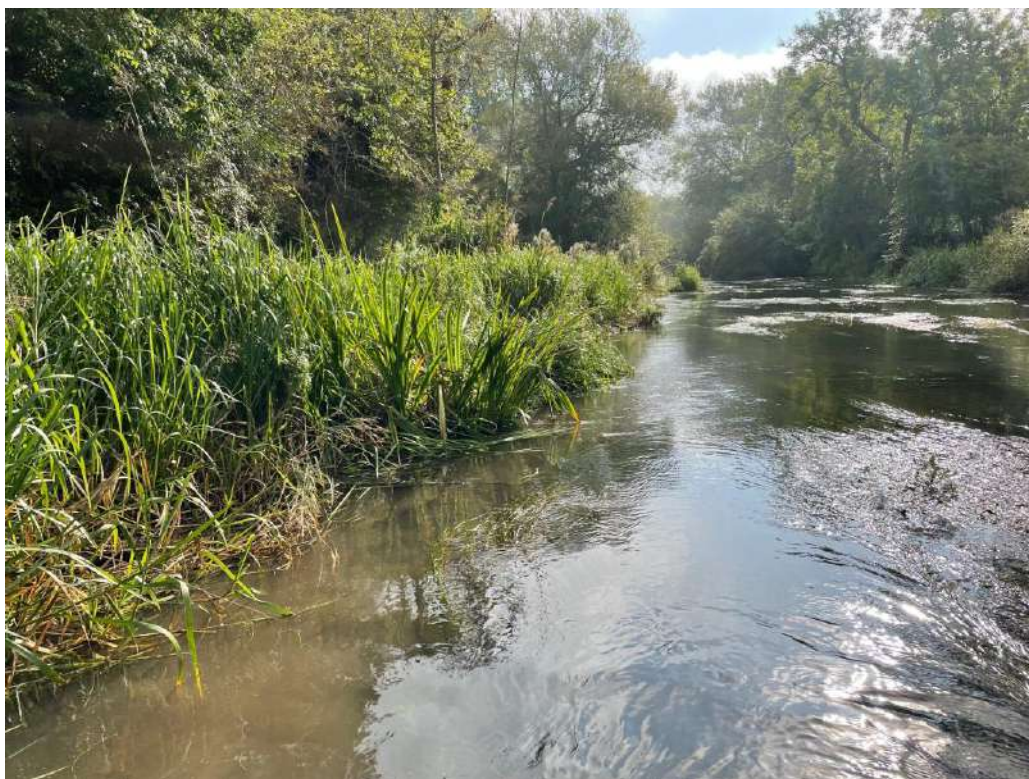
- 3.4 The level of water vole activity within the site has increased significantly in comparison with previous surveys, with the number of latrines recorded in 2021 being approximately double that recorded in previous years. The left bank of the river within Section 5 was found to have a particularly high density of water vole latrines, with approximately one latrine per metre of bankside, which is comparable with the highest densities likely to be found anywhere within the UK.

5	45m	None	38	12	14	7	10	7	10	5	Good habitat, with a very wide fringe (5m) of emergent vegetation dominated by reed sweet-grass.	Good habitat, with a very wide fringe (5m) of emergent vegetation dominated by reed sweet-grass.	Significant increase in relative density of water voles

Section 5 of the river – the left bank supports a very high density of water voles
