River Coln at Fairford

Water Vole Survey

Report ref: C122/R1/v2

Date: September 2018

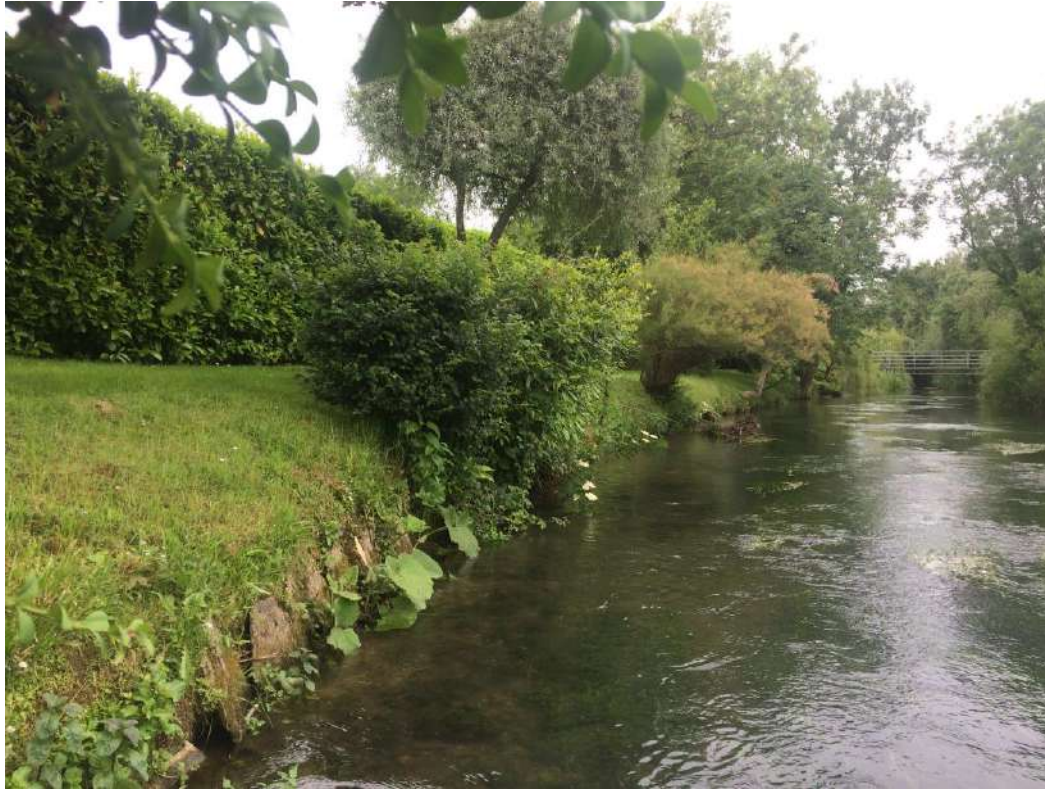
Section 2 (right bank of river, photo taken facing upstream)

- Improving the habitat on the right bank of the river in Section 2, where there is little emergent vegetation and the grassy bank is regularly mown by a private landowner.

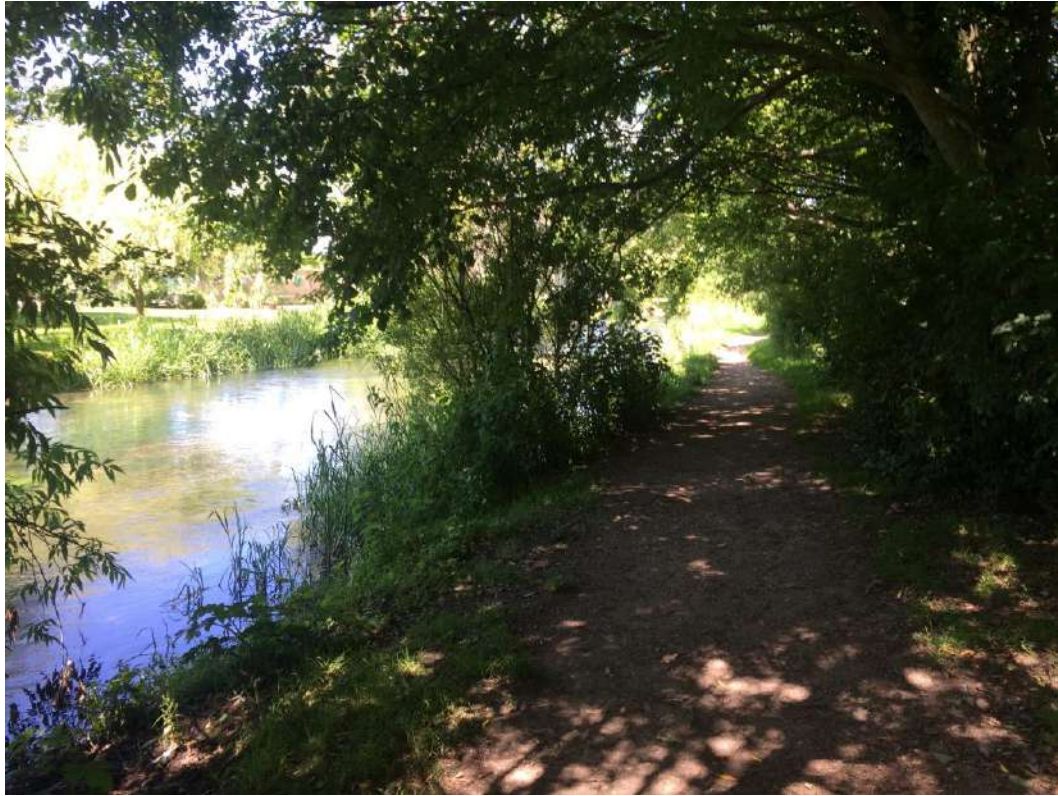
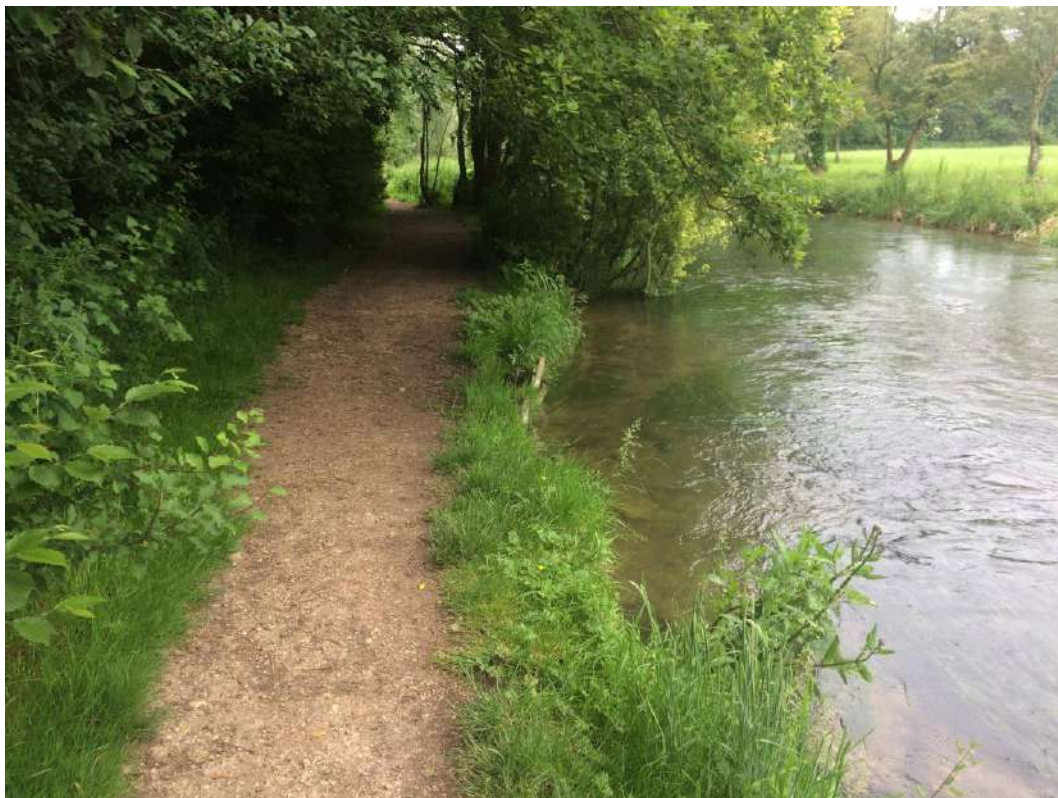
Section 3

3	20m	Relatively poor bankside vegetation due to shading from bankside trees.	June and Sep 2018 – None (on either bank) but water voles are present immediately downstream on the left bank	Medium/ Low	Within 1m of bank top	There is a likelihood of damaging burrows. Displace water voles from this short section by vegetation strimming.

- Works to be timed to take place during spring (March/April) when they are likely to have the least impact on water voles;
 - Water voles to be displaced from short sections where works are most likely to damage burrows, by vegetation strimming 5-10 days in advance of works commencing (Sections 3 and 4, 32m, and Section 6, 15-20m, left bank only in both cases);

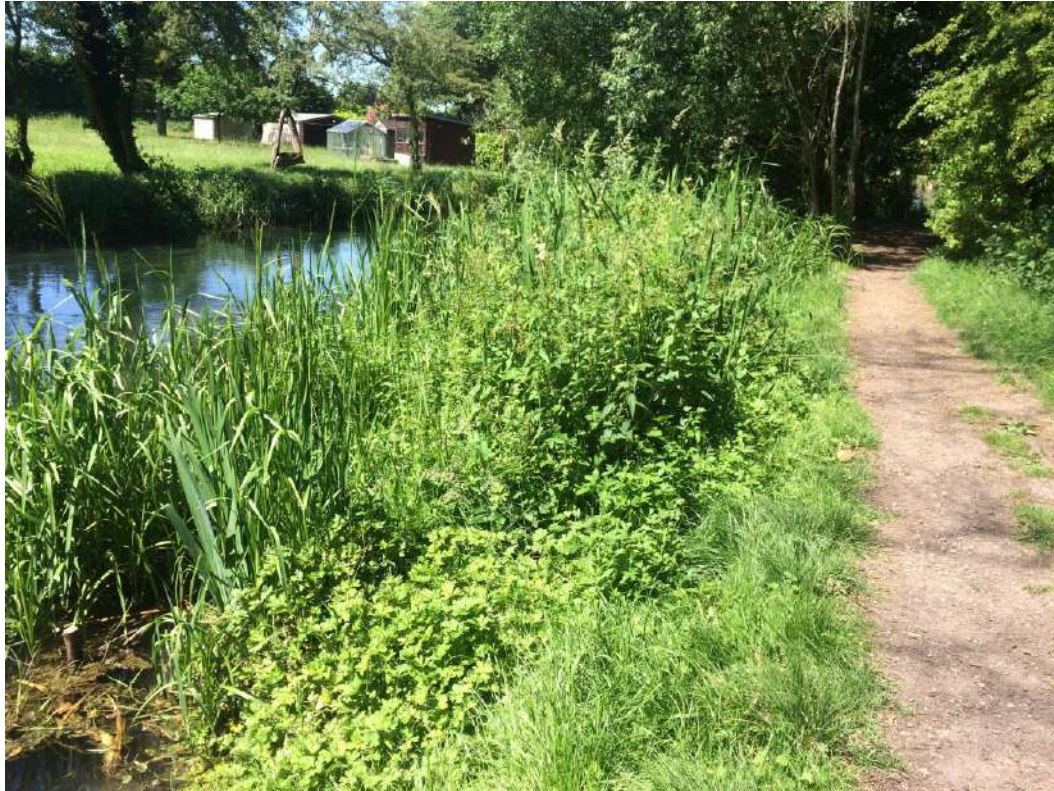
Section 4

Section	Approx. length	Habitat (Left bank)	Water vole field signs	Likelihood of burrows	Path proximity	Recommended approach
4	12m	Good habitat, with a wide fringe of emergent vegetation dominated by yellow flag.	June 2018 – Feeding remains only, no latrines Sep 2018 – 1 latrine and feeding remains on the left bank, no latrines on the right bank	High	Within 1m or 2m of bank top	There is a likelihood of damaging burrows. Displace water voles from this short section by vegetation strimming.
4 / 5	4-5m	Section of bank which has been washed away and repaired with faggots – further bank stabilisation work may be needed.	June and Sep 2018 – None	Low	Within 1m of bank top	Burrows unlikely to be present. Work under ecologist's supervision.
5	30m	Good habitat, with a very wide fringe (5m) of emergent vegetation dominated by reed sweet-grass.	June 2018 – 6 latrines on the left bank (likely to be an under-estimate) along with feeding remains. 15 latrines on the right bank. Sep 2018 – 10 latrines on the left bank (likely to be an under-estimate) along with feeding remains. 5 latrines on the right bank.	Low	1-2m from bank top	The bank profile is very shallow in this location with little height difference between top of bank and water level. The likelihood of damaging burrows is therefore minimal. Work under ecologist's supervision.

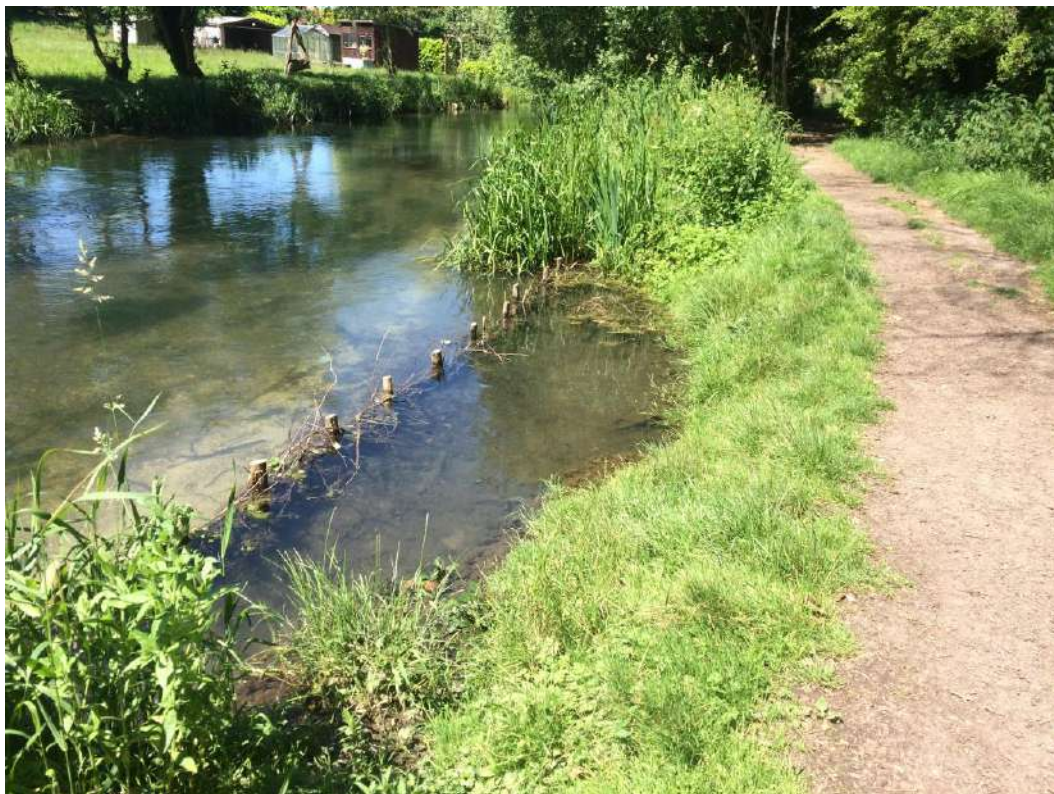
Eroded bank between sections 4 and 5

- 4.6 Small scale works to repair areas of eroded bank are unlikely to have any impacts on water vole burrows and are likely to be beneficial if a suitable bank for burrowing can be created and emergent vegetation introduced at the toe of the bank. Emergent vegetation can be plug planted or introduced in a coir fibre roll (which may be preferable in areas exposed to scouring). Any planted vegetation should be protected from trampling and grazing by wildfowl.

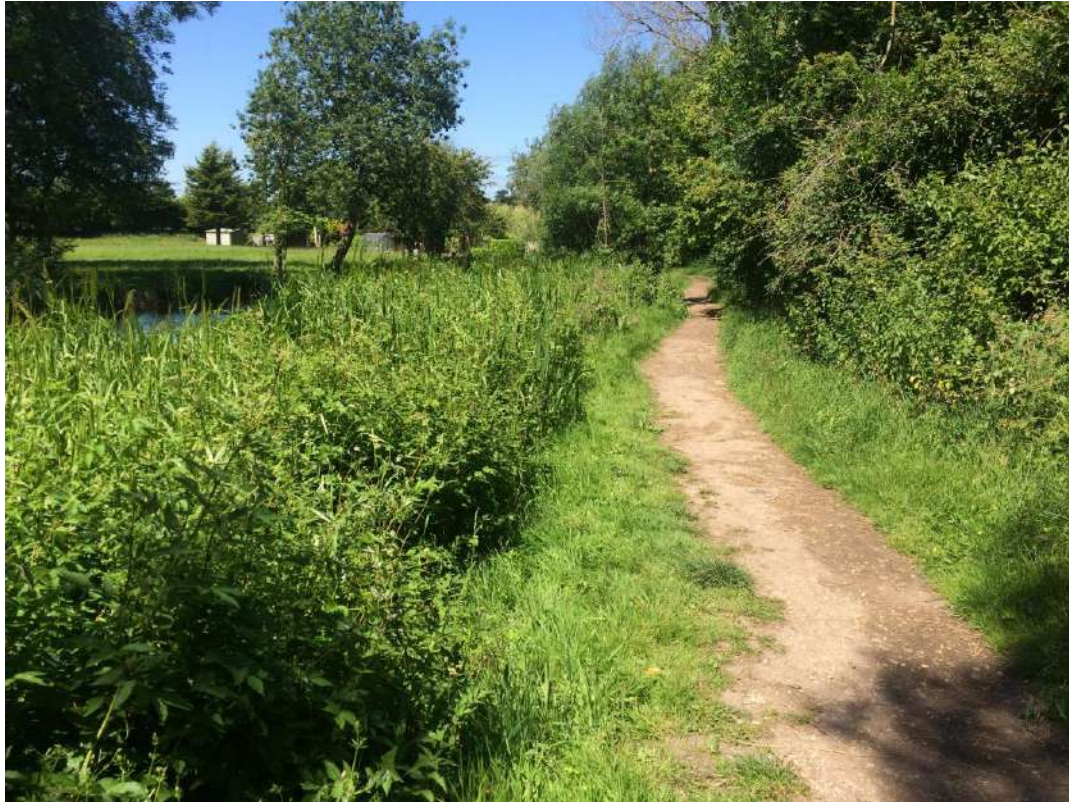
Section 6

Section	Approx. length	Habitat (Left bank)	Water vole field signs	Likelihood of burrows	Path proximity	Recommended approach
6	15-20m	Good habitat, with a wide fringe of emergent vegetation dominated by reed sweet-grass, and bankside vegetation dominated by willowherb and nettles.	<p>June 2018 – Feeding remains and burrows on the left bank, but no latrines. 5 latrines recorded on the right bank.</p> <p>Sep 2018 – 3 latrines and feeding remains recorded on a small island of emergent vegetation which has become established as water levels have dropped (immediately adjacent to the left bank); no signs on the right bank</p>	Confirmed present	Within 1m of bank top	There is a likelihood of damaging burrows (greater than for Section 5, due to the narrower width of emergent vegetation and steeper bank profile in this section). Displace water voles from this short section by vegetation strimming.

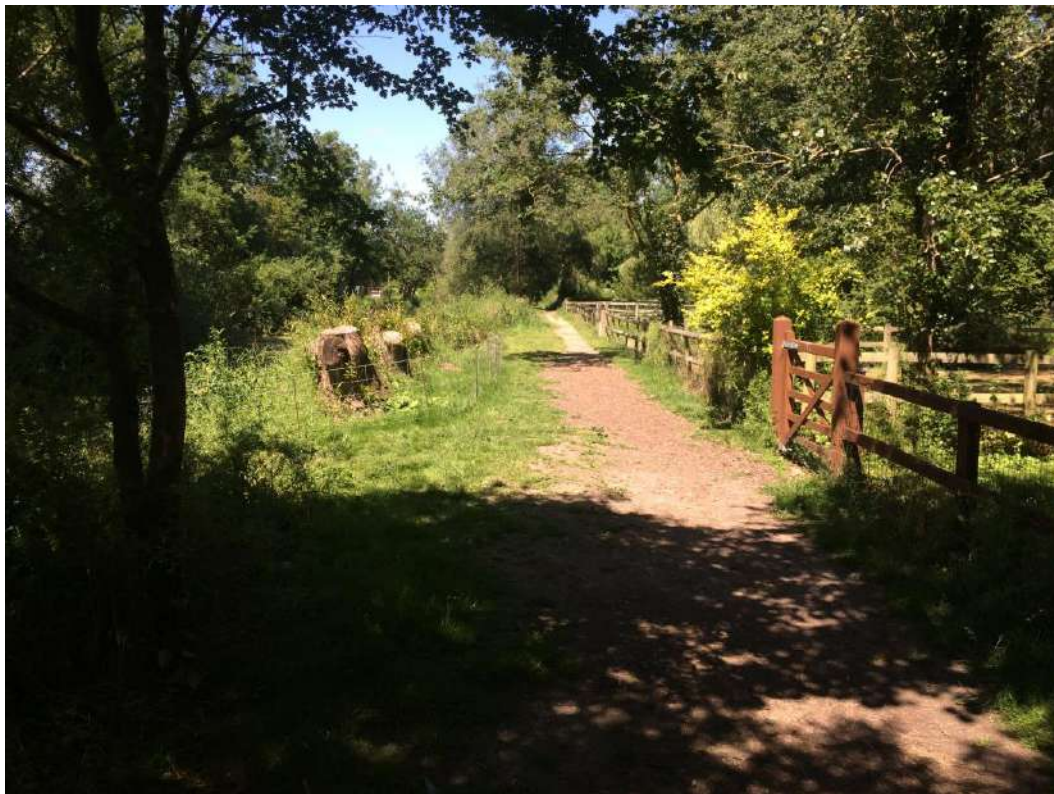
Section 7 (path)

Section	Approx. length	Habitat (Left bank)	Water vole field signs	Likelihood of burrows	Path proximity	Recommended approach
7	20m	Poor habitat with emergent vegetation only present in occasional patches. Several recently felled willow pollards is present in this section which are likely to have shaded this section until recently.	June 2018 – None (on either bank) Sep 2018 – 1 burrow and 1 latrine recorded on the left bank where the path is 3-4m from the bank face; no signs recorded on the right bank	Low	3m from toe of bank	Given the shallow bank profile, lack of field signs in June 2018, and distance of the path from the channel, the likelihood of damaging burrows (assuming a no-dig approach) is minimal, provided that works take place in spring when this section is less likely to be used by water voles. Work under ecologist's supervision.
8	15m	Good habitat, with a wide fringe of emergent vegetation dominated by yellow flag and reed sweet-grass.	June 2018 – Very high density of field signs: 13 latrines (left bank) and a significant number of piles of feeding remains. Feeding remains but no latrines on the right bank. Sep 2018 – very high density of field signs – at least 20 well-established latrines and feeding remains, suggesting this is the core of the colony. 4 latrines on the right bank	High	3m from top of bank	Given the distance of the path from the channel the likelihood of damaging burrows (assuming a no-dig approach) is minimal. Work under ecologist's supervision.

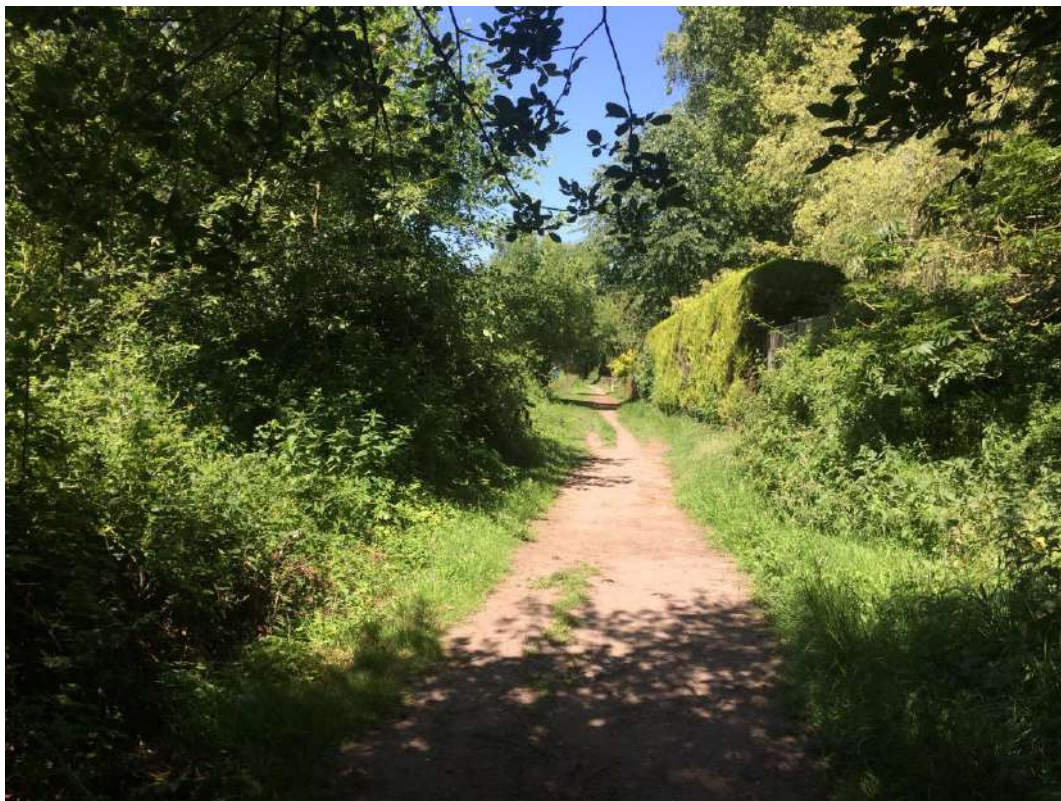
Section 9 (path)

Section	Approx. length	Habitat (Left bank)	Water vole field signs	Likelihood of burrows	Path proximity	Recommended approach
9	10m	Good habitat, with a wide fringe of emergent vegetation dominated by reed sweet-grass and willowherb.	June 2018 – Very high density of field signs: 4 latrines (left bank) and a significant number of piles of feeding remains. Feeding remains but no latrines on the right bank. Sep 2018 – very high density of field signs (at least 6 latrines on the left bank and 6 on the right bank)	High	5m from top of bank	Given the distance of the path from the channel the likelihood of damaging burrows (assuming a no-dig approach) is minimal. Work under ecologist's supervision.
10	40m	Poor habitat as heavily shaded by bankside trees; patches of emergent vegetation in places.	June 2018 – Feeding remains, but no latrines (on either bank). Sep 2018 – no latrines on the left bank, 1 latrine on the right bank	Low	3-4m from top of bank	Given the lack of latrines and distance of the path from the channel, the likelihood of damaging burrows (assuming a no-dig approach) is minimal. Work under ecologist's supervision.

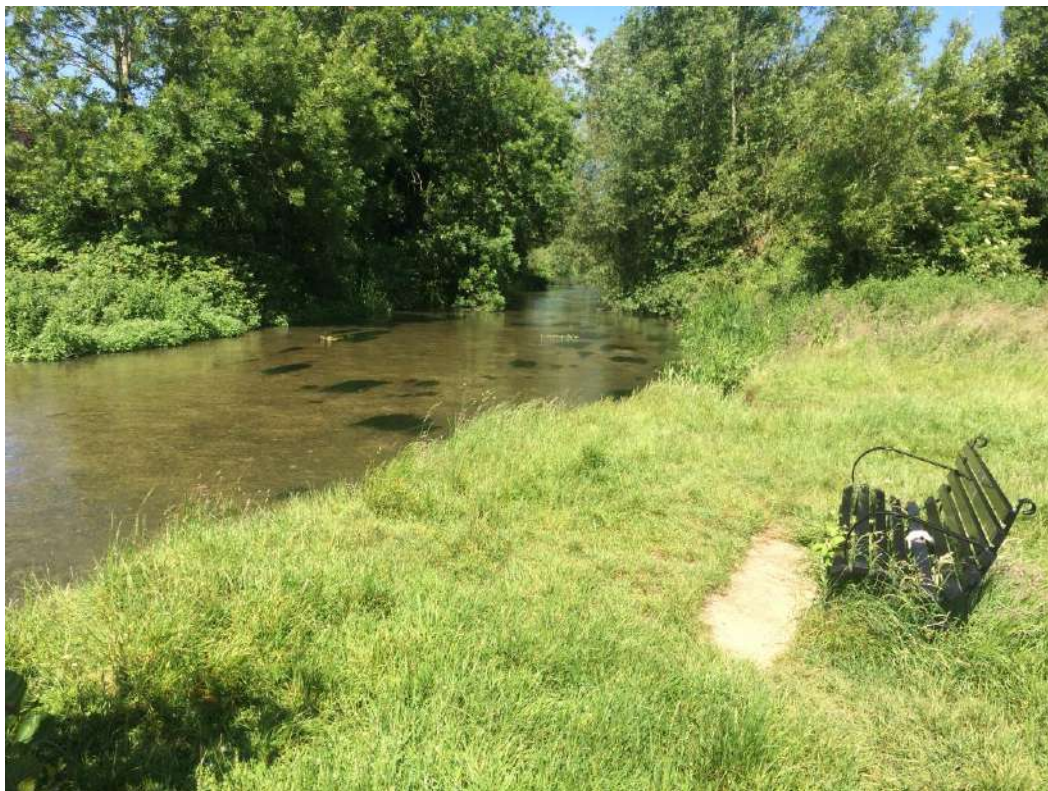
Section 11

11	15-20m	Poor habitat in general as the bank is undercut and lacks emergent vegetation.	June and Sep 2018 – None	Low	More than 3m	Given the lack of field signs and distance of the path from the channel, the likelihood of damaging burrows (assuming a no-dig approach) is minimal. Work under ecologist's supervision.

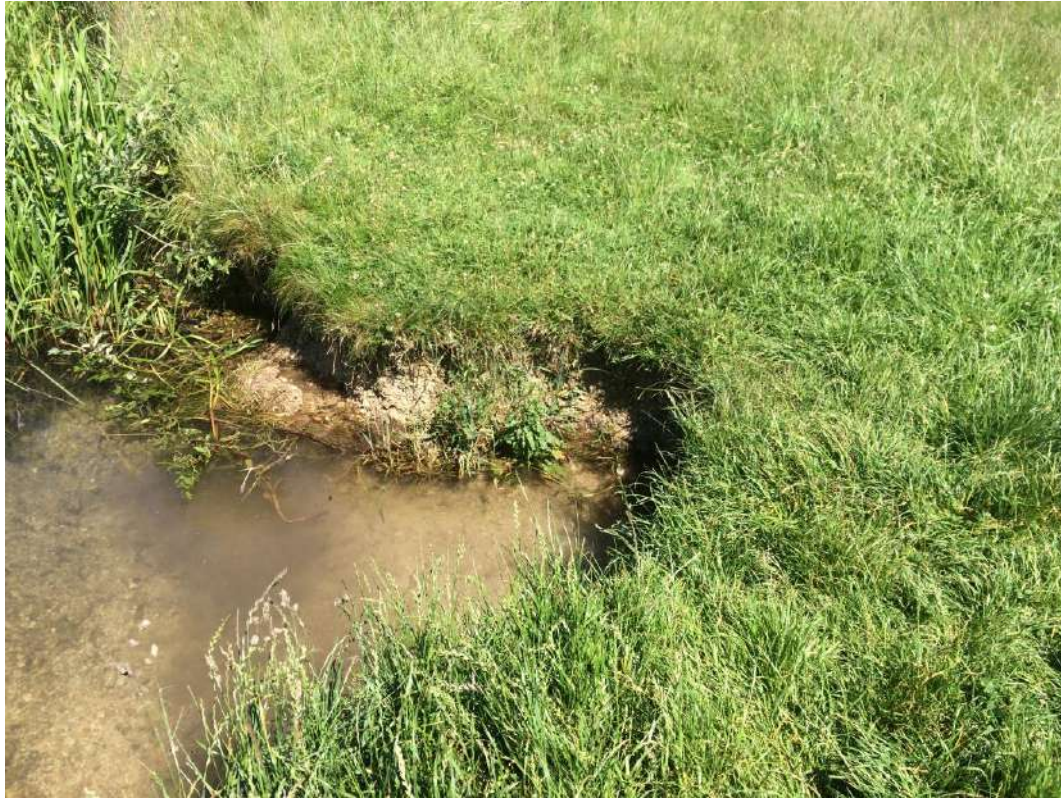
Section	Approx. length	Habitat (Left bank)	Water vole field signs	Likelihood of burrows	Path proximity	Recommended approach
11a	1m	Eroded section of bank, which lacks emergent vegetation.	June and Sep 2018 – None	Absent	n/a	Burrows unlikely to be present. Work under ecologist's supervision.

Eroded bank at 11a
