Inspection Report For:
Fairford Town Council

Inspection Location:
39989 - The Croft Park

Inspection Date:
24/02/2026

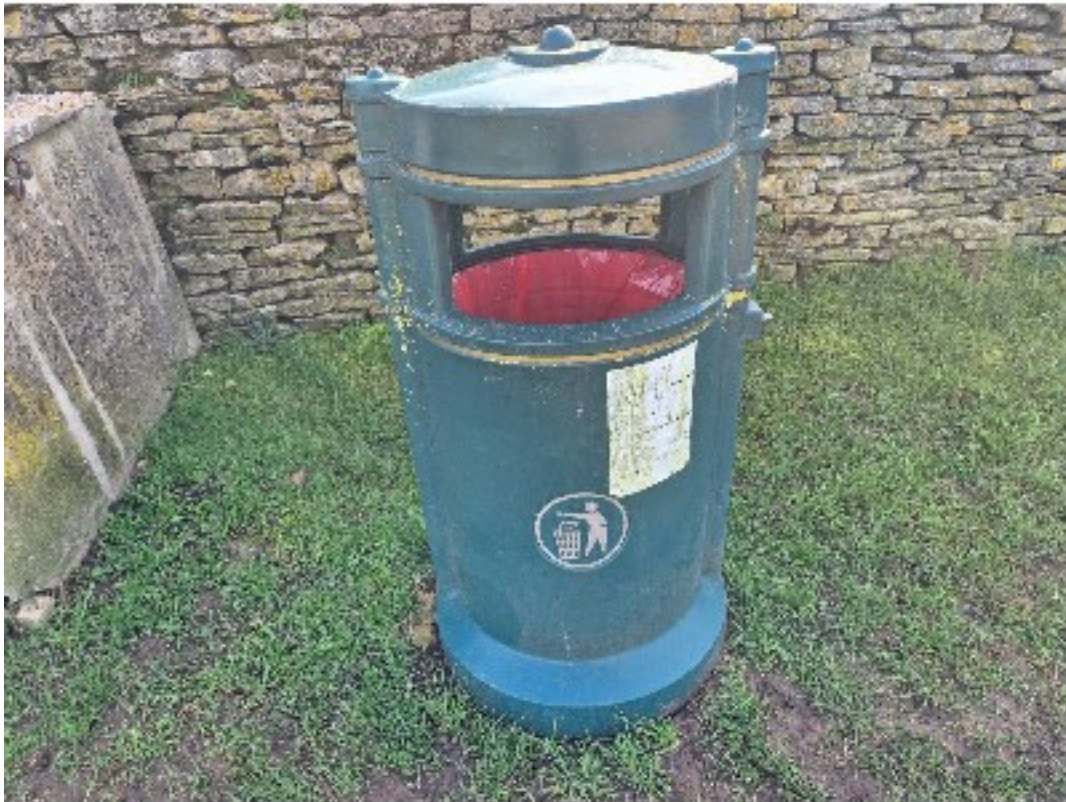
Litter Bins

Low Risk

Surfacing Type:	Grass	Surfacing is without defect:	Yes
Equipment Supplier:	Unknown	Equipment is without defect:	Yes
Equipment is labelled:	Yes

Finding One: The item is in good overall condition

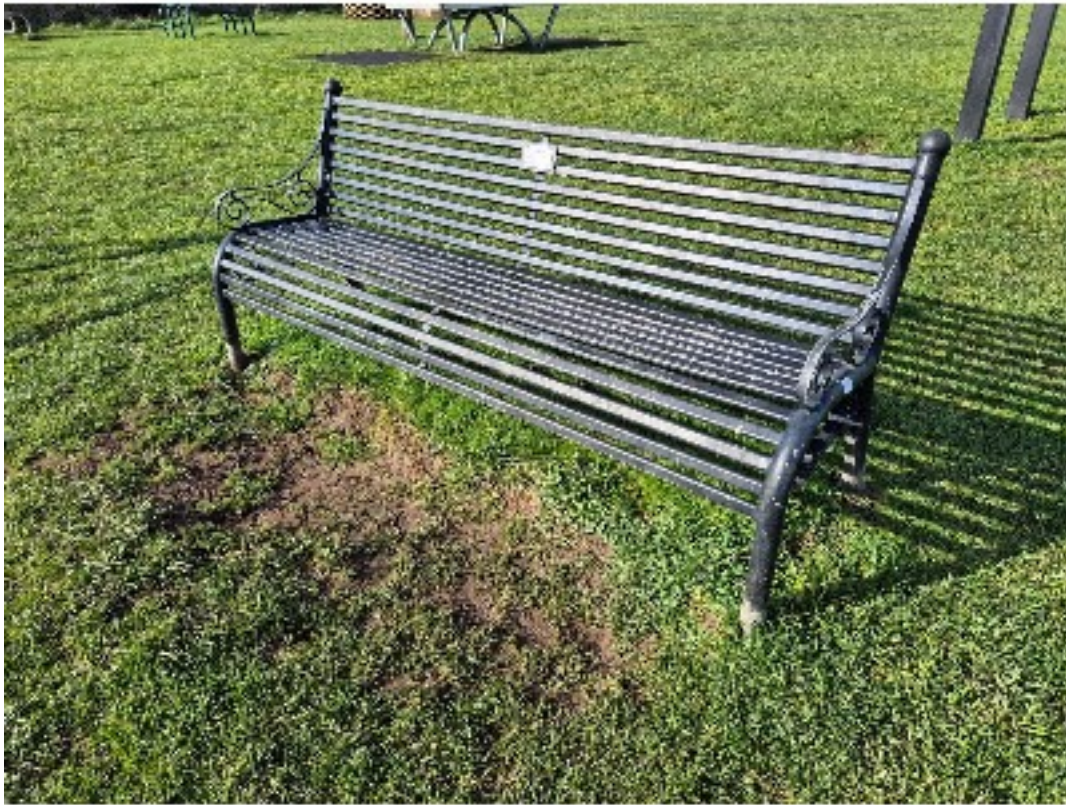
Bench

Low Risk

Surfacing Type:	Grass	Surfacing is without defect:	Yes
Equipment Supplier:	Unknown	Equipment is without defect:	Yes
Equipment is labelled:	Yes

Finding One: The item is in good overall condition

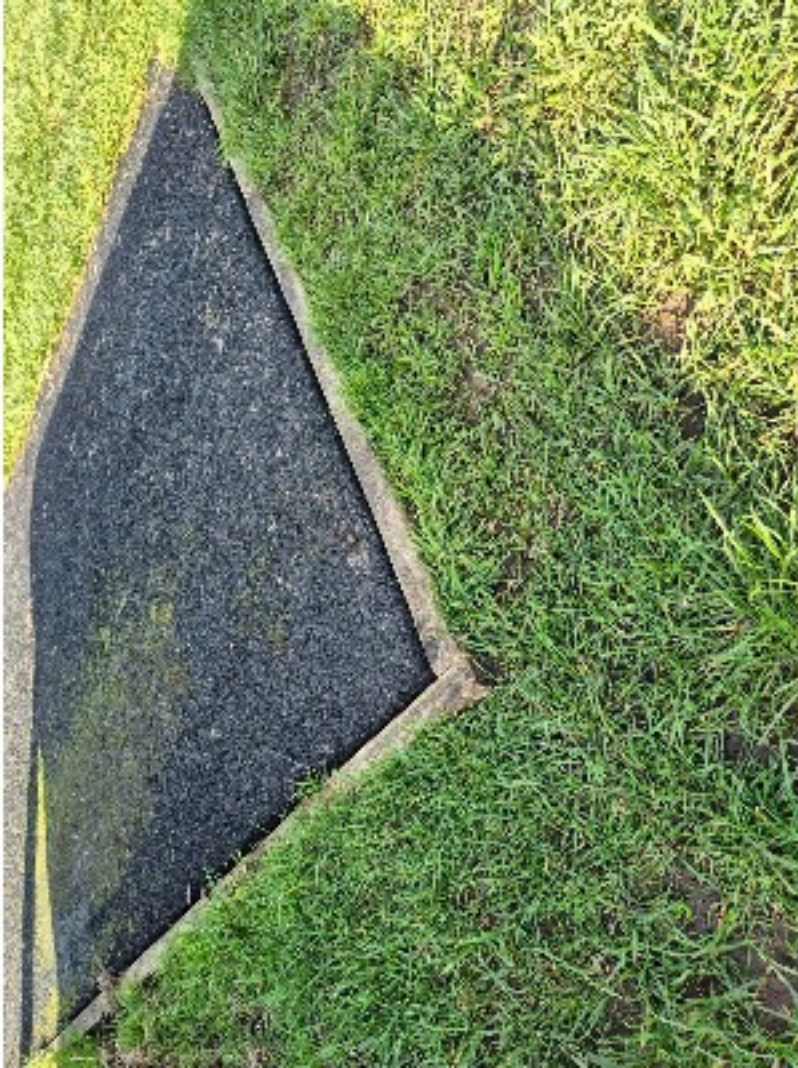
Basketball Post

Surfacing Type:	Wetpour	Surfacing is without defect:	No
Equipment Supplier:	Sure Shot	Equipment is without defect:	Yes
Equipment is labelled:	Yes

Finding One: The item is in good overall condition

Finding Two: Parts of the metal work are starting to rust/corrode

Finding Three: There are trip hazards at the edges of the surface

Consider building up ground level to eliminate trip hazards

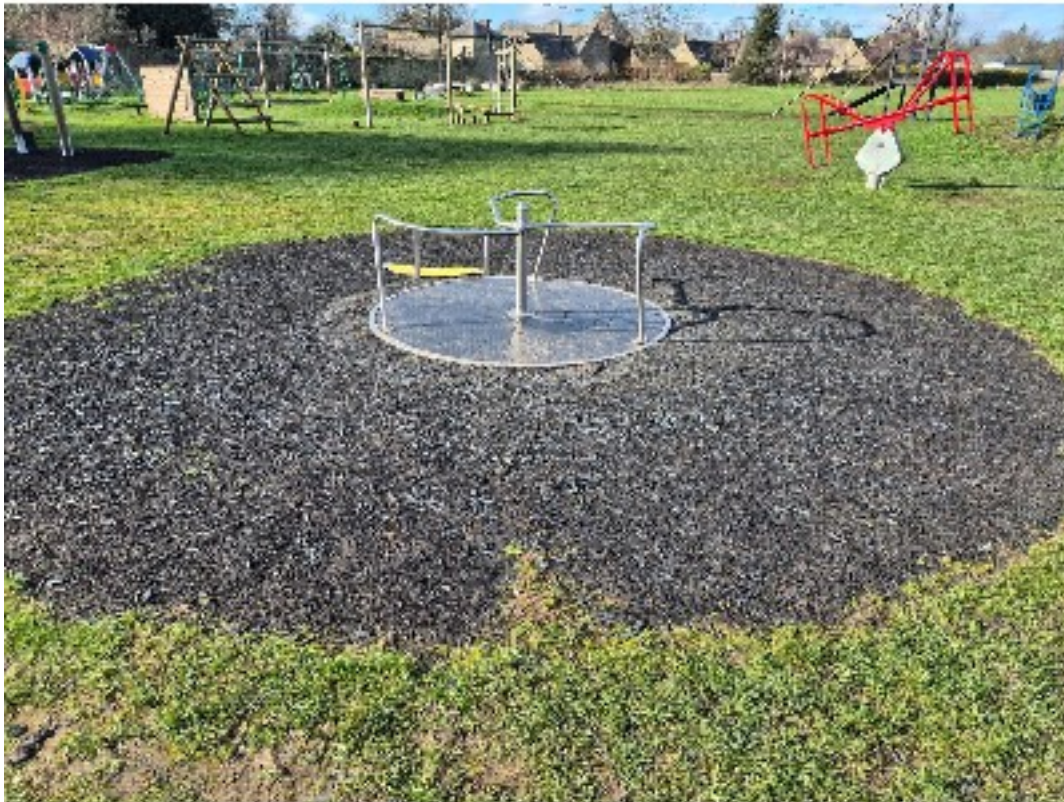
Inclusive Roundabout

Low Risk

Surfacing Type:	Rubber Mulch	Surfacing is without defect:	Yes
Equipment Supplier:	Playdale	Equipment is without defect:	Yes
Equipment is labelled:	Yes

Finding One: The item is in good overall condition

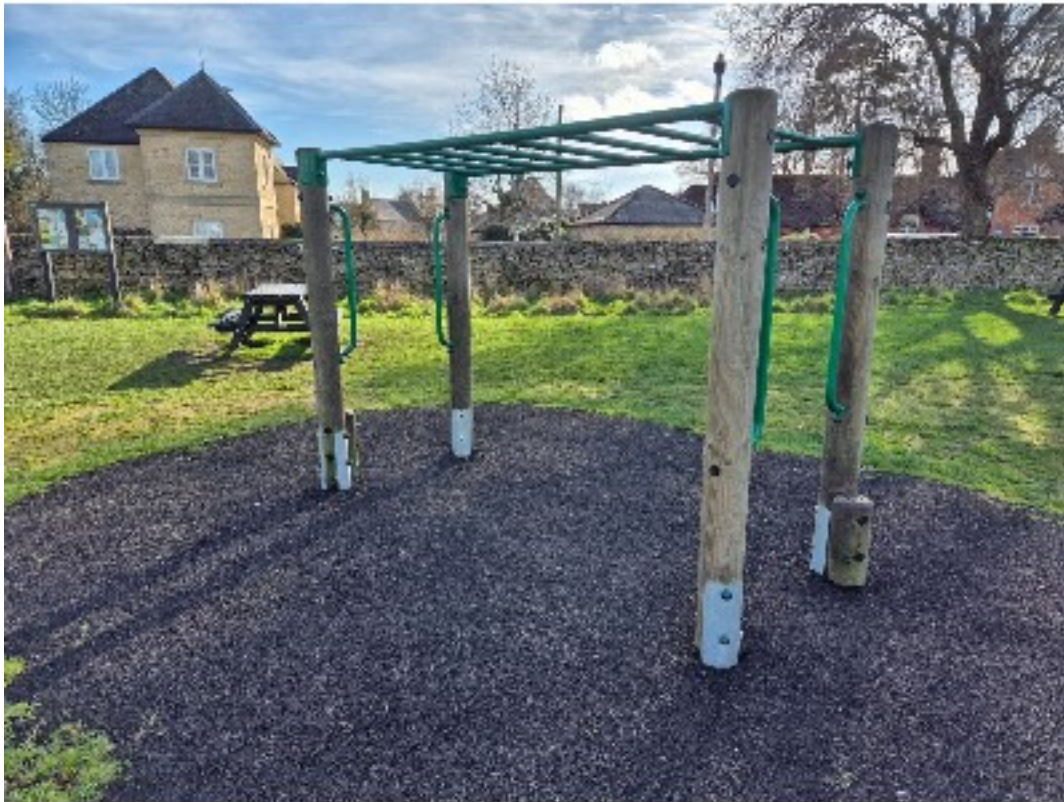
Overhead Bars

Low Risk

Surfacing Type:	Rubber Mulch	Surfacing is without defect:	Yes
Equipment Supplier:	AE Evans	Equipment is without defect:	Yes
Equipment is labelled:	Yes

Finding One: The item is in good overall condition

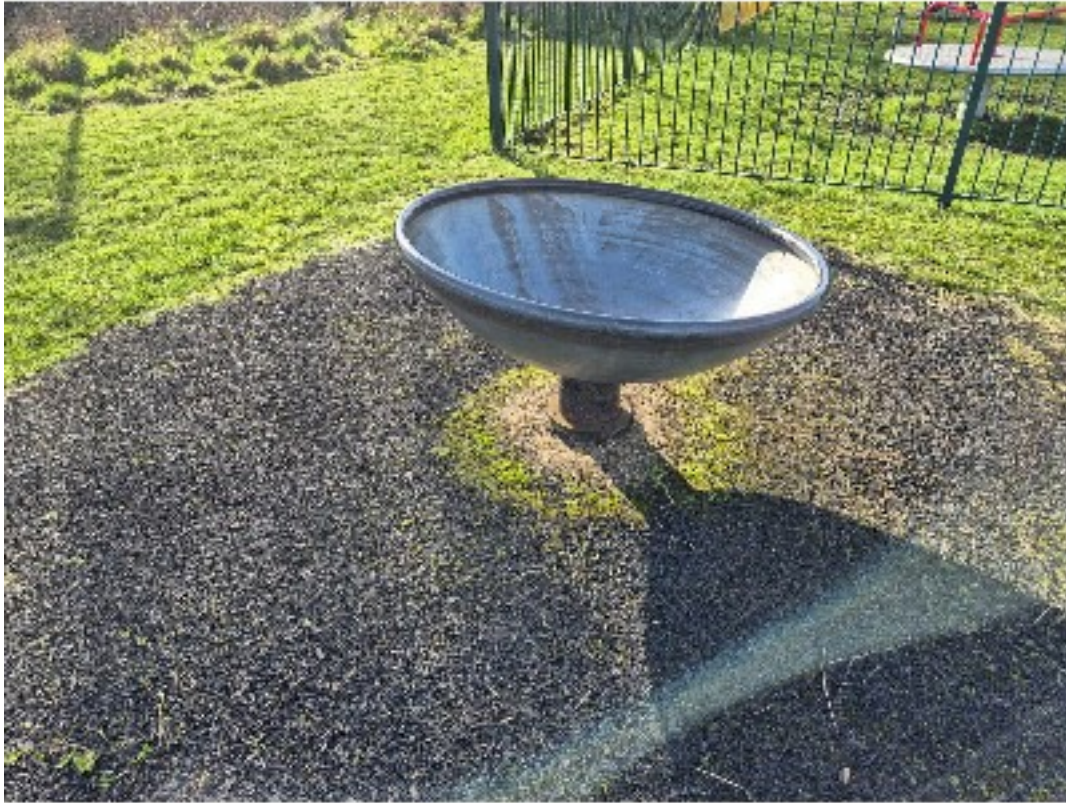
Spinning Bowl

Low Risk

Surfacing Type:	Rubber Mulch	Surfacing is without defect:	Yes
Equipment Supplier:	Unknown	Equipment is without defect:	Yes
Equipment is labelled:	No

Finding One: The item is in moderate overall condition

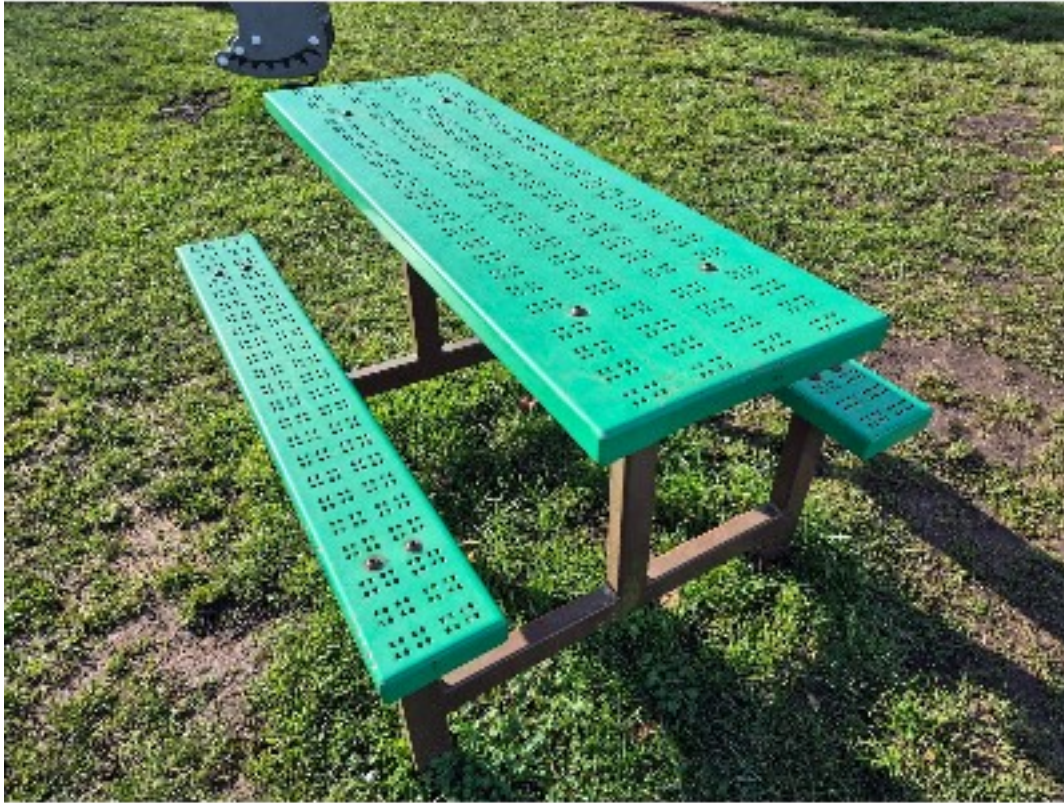
Picnic Table

Low Risk

Surfacing Type:	Grass	Surfacing is without defect:	Yes
Equipment Supplier:	Wicksteed	Equipment is without defect:	Yes
Equipment is labelled:	No

Finding One: The item is in moderate overall condition

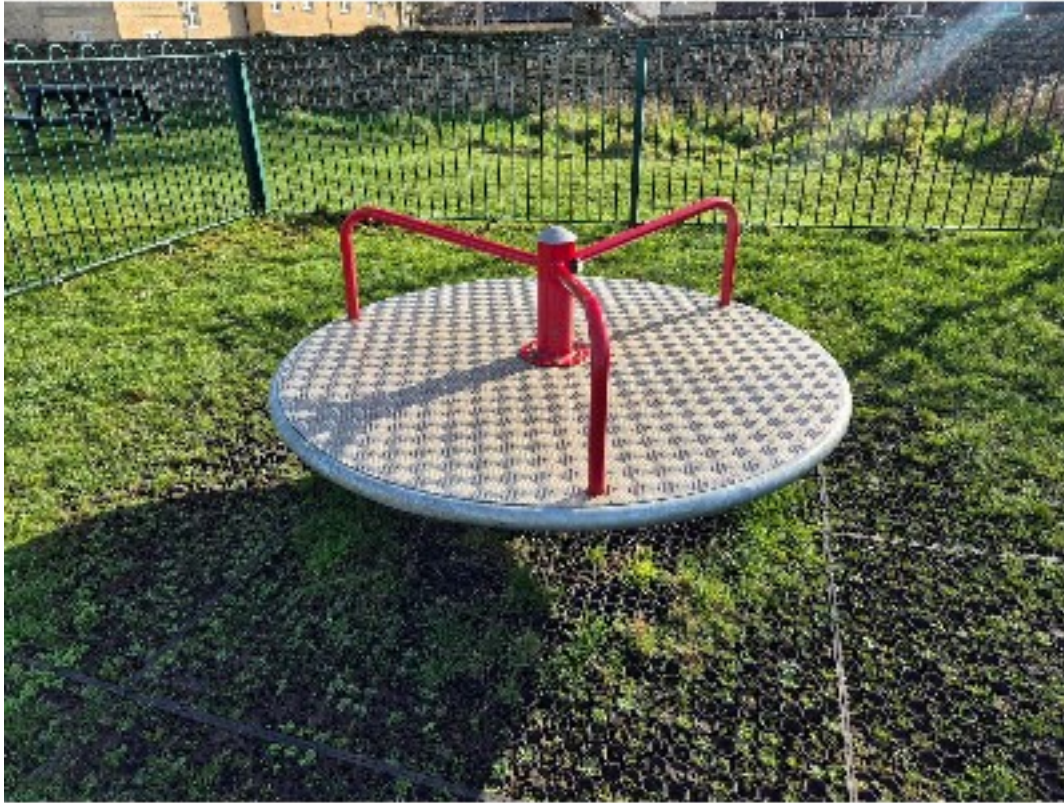
Roundabout

Low Risk

Surfacing Type:	Grass Guard	Surfacing is without defect:	Yes
Equipment Supplier:	Kompan	Equipment is without defect:	Yes
Equipment is labelled:	Yes

Finding One: The item is in good overall condition

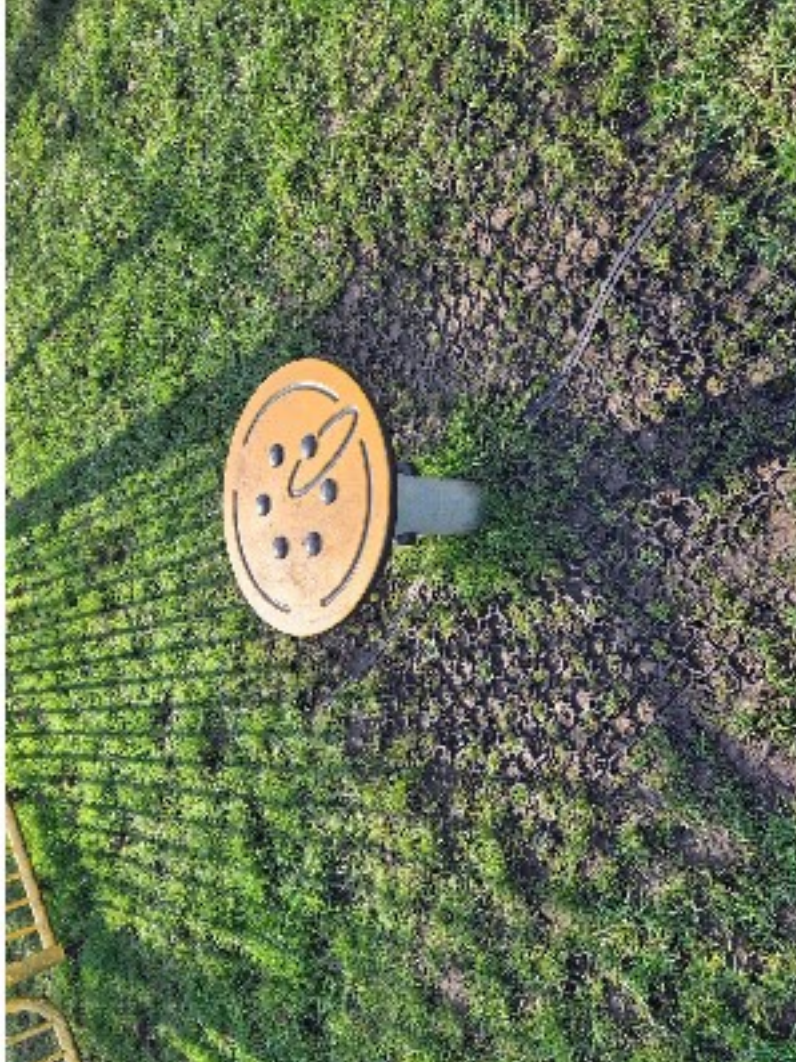
Rotating Disc

Low Risk

Surfacing Type:	Grass Guard	Surfacing is without defect:	Yes
Equipment Supplier:	Kompan	Equipment is without defect:	Yes
Equipment is labelled:	Yes

Finding One: The item is in good overall condition

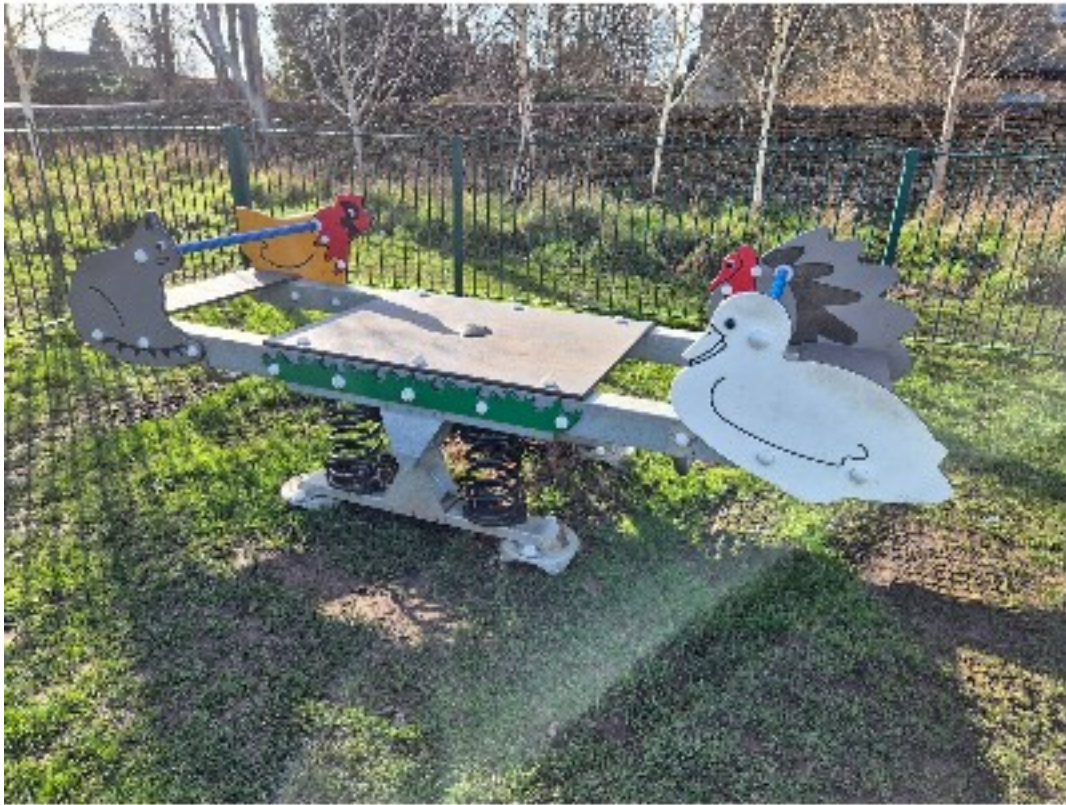
See-Saw

Low Risk

Surfacing Type:	Grass Guard	Surfacing is without defect:	Yes
Equipment Supplier:	Kompan	Equipment is without defect:	Yes
Equipment is labelled:	Yes

Finding One: The item is in good overall condition

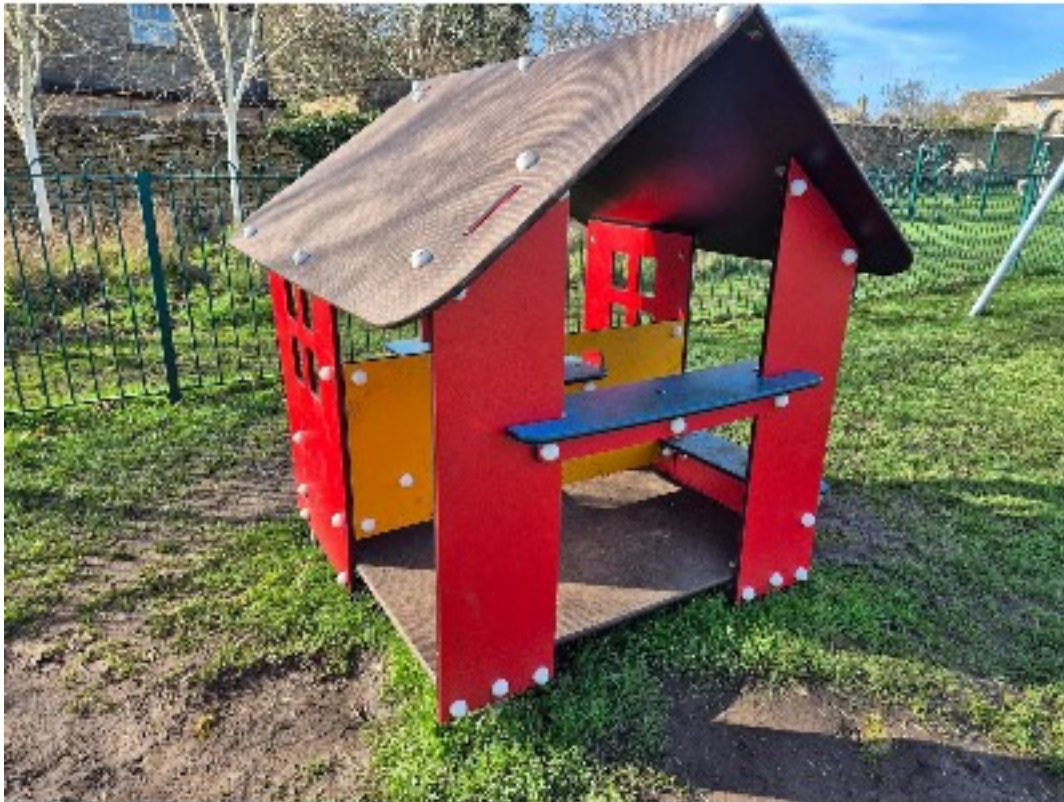
Play Hut

Low Risk

Surfacing Type:	Grass Guard	Surfacing is without defect:	Yes
Equipment Supplier:	Kompan	Equipment is without defect:	Yes
Equipment is labelled:	Yes

Finding One: The item is in good overall condition

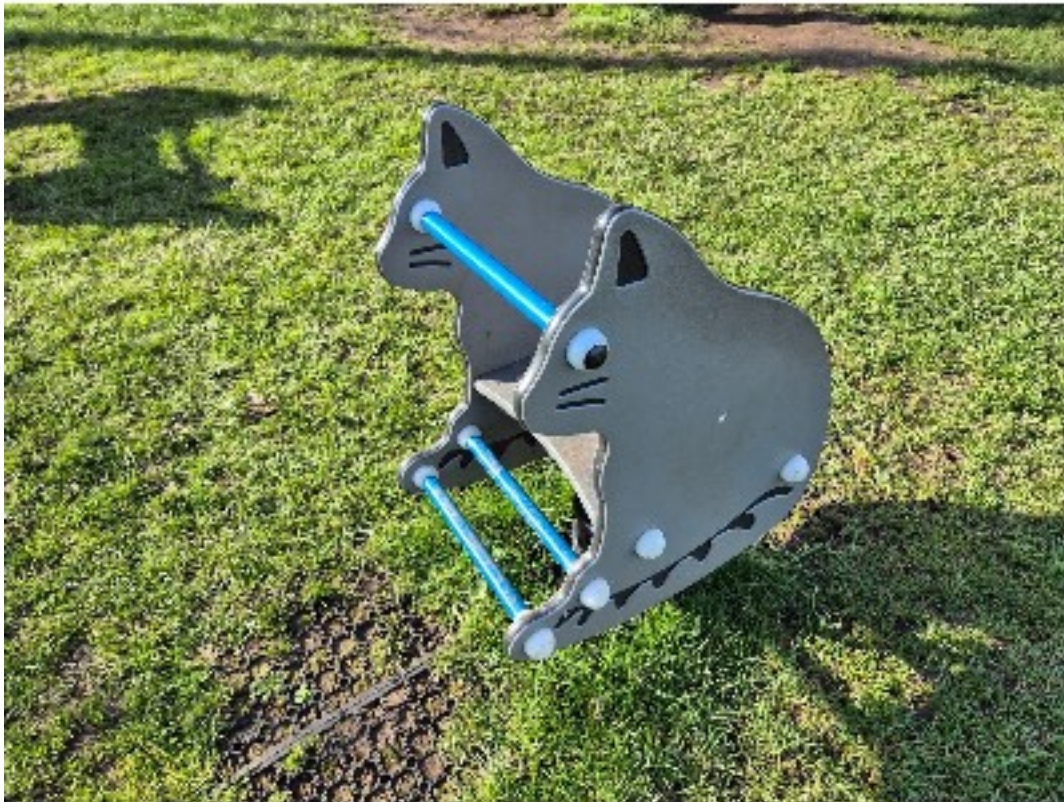
Springer

Low Risk

Surfacing Type:	Grass Guard	Surfacing is without defect:	Yes
Equipment Supplier:	Kompan	Equipment is without defect:	Yes
Equipment is labelled:	Yes

Finding One: The item is in good overall condition

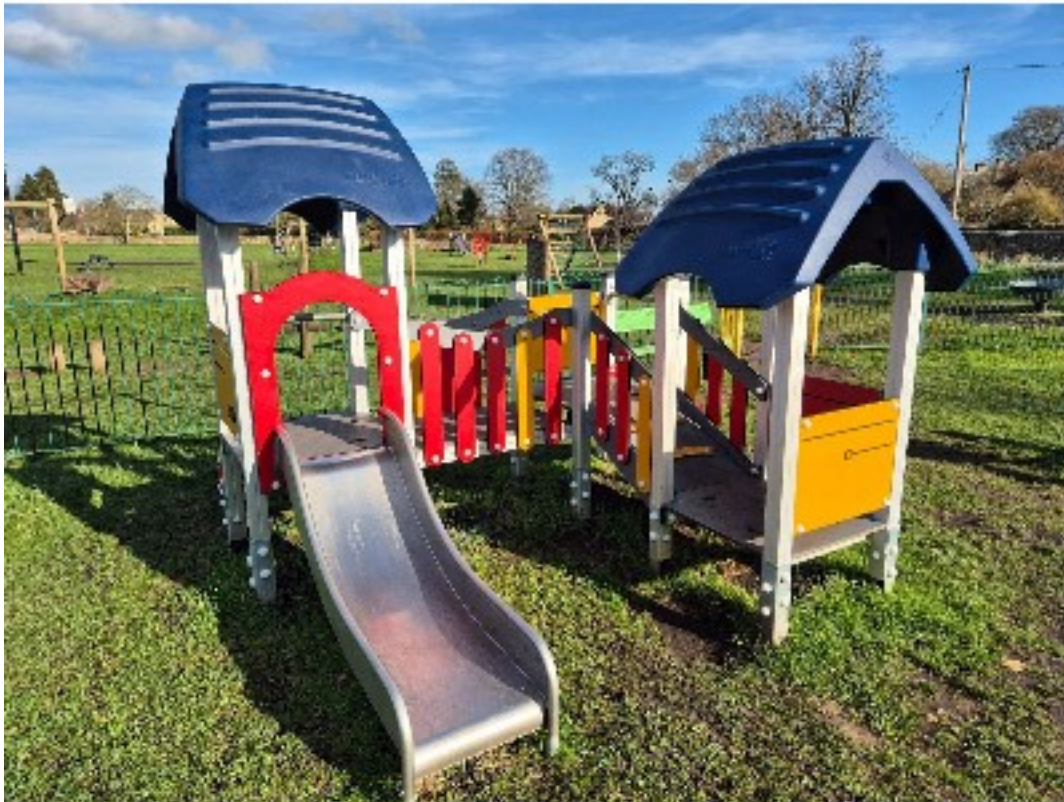
Multi Play Unit

Low Risk

Surfacing Type:	Grass Guard	Surfacing is without defect:	Yes
Equipment Supplier:	Kompan	Equipment is without defect:	Yes
Equipment is labelled:	Yes

Finding One: The item is in good overall condition

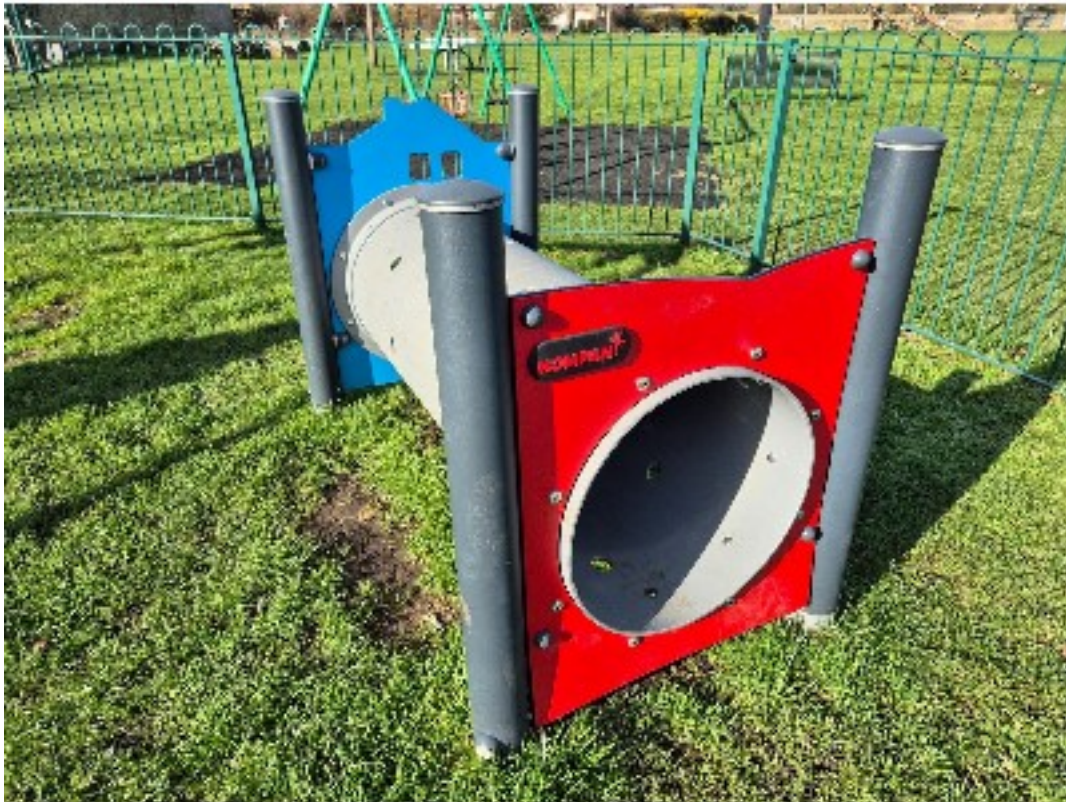
Crawl Tunnel

Low Risk

Surfacing Type:	Grass Guard	Surfacing is without defect:	Yes
Equipment Supplier:	Kompan	Equipment is without defect:	Yes
Equipment is labelled:	Yes

Finding One: The item is in good overall condition

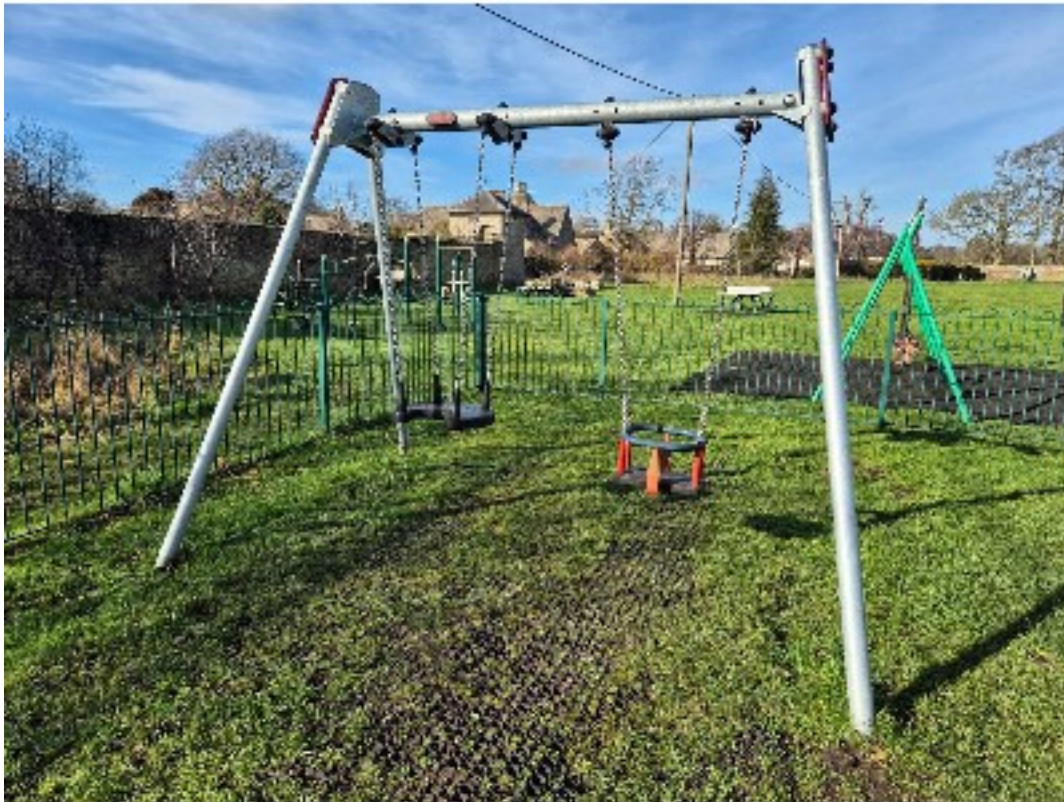
Toddler Swing

Low Risk

Surfacing Type:	Grass Guard	Surfacing is without defect:	No
Equipment Supplier:	Kompan	Equipment is without defect:	Yes
Equipment is labelled:	Yes

Finding One: The item is in good overall condition
